Electronic Systems Failures and Anomalies Attributed to Electromagnetic Interference

R.D. Leach and M.B. Alexander, Editor

R.D. Leach and M.B. Alexander, Editor
Marshall Space Flight Center • MSFC, Alabama

July 1995

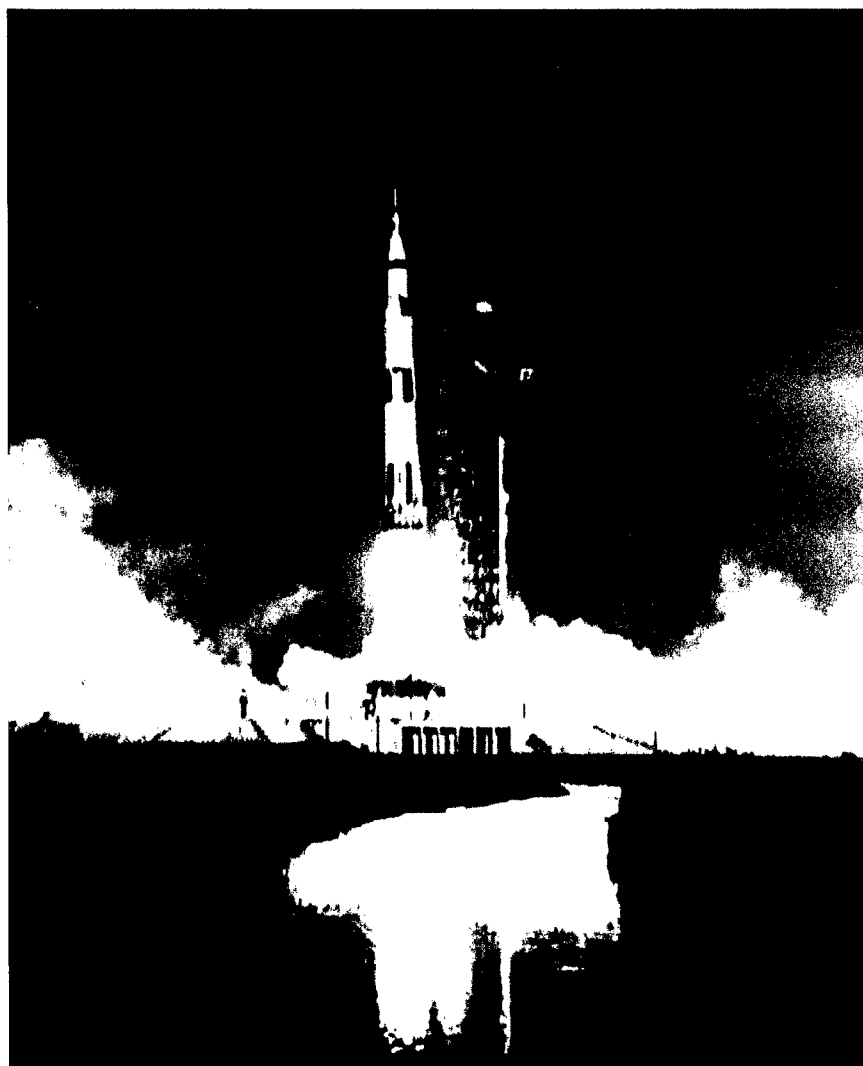
Figure 1. Saturn V launch.

During on-pad checkout at the Kennedy Space Center (KSC) prior to one of the early developmental test flights of the Saturn launch vehicle, the range safety receivers detected an extraneous signal. Because these receivers processed commands for engine cutoff, arm, and destruct, a thorough investigation was conducted to determine the cause of this unintended signal transmission. The problem appeared to be the production of spurious signals originating from the sum and difference combinations possible when signals frequencies are mixed. Although technically these spurious signals are not beat frequencies (associated with sound energy), this particular case is known within NASA as the beat frequency case and is maintained in this report by that title. The spurious signals were caused by the multitude of transmitters located on board to collect test data. Analysis determined that spurious signal frequencies very near the frequency of the range safety receivers were produced by a combination of frequencies from several telemetry transmitters in combination with one of the vehicle’s tracking transponders. Further investigation determined that mixing sources for the signals were the hinged cable tray covers and chain handrails on the gantry. This insight and analysis proved to be useful later. With a Saturn vehicle on pad, the range safety receivers detected a spurious command signal for engine cutoff from a Titan launch vehicle checkout on the next pad. The Titan was using the same modulation frequencies on a different carrier frequency for its range safety receivers. A signal sent to the Titan vehicle was also received by the tracking transponder on the Saturn vehicle. The retransmitted signal of the transponder was mixed with certain telemetry signals resulting in the false engine cutoff command. After this incident, the decision was made to fly with the culprit transponder inactive (eventually it was removed from the vehicle). Later, both

telemetry and range safety transmissions were moved to a higher frequency range where the production of spurious signals did not interfere with the range safety system.⁵
