Spacecraft System Failures and Anomalies Attributed to the Natural Space Environment

K.L. Bedingfield, R.D. Leach, and M.B. Alexander, Editor

SPACECRAFT SYSTEM FAILURES AND ANOMALIES ATTRIBUTED TO THE NATURAL SPACE ENVIRONMENT

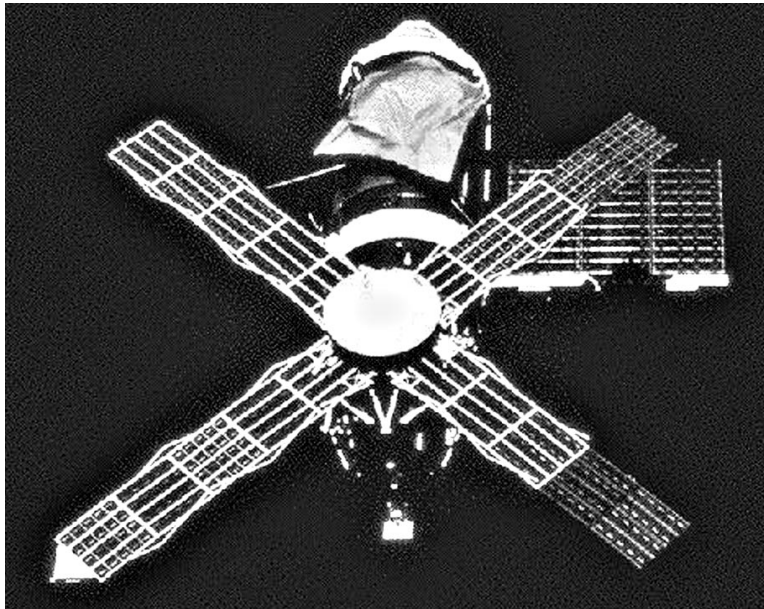
Figure 4. *Skylab*.

On July 11, 1979, *Skylab* (fig. 4) prematurely reentered the Earth's atmosphere. This orbiting laboratory, the first of its kind, experienced the density effects of the neutral thermosphere. As atmospheric drag increased, the spacecraft reached the point at which it could no longer stay in orbit, and before a rescue mission could be launched, it fell to Earth.⁴

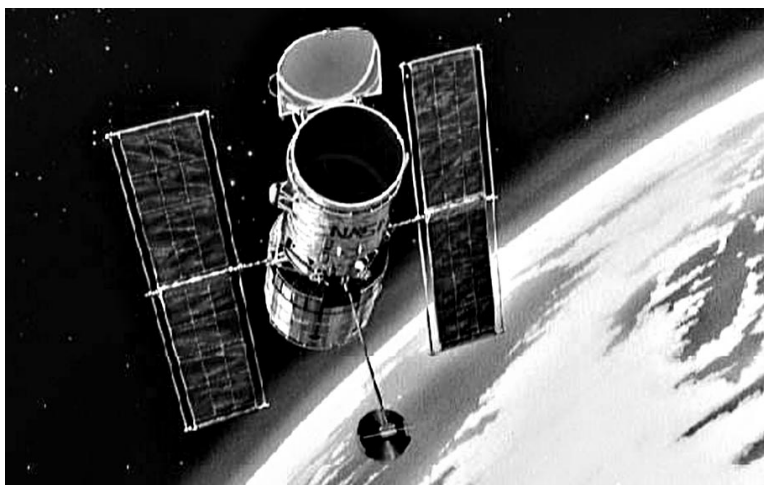
Figure 7. HST.

Before the December 1993 HST service mission, the solar arrays vibrated severely each time the observatory emerged from shade into sunlight. Active vibration cancellation using the onboard gyros was implemented before the service mission to minimize the problem. Thermal expansion of the support poles (also called bistems) was blamed for the vibrations, which interfered with deep-space observations. The new arrays installed during the service mission had sleeves over the bistems to provide jitter-free imagery⁷ (fig. 7).

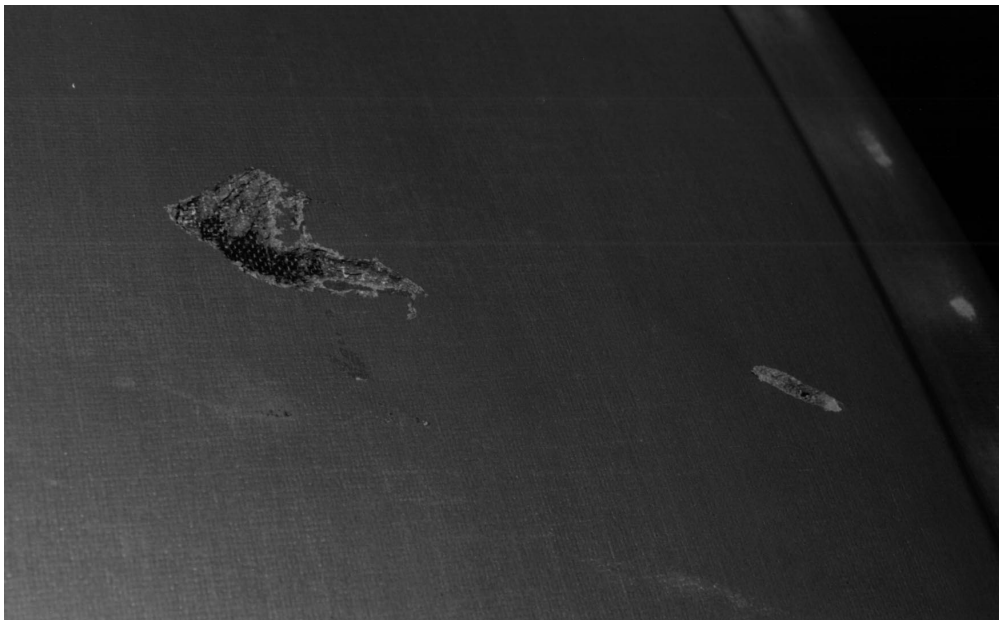
Figure 13. Orbiter *Atlantis* (STS-45) right wing leading edge gouges.

On Space Shuttle mission STS-45, launched March 24, 1992, the orbiter *Atlantis* suffered two gouges, (1.9 by 1.6 in. and 0.4 by 1 in.), on the upper portion of the right wing leading edge (fig. 13). The most probable cause was a low-velocity (relative to the spacecraft) debris impact on orbit or during reentry. However, Johnson Space Center (JSC) engineering has not ruled out prelaunch or ascent debris as the cause of the damage. This particular event raised concern about the consequences of a higher energy impact to the integrity of the spacecraft.¹¹
