Spacecraft System Failures and Anomalies Attributed to the Natural Space Environment

K.L. Bedingfield, R.D. Leach, and M.B. Alexander, Editor

REFERENCE PUBLICATION

SPACECRAFT SYSTEM FAILURES AND ANOMALIES ATTRIBUTED TO THE NATURAL SPACE ENVIRONMENT

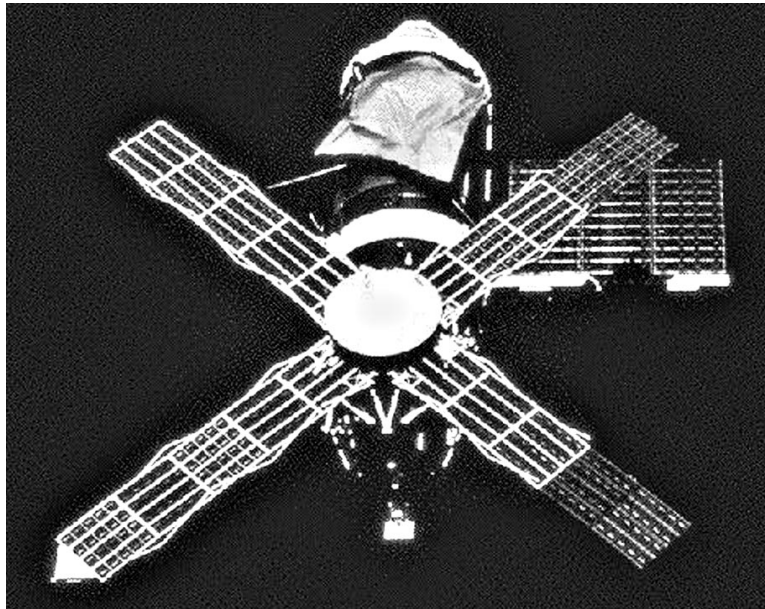
Figure 4. *Skylab*.

On July 11, 1979, *Skylab* (fig. 4) prematurely reentered the Earth's atmosphere. This orbiting laboratory, the first of its kind, experienced the density effects of the neutral thermosphere. As atmospheric drag increased, the spacecraft reached the point at which it could no longer stay in orbit, and before a rescue mission could be launched, it fell to Earth.⁴

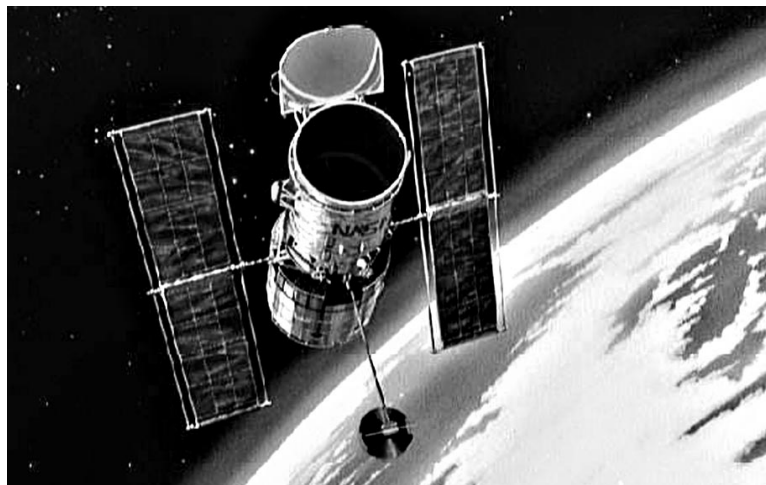
Figure 7. HST.

Before the December 1993 HST service mission, the solar arrays vibrated severely each time the observatory emerged from shade into sunlight. Active vibration cancellation using the onboard gyros was implemented before the service mission to minimize the problem. Thermal expansion of the support poles (also called bistems) was blamed for the vibrations, which interfered with deep-space observations. The new arrays installed during the service mission had sleeves over the bistems to provide jitter-free imagery⁷ (fig. 7).

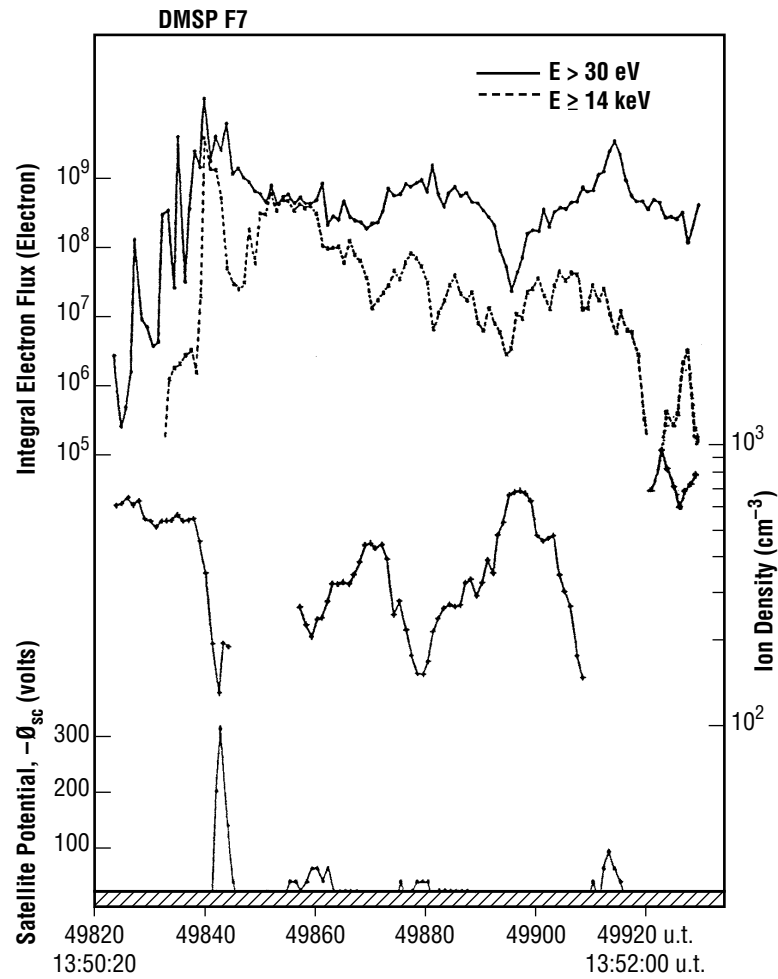
Figure 8. An example of the type of charging events encountered by the DMSP satellite F7 on November 26, 1983. DMSP 7 is a defense meteorological satellite flying LEO/polar.

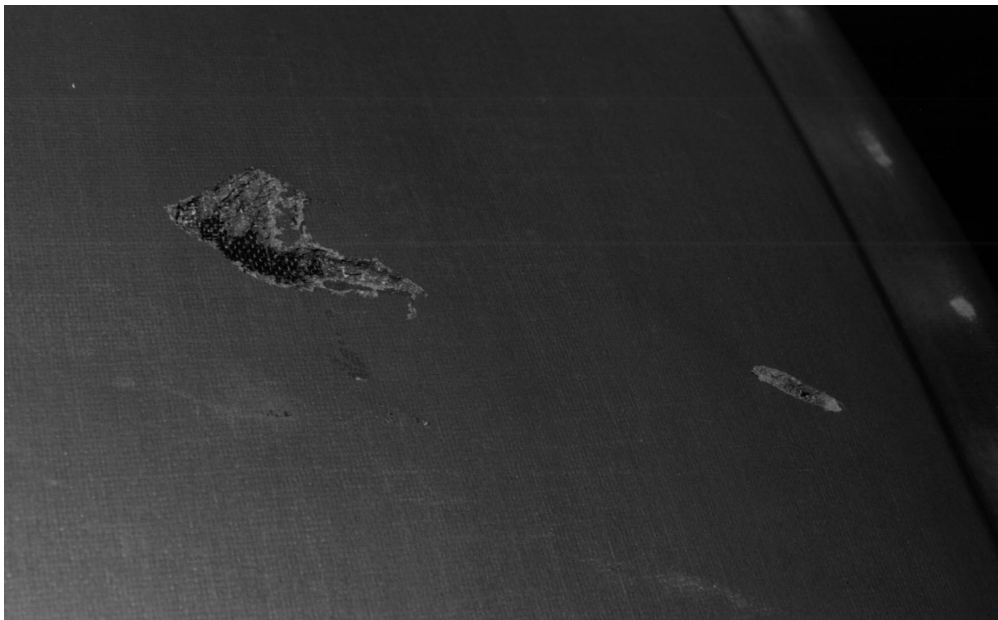
Figure 13. Orbiter *Atlantis* (STS-45) right wing leading edge gouges.

On Space Shuttle mission STS-45, launched March 24, 1992, the orbiter *Atlantis* suffered two gouges, (1.9 by 1.6 in. and 0.4 by 1 in.), on the upper portion of the right wing leading edge (fig. 13). The most probable cause was a low-velocity (relative to the spacecraft) debris impact on orbit or during reentry. However, Johnson Space Center (JSC) engineering has not ruled out prelaunch or ascent debris as the cause of the damage. This particular event raised concern about the consequences of a higher energy impact to the integrity of the spacecraft.¹¹
