AGARD Corrosion Handbook Volume 1 Aircraft Corrosion: Causes and Case Histories

AIRCRAFT CORROSION: CAUSES AND CASE HISTORIES

W.Wallace
Head, Structures and Materials Laboratory
National Aeronautical Establishment
National Research Council Canada
Ottawa, Ontario, Canada

D.W.Hoeppner
Cockburn Professor of Engineering Design
Department of Mechanical Engineering
University of Toronto
Toronto, Ontario, Canada

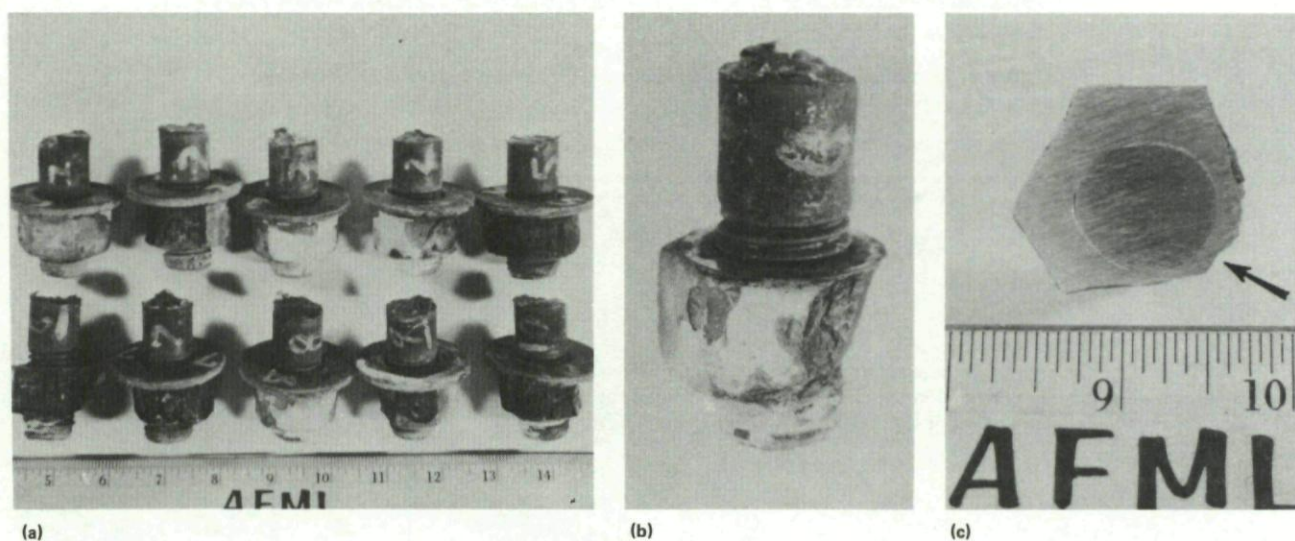
Visual and optical examination verified that considerable corrosion existed on all part surfaces. However, the most severely affected areas were found to be on the surfaces of the nuts, as shown in Figure 7-10(b). Cross-sections through the nuts and bolts revealed the severity of corrosion, and showed that nearly one-third of the cross-sectional area on all ten nuts had been lost to corrosion. The depth of corrosion, in some areas, extended almost to the bolt surface, as shown in Figure 7-10(c).

Fig. 7-10 Corrosion of structural steel fasteners

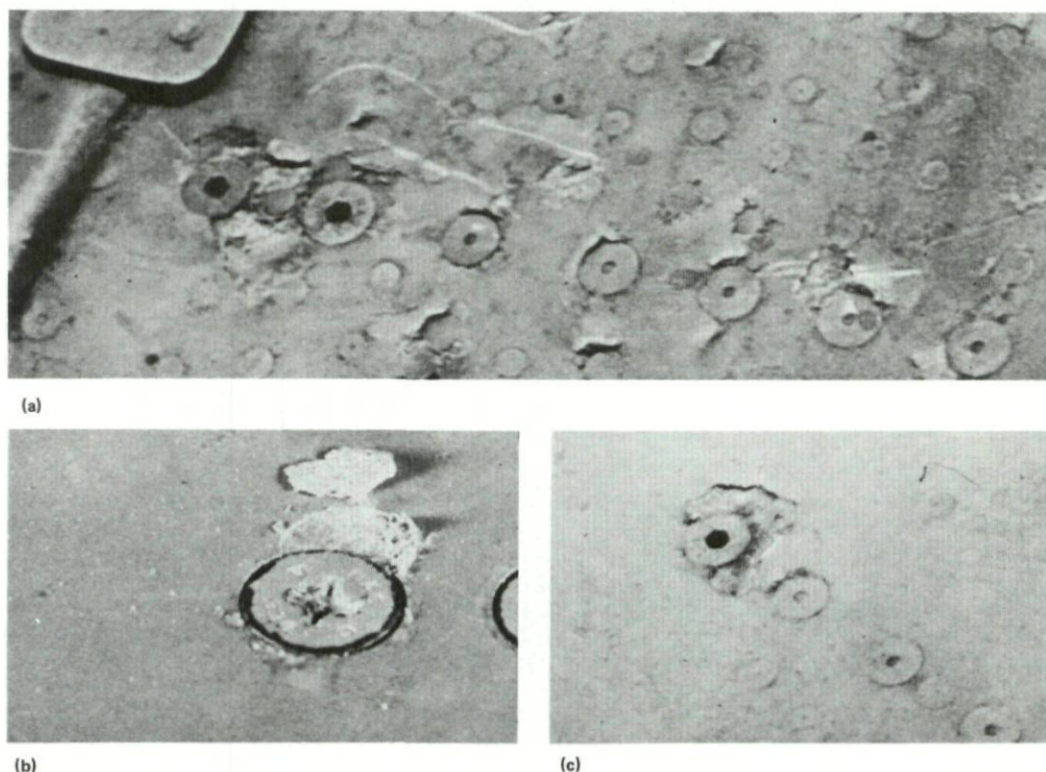
Fig. 8-1 Galvanic corrosion occurring around cadmium plated steel fasteners in a 7075-T6 aluminium skin

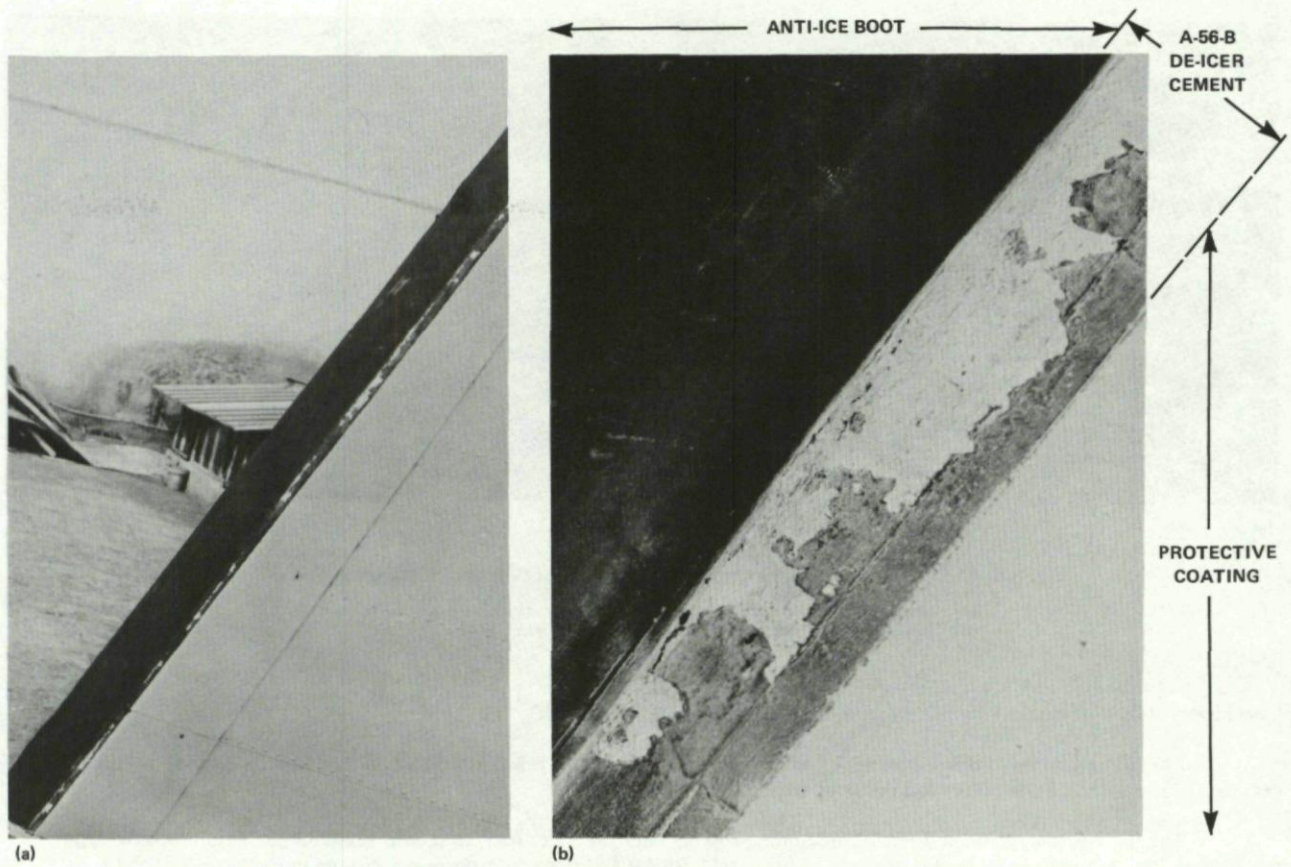
Fig. 8-4 Galvanic corrosion in an aluminium alloy skin due to contact with a conductive cement

The personnel involved in the repair and overhaul of this aircraft recommended the use of a rain erosion resistant anti-static coating system (MIL-C-7439) to replace the conductive de-icer cement. The important requirement is to avoid the use of a conductive cement in exposed contact with the aluminium. In the example cited, corrosion damage to the 2024 aluminium would have been much reduced had the bare cement been covered by a protective coating to prevent mechanical damage to the cement and to prevent the intrusion of water.

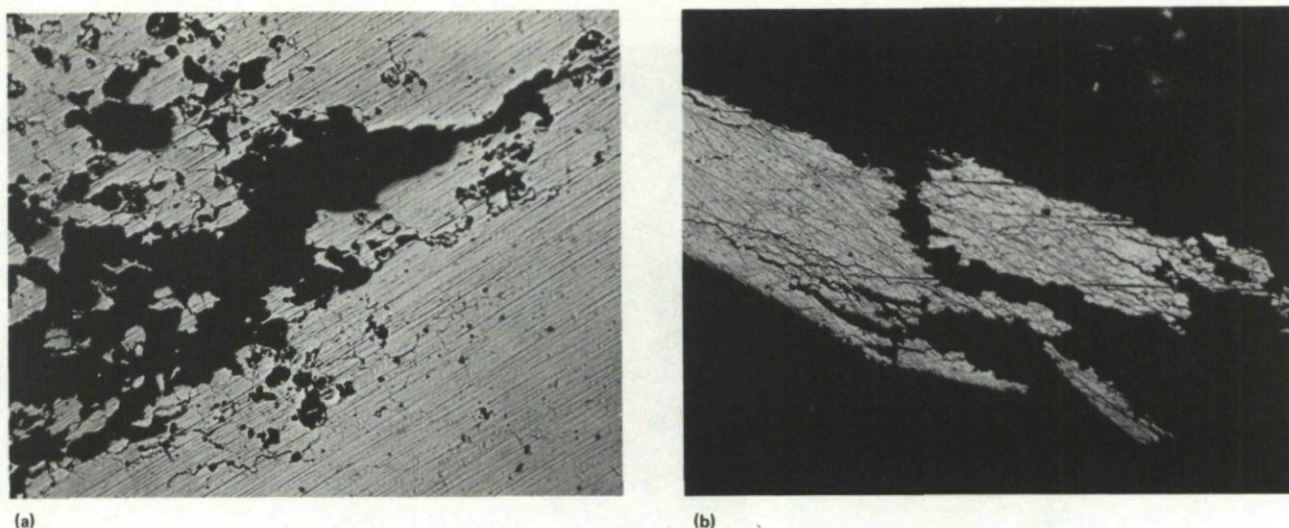
Fig. 8-6 Metallographic sections through the aluminium skin shown in Figures 8-4 and 8-5

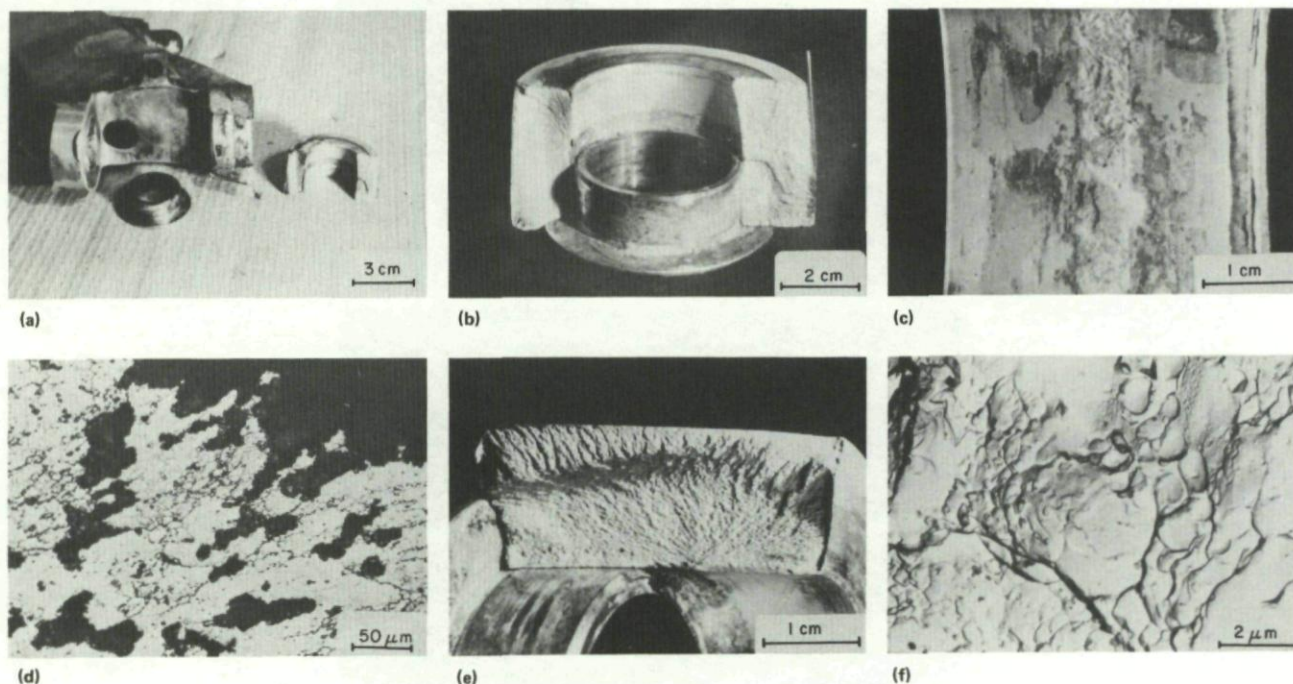
Figures 8-7(e) and 8-7(f) show one of the fracture surfaces produced by the failure. Figure 8-7(e) shows that the fracture originated at the site of the corrosion damage. Electron fractography of the same fracture surface (Fig. 8-7(f)) revealed mainly ductile dimples indicative of ductile failure.

Fig. 8-7 Galvanic corrosion in a 7075-T6 king pin lug of a fighter aircraft main leg

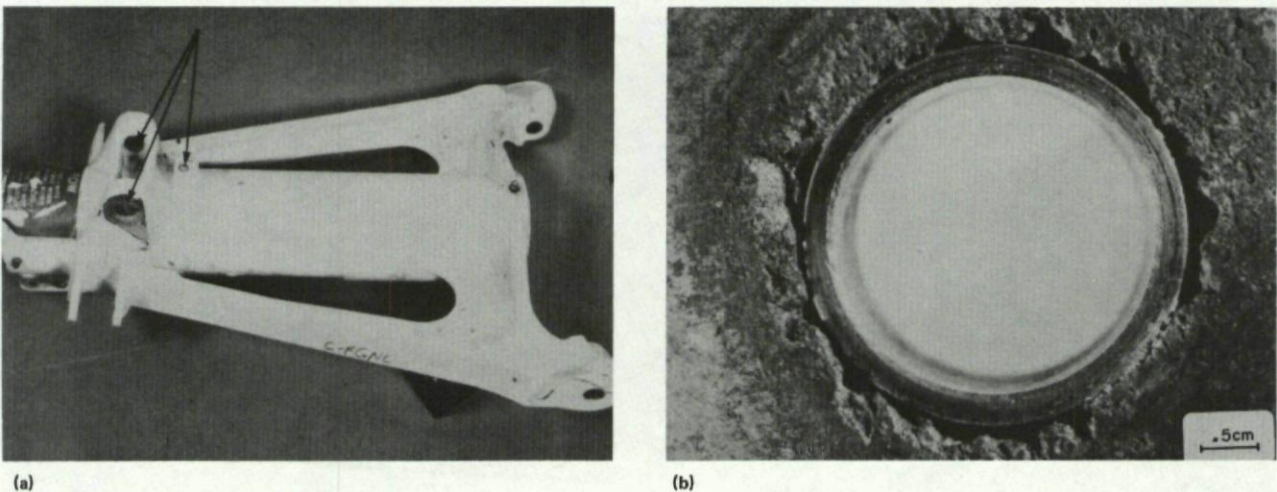
Fig. 8-8 Galvanic corrosion between a steel bushing and a cast magnesium alloy nose gear strut

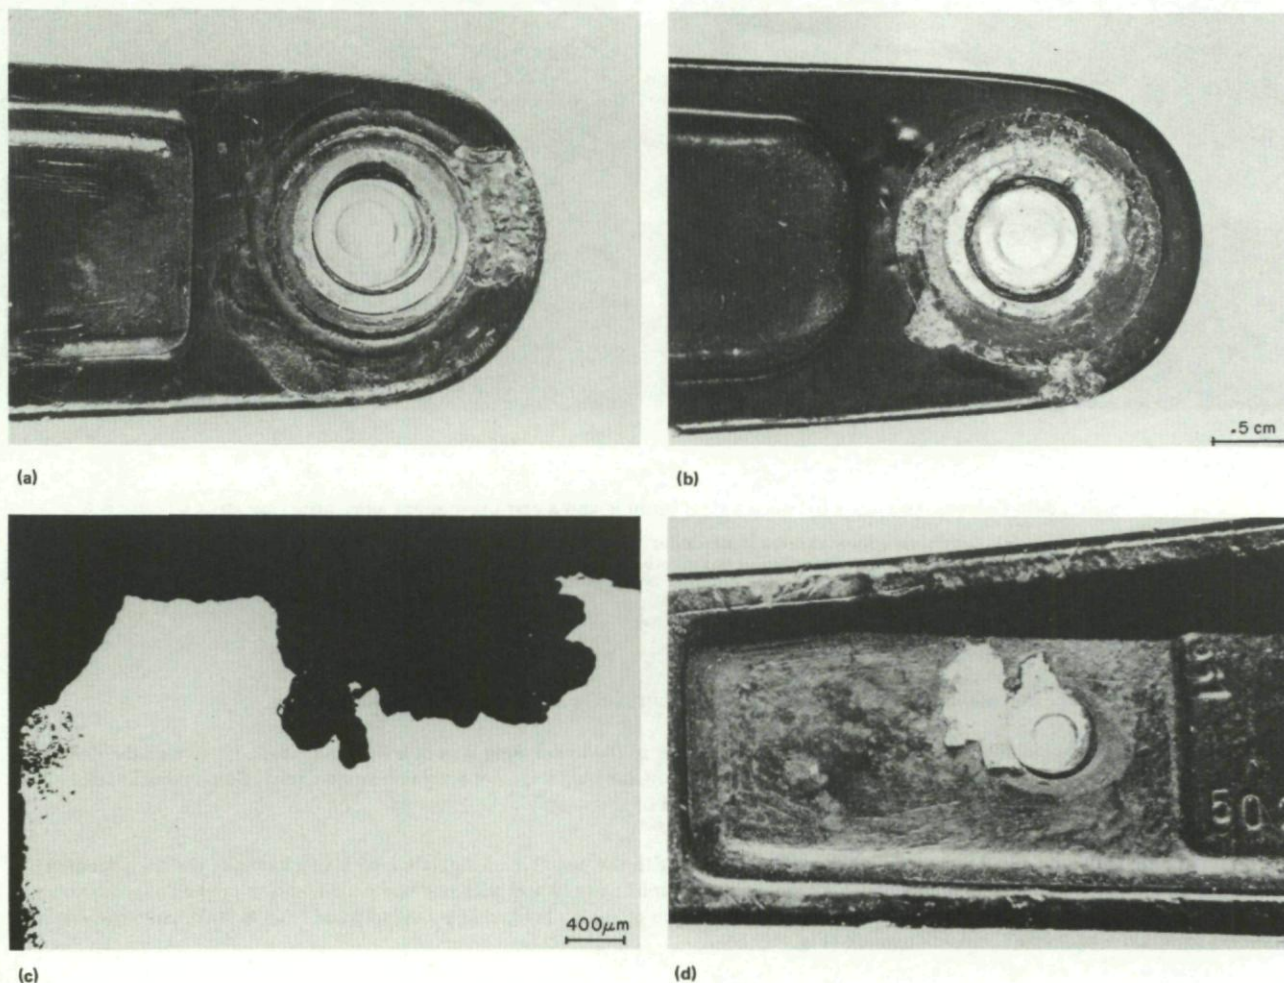
The control levers of a flap deflection mechanism of an aircraft were made from a magnesium casting alloy with a nominal composition Mg - 6%, Zn - 2%, Th - 0.75 Zr, similar to ZH62A. The levers were protected with a zinc-chromate primer and an epoxy top-coat. Galvanic corrosion was found in the levers in a socket where steel balls had been located. The ends of the lever arms are shown in Figures 8-10(a) and 8-10(b), which also show the corrosion damage. Figure 8-10(c) shows a cross-section through the lever arm in the corroded area and shows deep cavities due to this galvanic corrosion.

Fig. 8-10 Galvanic corrosion in a cast magnesium alloy flap control lever arm

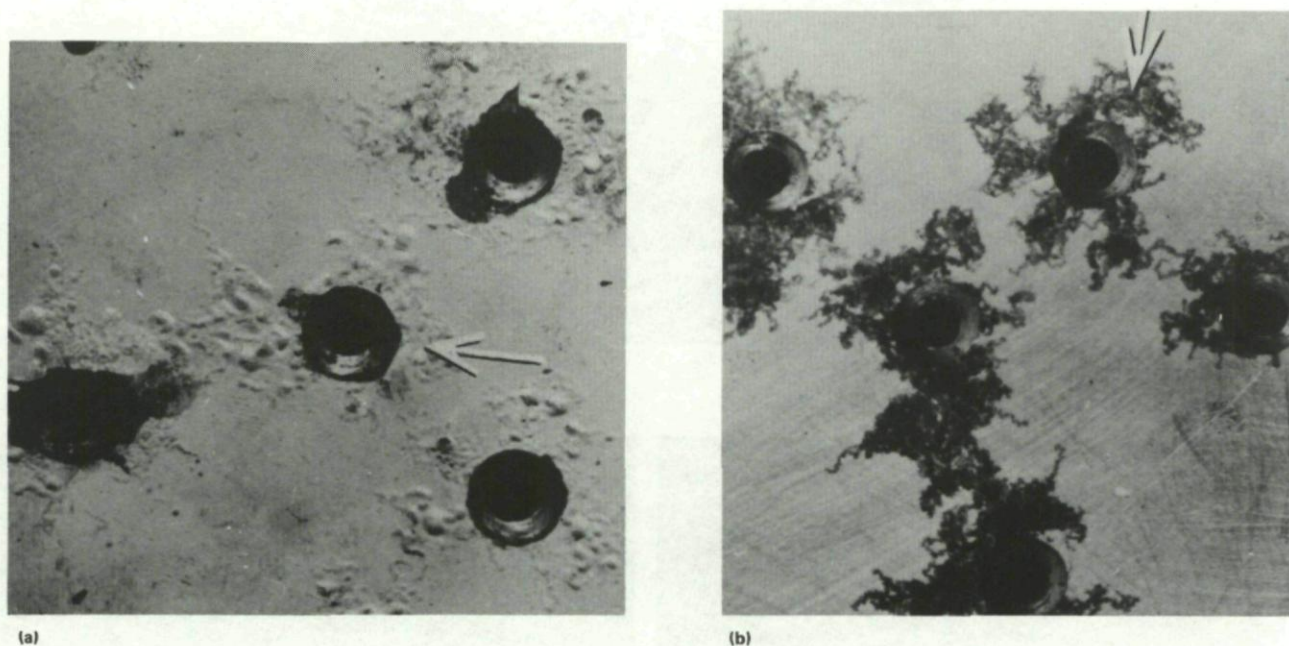
Fig. 9-4 Filiform corrosion in an aluminium alloy sheet structure

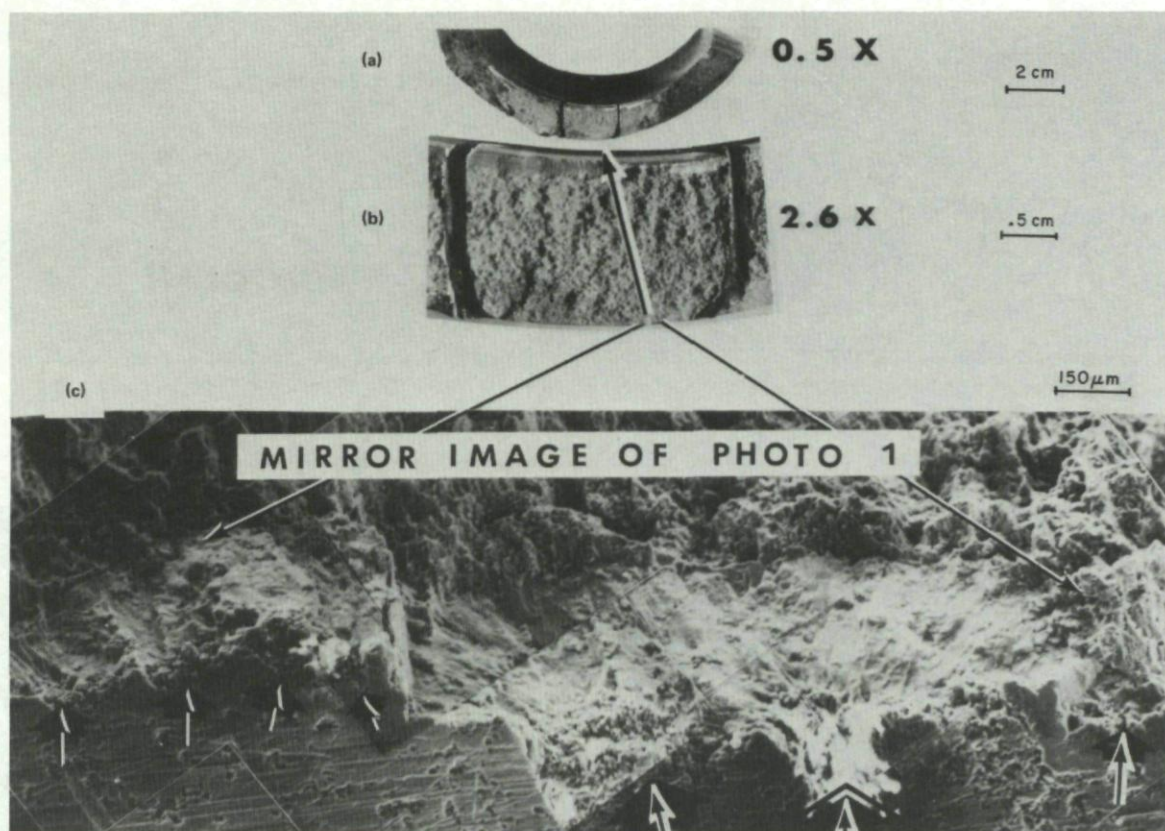
Within a one month period, three naval aircraft were damaged due to failure of their main landing gear struts. The failed struts were submitted for laboratory examination, which showed the strut outer barrel was fabricated from 2014-type aluminium alloy, and all were within the specified dimensional tolerances with respect to wall thicknesses.

Fig. 9-6 Pitting corrosion and fatigue of a 2014 aluminium alloy main landing gear strut

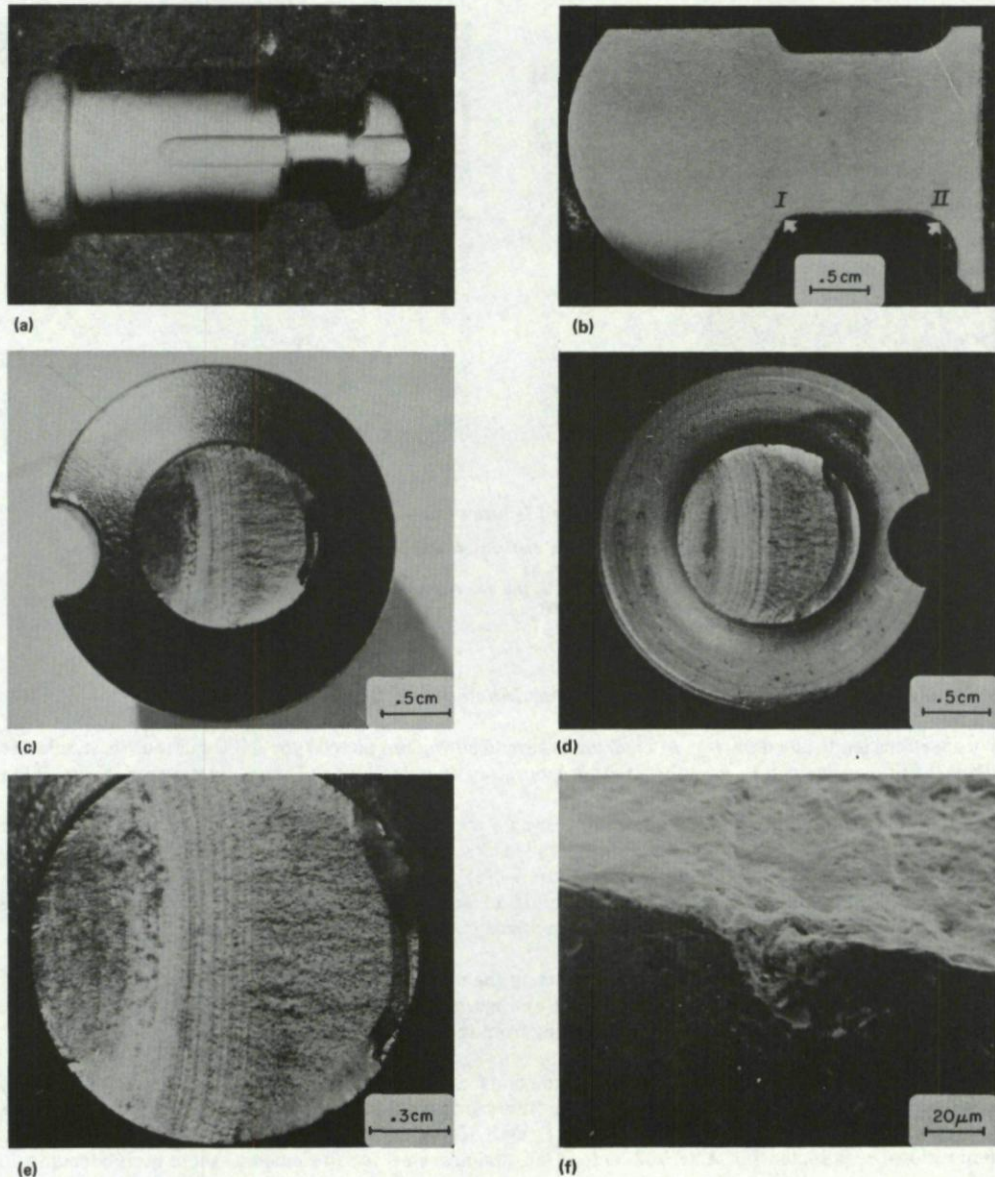
All of the failures initiated at the side of the latch knobs facing towards the wing lower side, and in every failure almost half the cross-section showed a fatigue fracture surface. An investigation with the scanning electron microscope revealed that the failures were initiated by corrosion pits. This is illustrated in Figure 9-7(f), showing a corrosion pit at the origin of one of the fatigue fractures.

Fig. 9-7 Pitting corrosion and fatigue failure of a 4340 steel tip tank latch knob

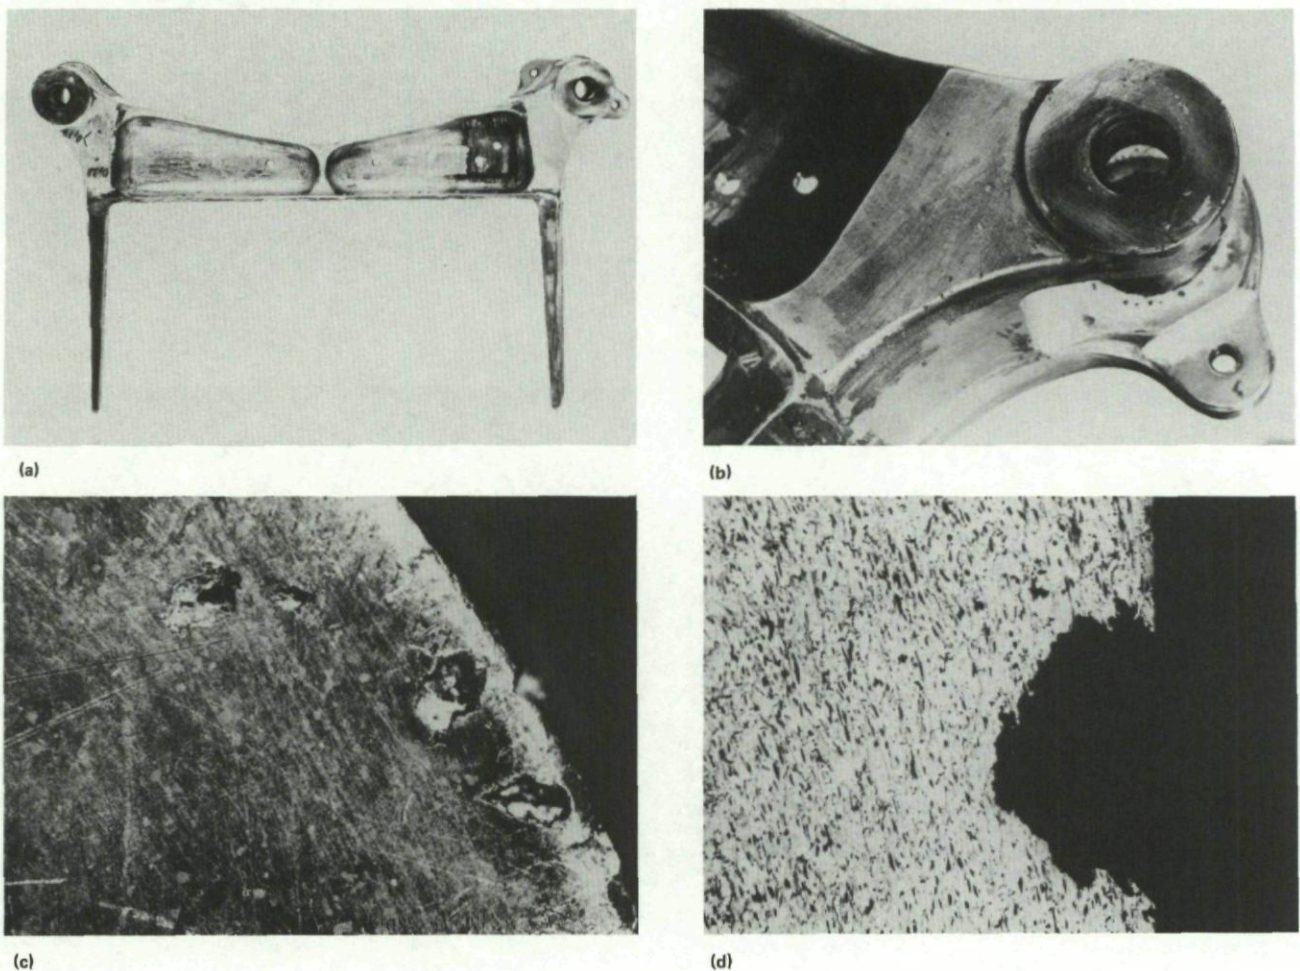
Fig. 9-12 Pitting corrosion of a 7075 aluminium tail cone fitting

These problems led to more regular maintenance of the protective finishes, especially around the key boss areas where the heat shields contact the wheels. The problem also led to an investigation of adhesive tapes to provide insulation between the stainless steel and the aluminium wheel, and an aluminium foil tape which was thought would provide better heat dissipation properties and less likely to damage the wheel anodic coating. The heat shields could not be removed since high temperatures would occur in the wheels and lead to fuse plug release. A more rigorous programme of non-destructive inspection was also implemented, involving eddy current inspection about the bead seat radius and ultrasonic inspection for defects in the key boss radius-heat shield contact area.

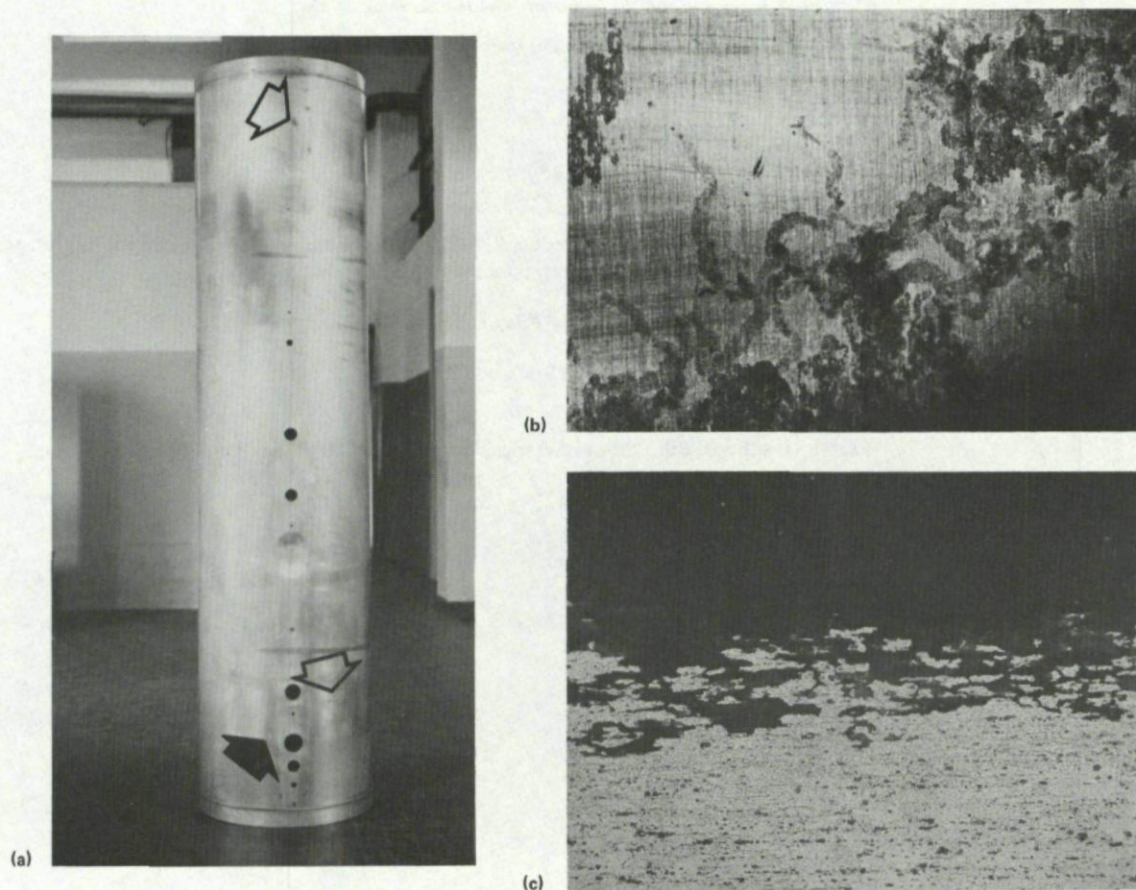
Closer surface examination showed that the corrosion followed the characteristic wandering path of filiform corrosion, as shown in Figure 9-13(b), while metallographic sections through the corrosion damage showed areas resembling broad pits and intergranular tunnelling (Fig. 9-13(c)). The alloy was found to be 6061 aluminium with a hardness of H_B 52, suggesting the alloy was in a T6 temper condition. The protective coating on this part had been removed by the operator prior to laboratory inspection, and therefore is unknown, however modern epoxy primers and polyurethane paint finishes, if properly maintained, should be sufficient to prevent this type of problem from recurring.

Fig. 9-13 Filiform corrosion in a fighter aircraft pylon tank

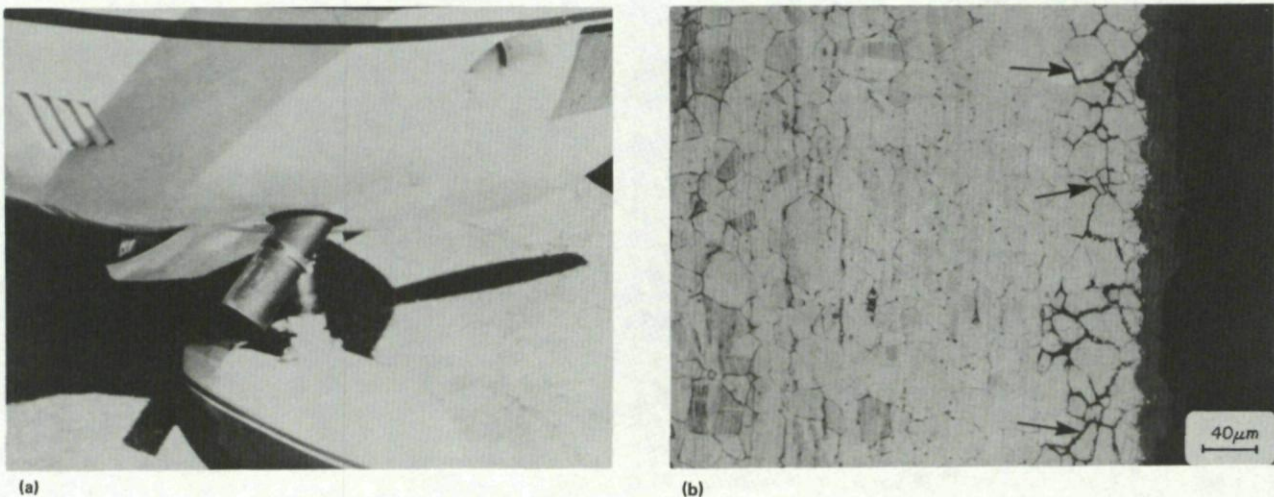
Fig. 10-3 Intergranular corrosion and fatigue of a light aircraft engine exhaust

- (a) Silencer extension fitted onto the exhaust pipe.
- (b) Intergranular attack of the austenitic stainless steel pipe. Kalling's etch. (Mag. $\times 250$)

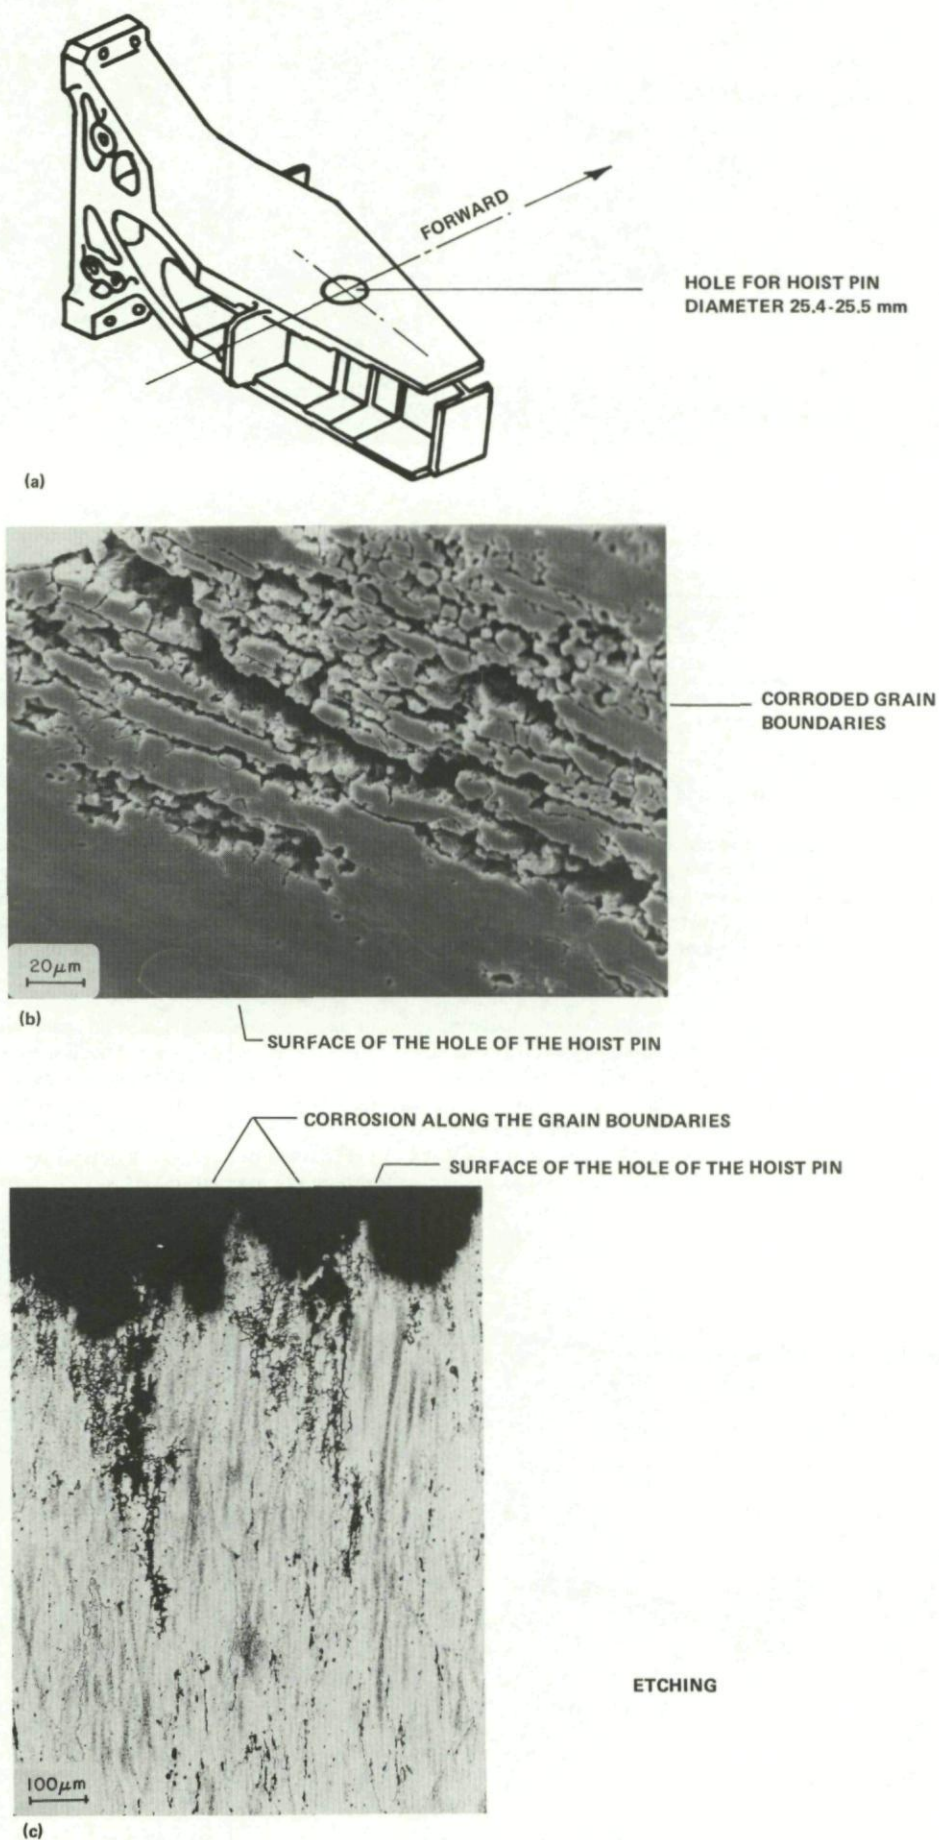
Fig. 10-4 Intergranular corrosion of an Al-Zn-Mg-Cu alloy wing attachment forging

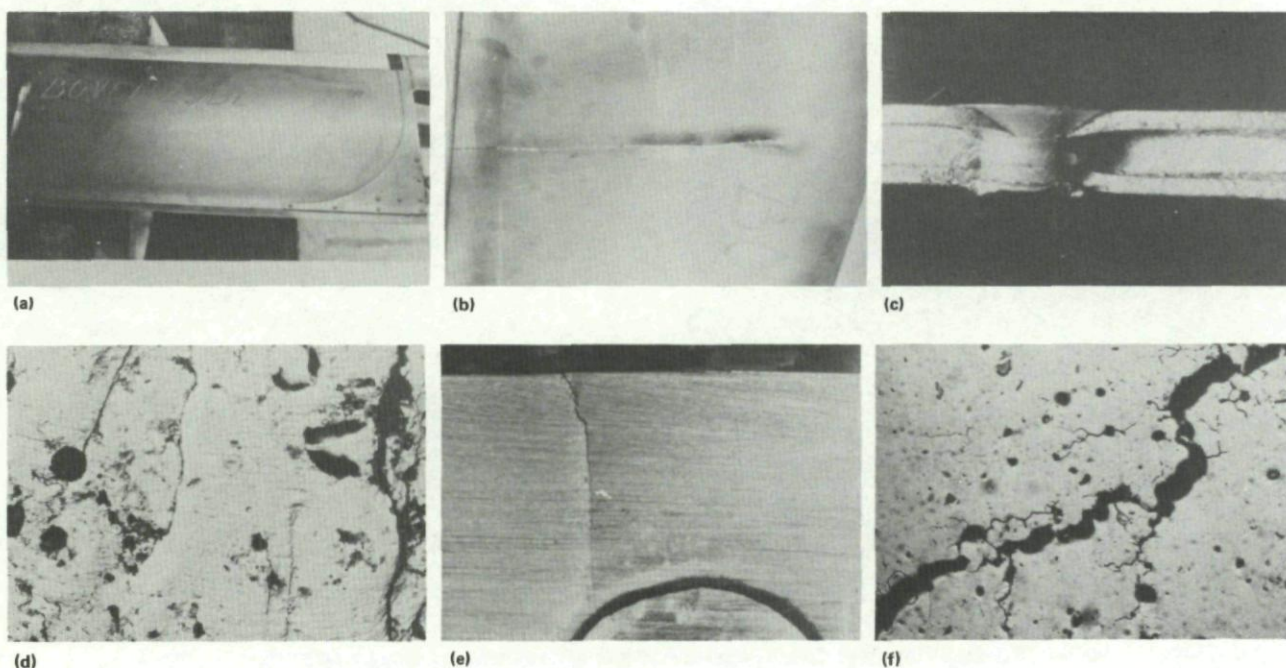
Fig. 10-6 Intergranular corrosion and fatigue in a helicopter main rotor blade

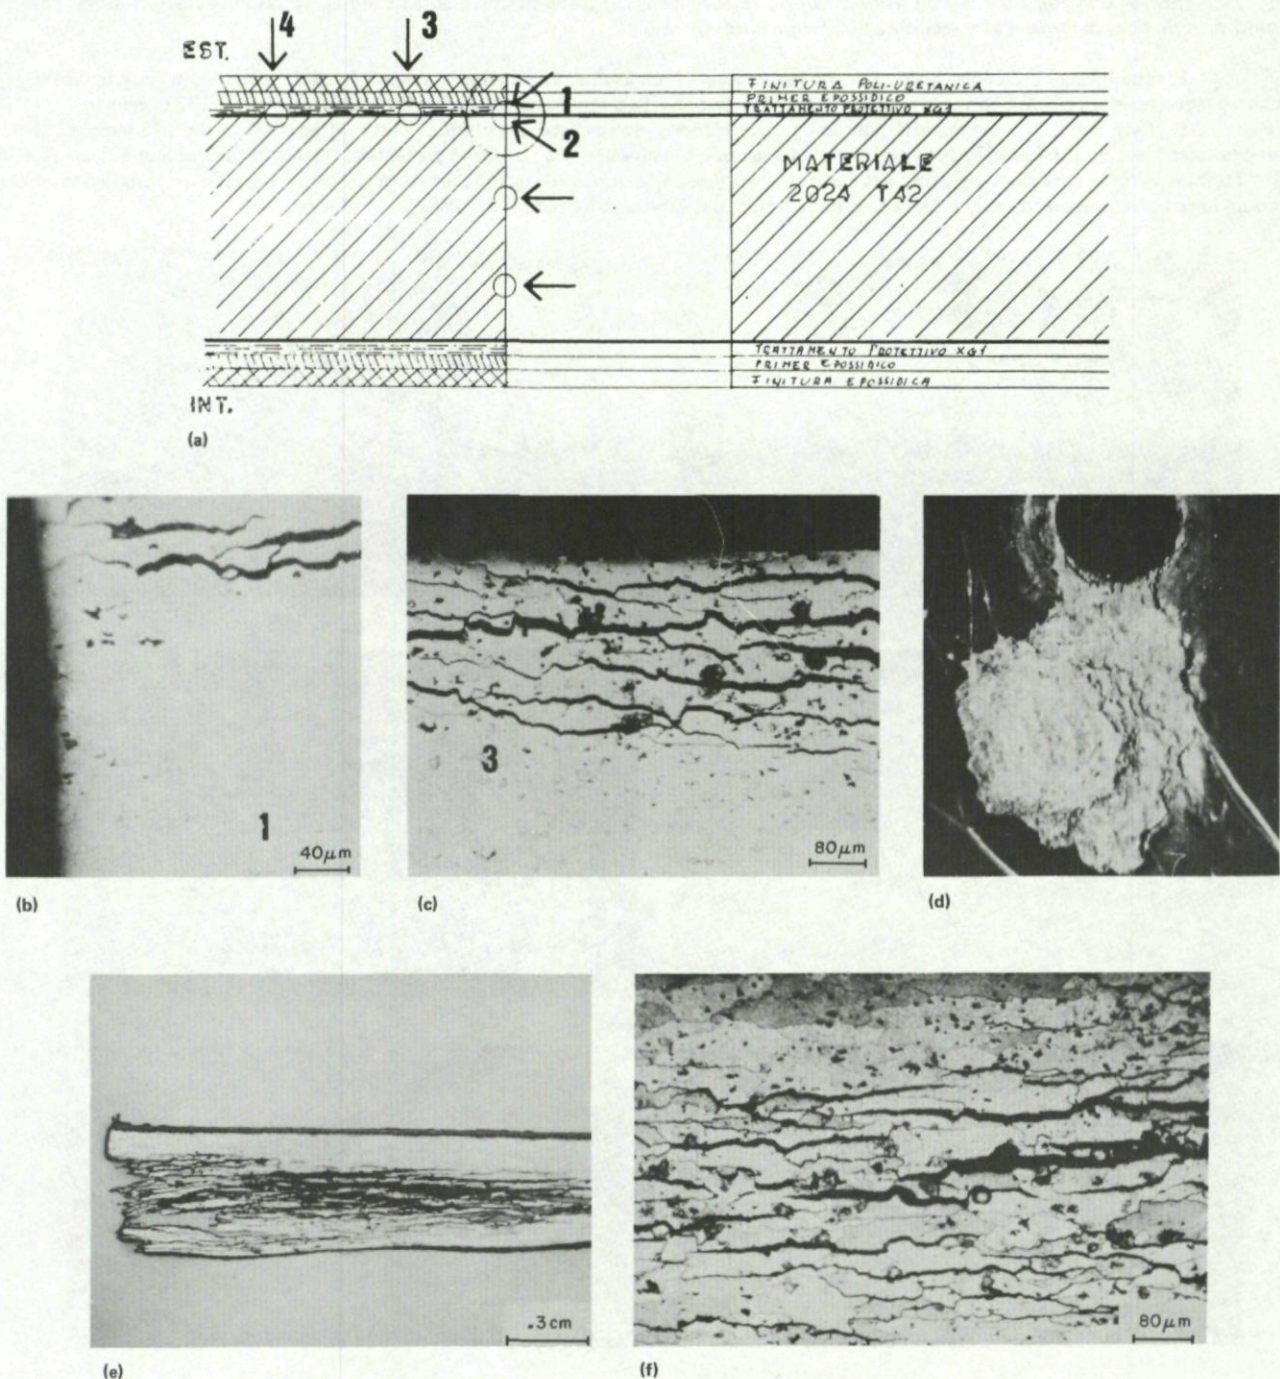
Fig. 10-7 Intergranular corrosion and exfoliation in a 2024-T42 vertical fin and horizontal stabilizer

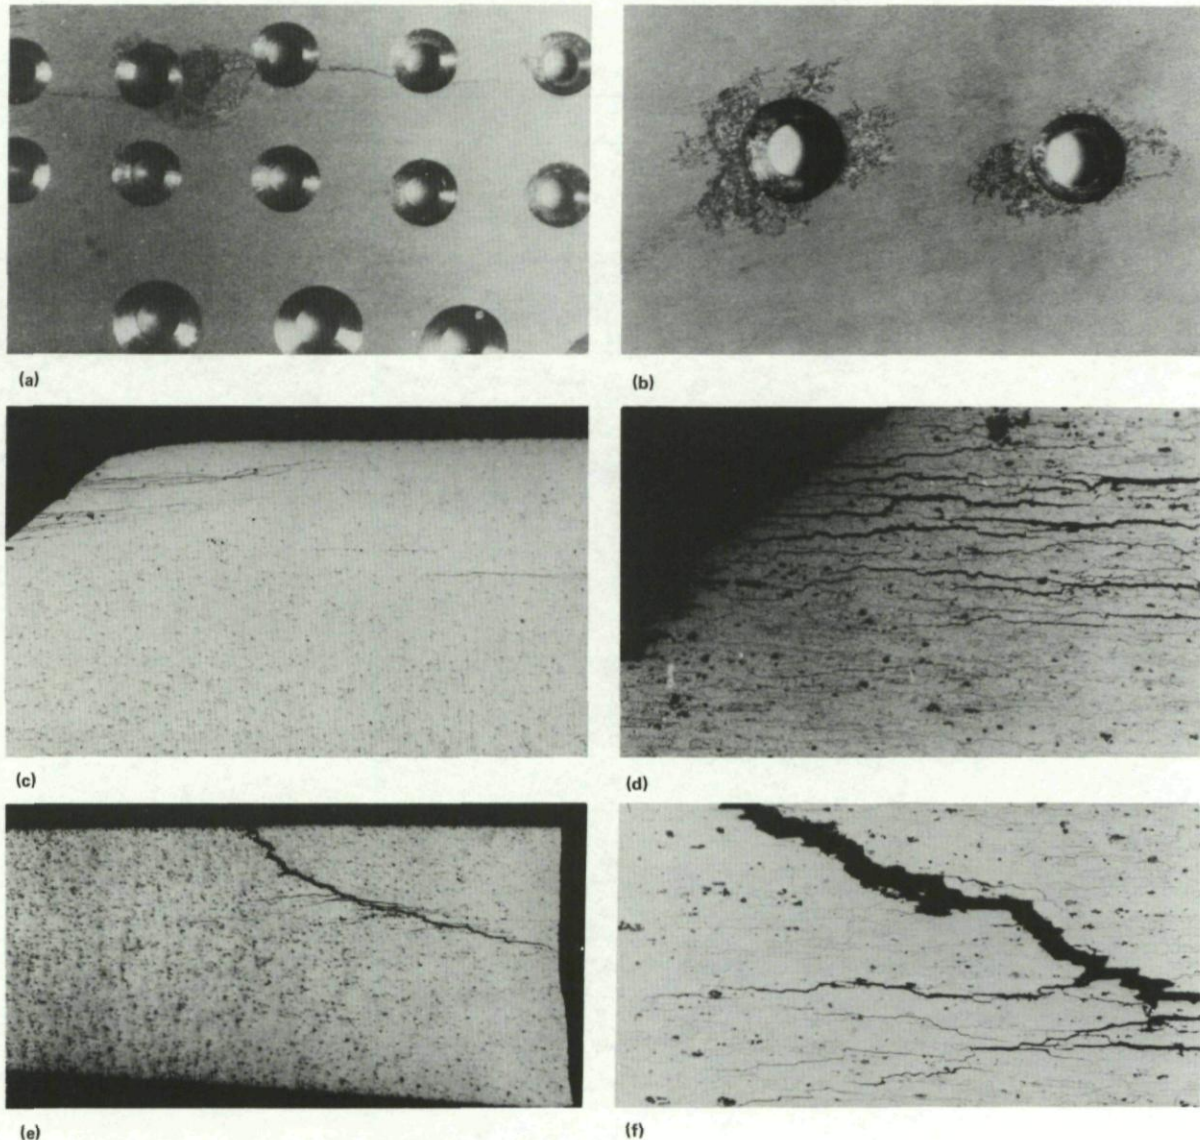
Fig. 10-8 Intergranular corrosion and exfoliation of a 7075-T6 wing box lower panel

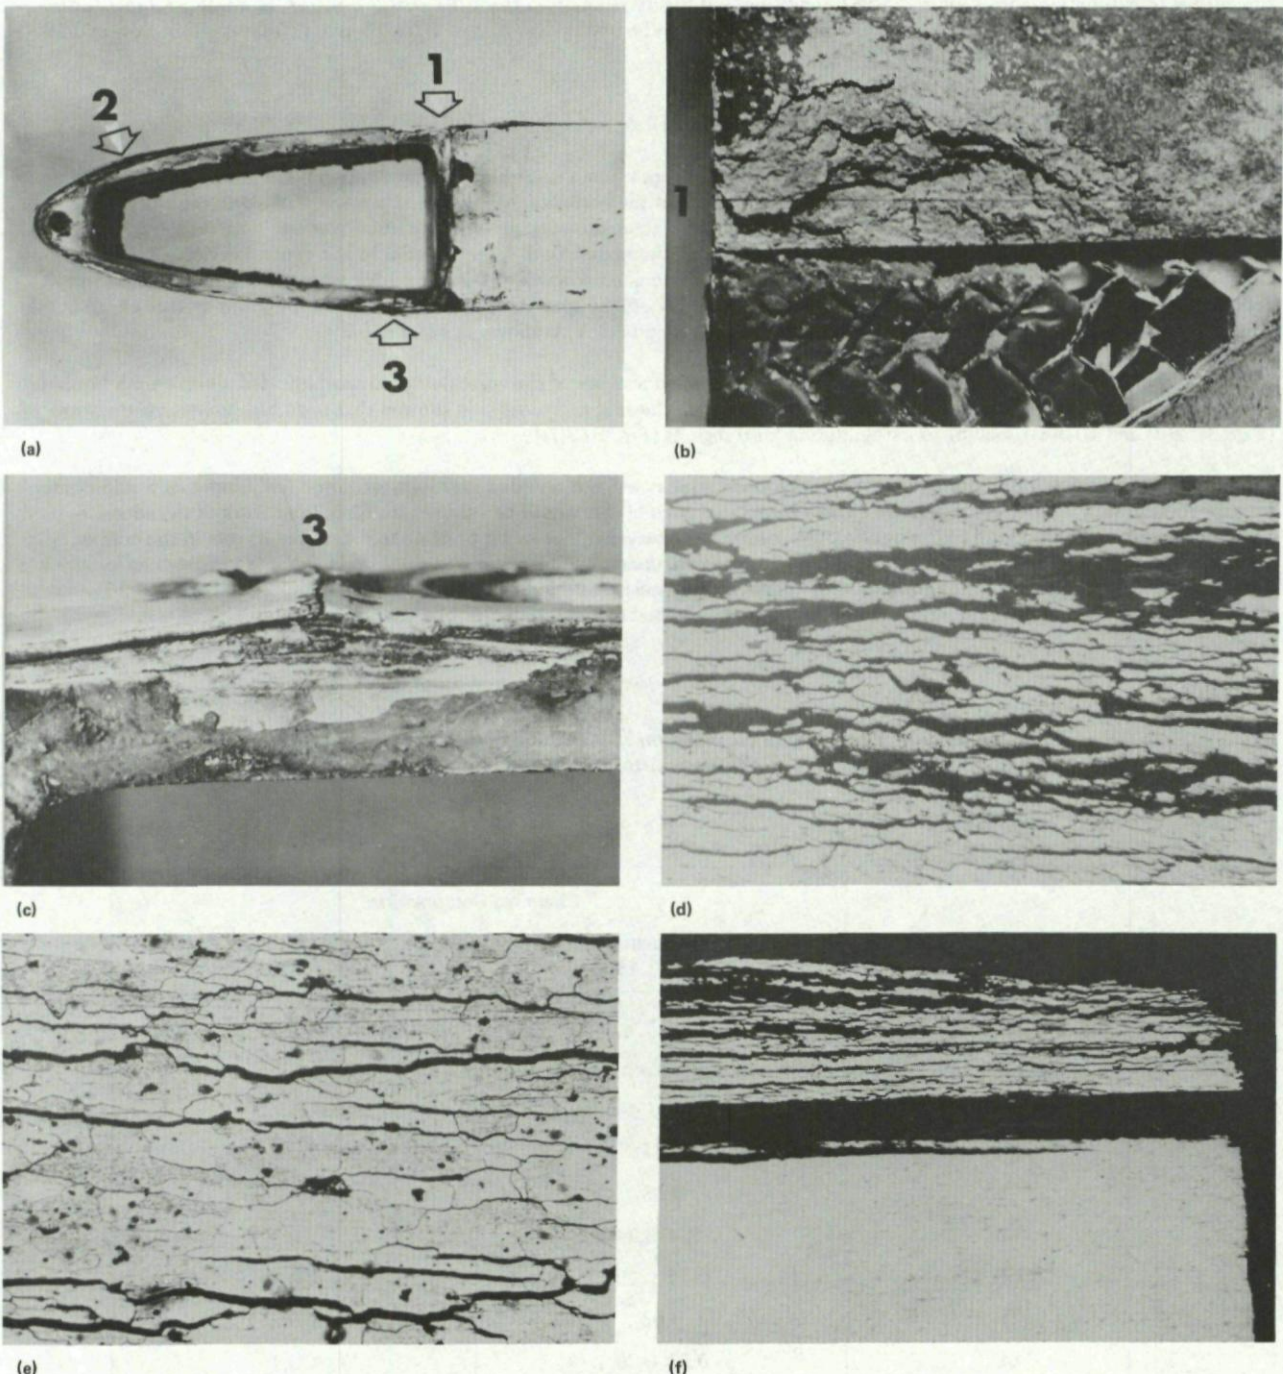
Fig. 10-9 Corrosion of a 2024 aluminium alloy helicopter rotor blade

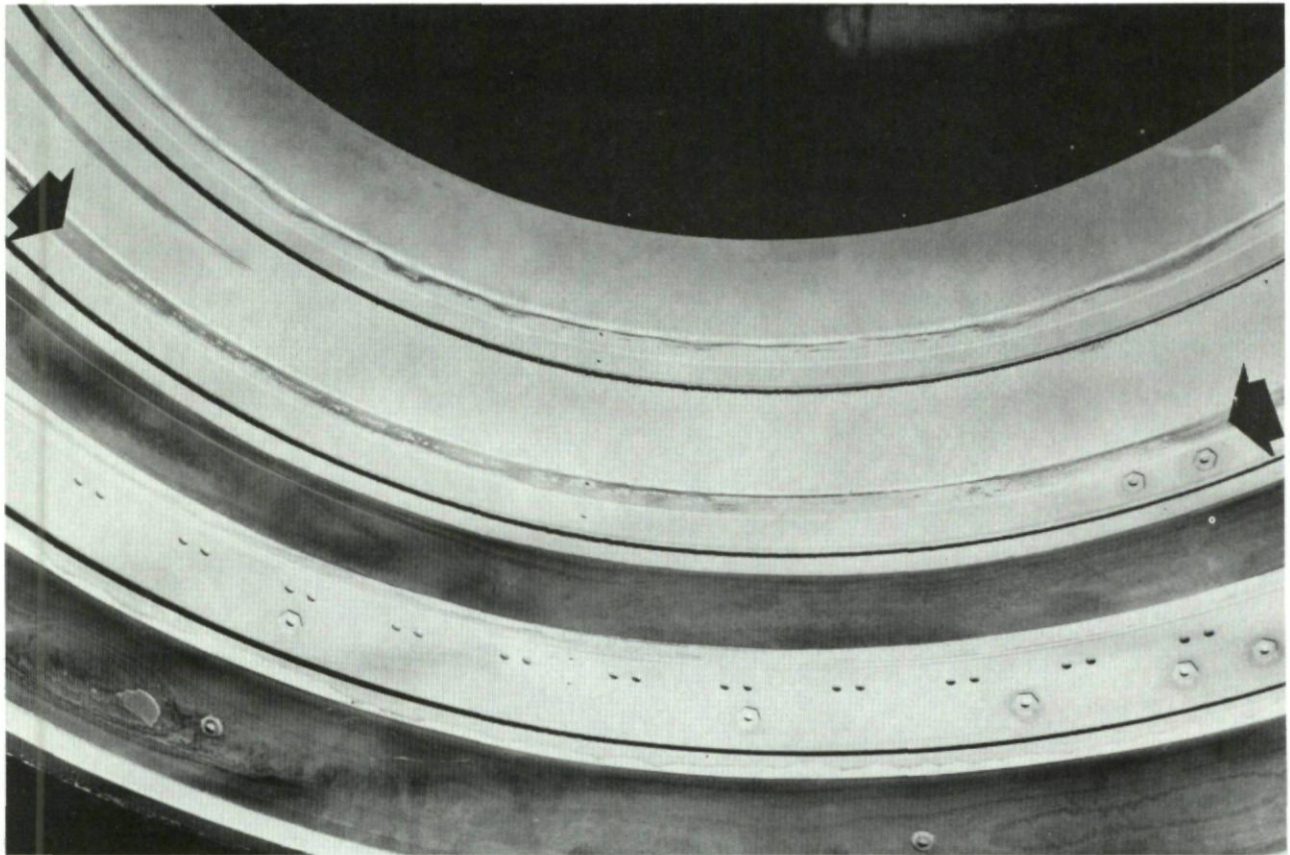
Fig. 11-2 Fretting corrosion in a magnesium alloy (EZ-33) compressor casing, indicated by arrows
