AGARD Corrosion Handbook Volume 1 Aircraft Corrosion: Causes and Case Histories

AIRCRAFT CORROSION: CAUSES AND CASE HISTORIES

W.Wallace
Head, Structures and Materials Laboratory
National Aeronautical Establishment
National Research Council Canada
Ottawa, Ontario, Canada

D.W.Hoeppner
Cockburn Professor of Engineering Design
Department of Mechanical Engineering
University of Toronto
Toronto, Ontario, Canada

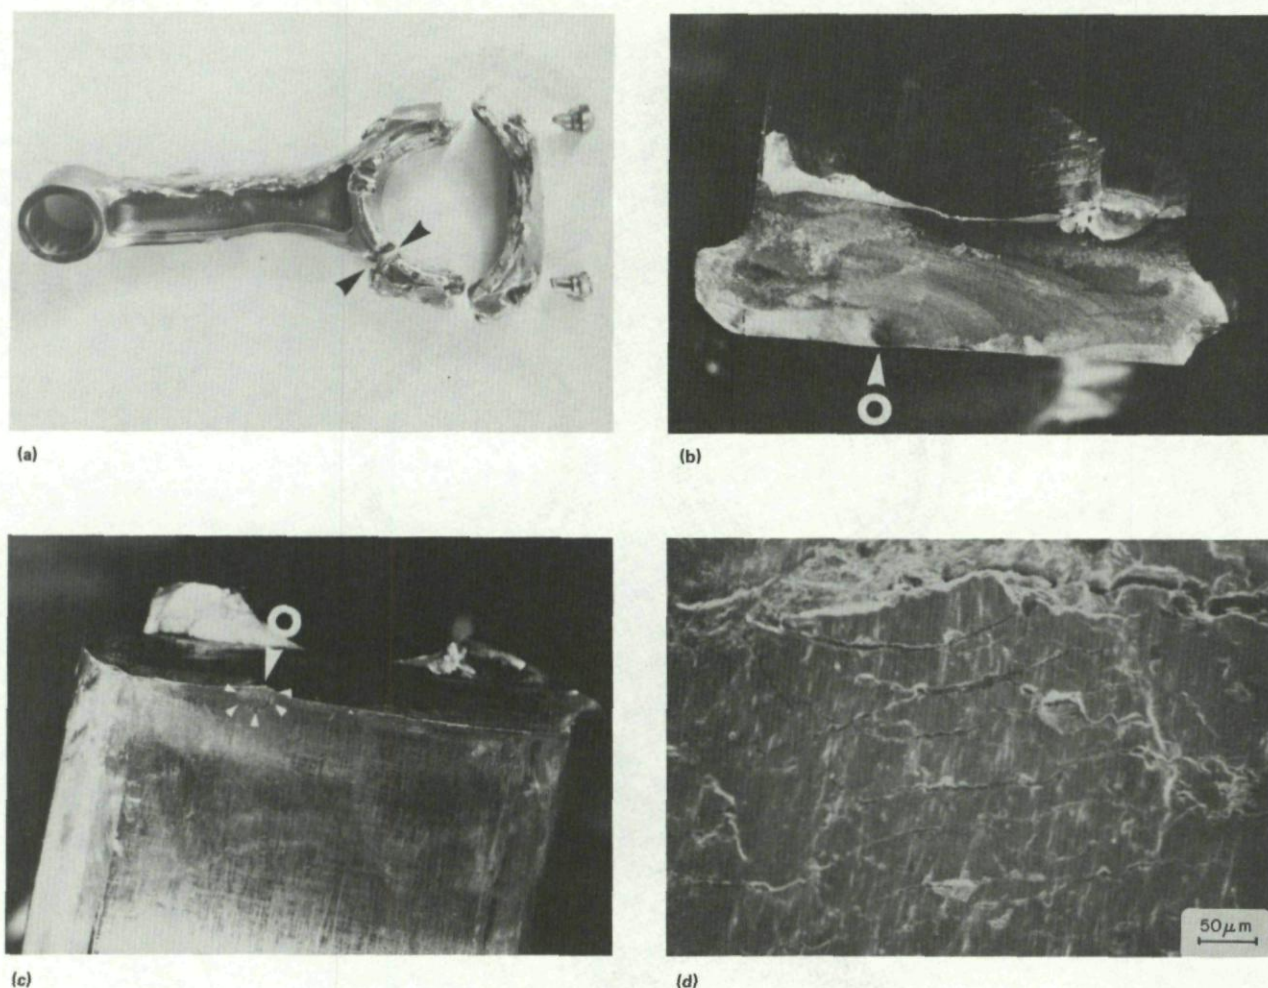
Fig. 11-3 Fretting corrosion and fatigue of a helicopter engine connecting rod

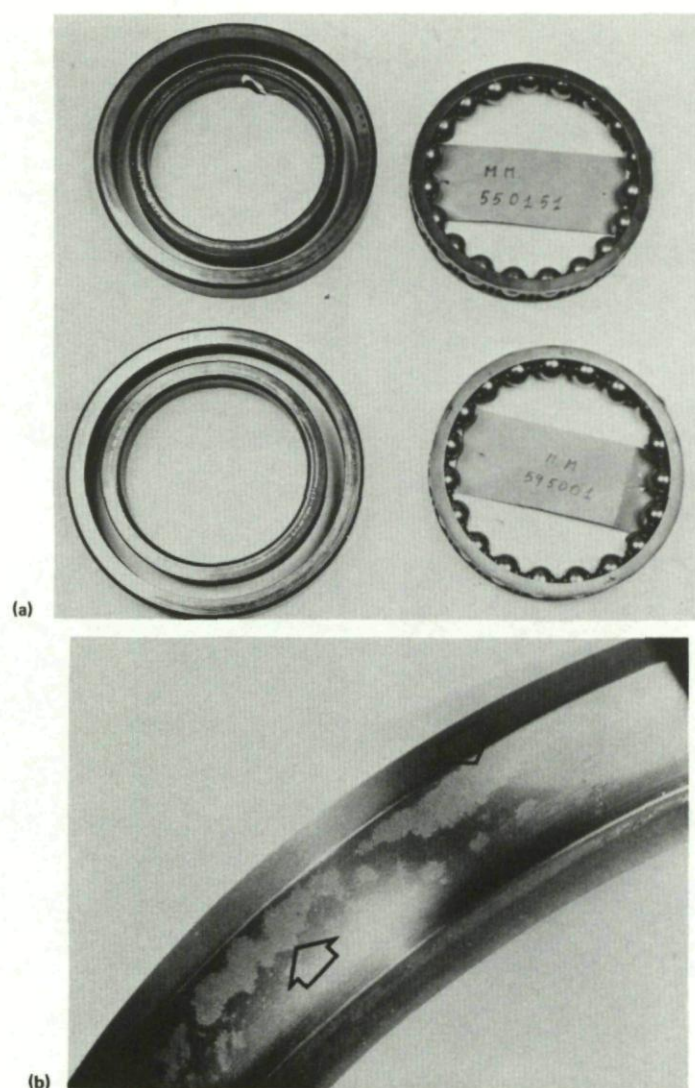
Fig. 11-4 Fretting corrosion in propeller shaft ball bearings

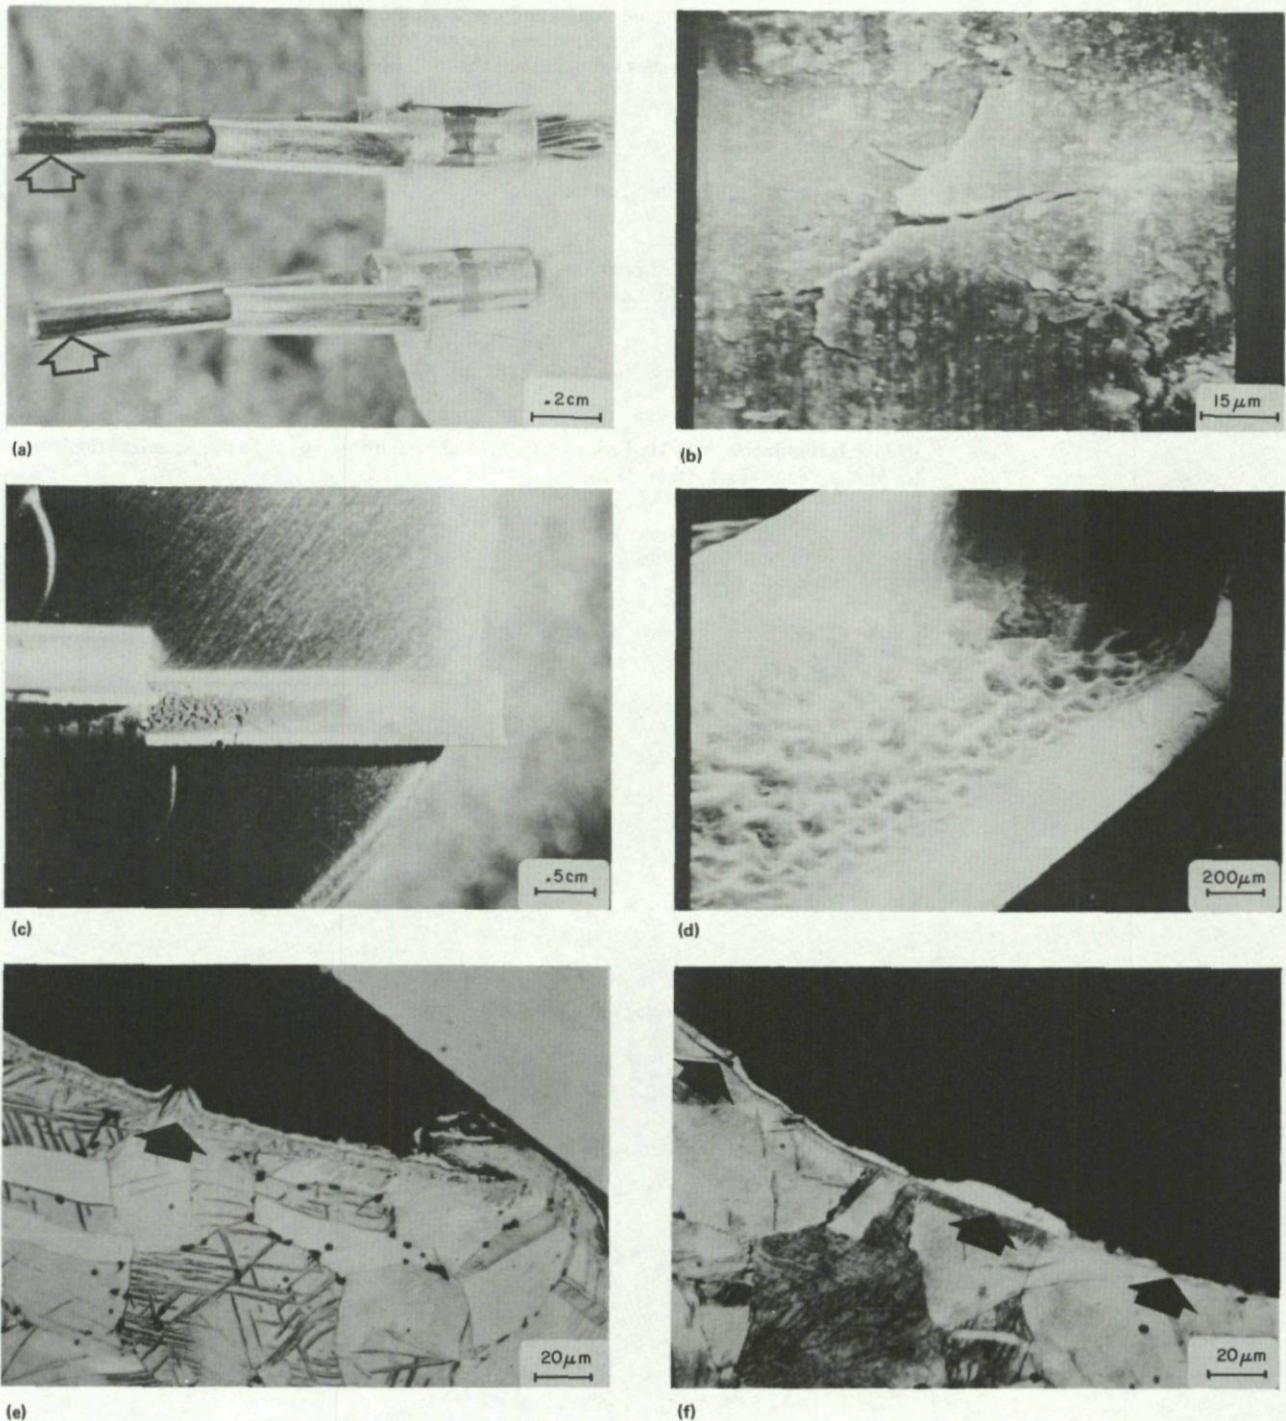
Fig. 11-5 Fretting corrosion in electrical connectors

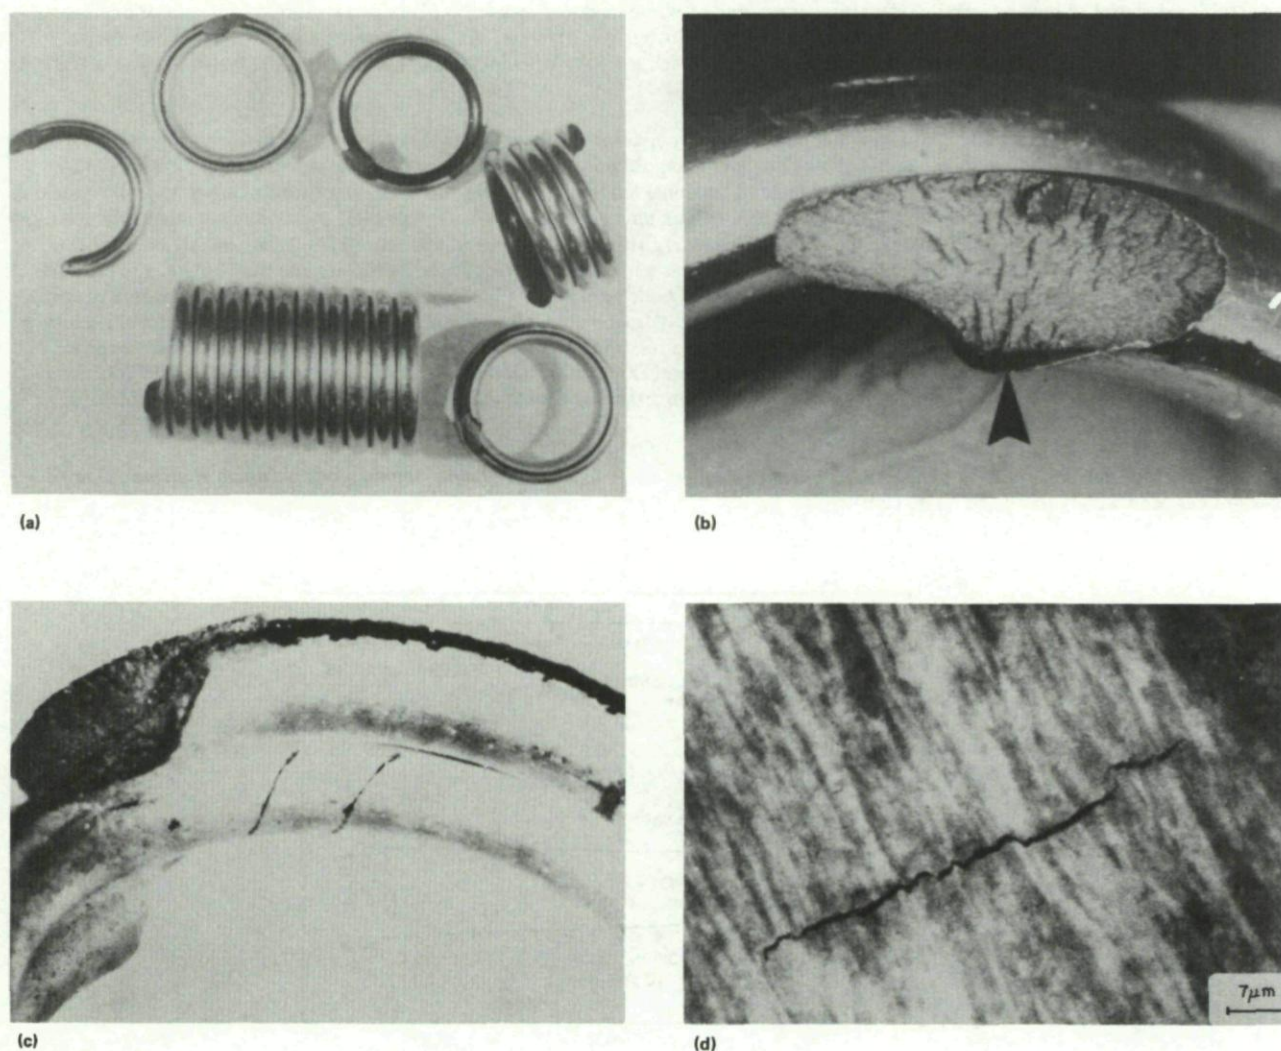
Fig. 12-7 Hydrogen embrittlement of a carbon steel flap control return spring

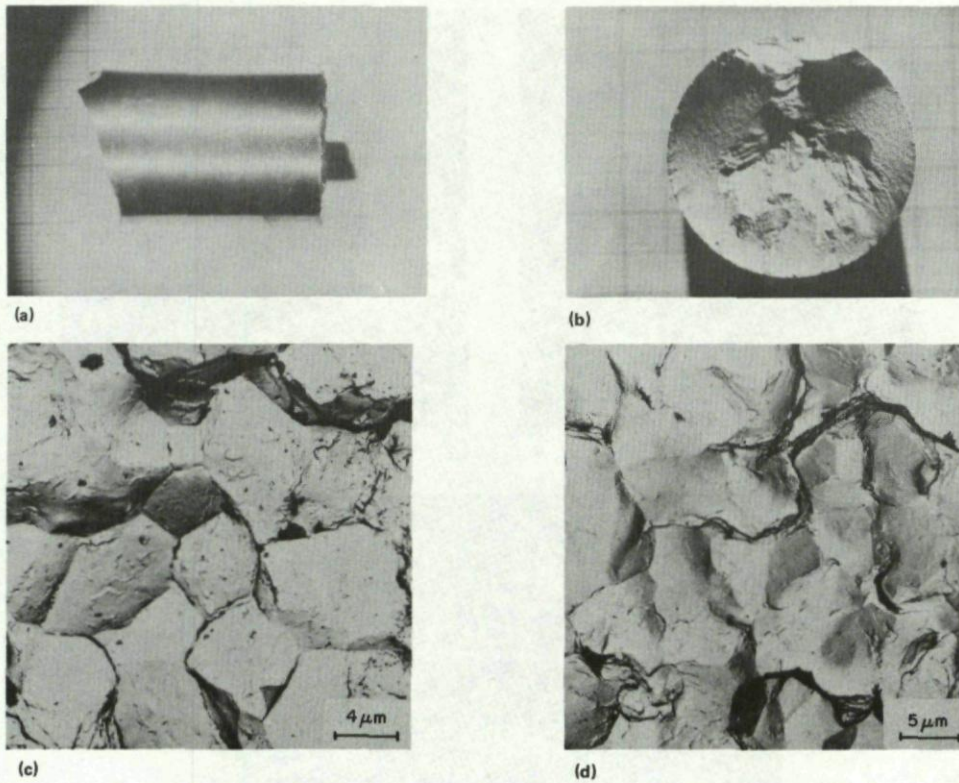
Fig. 12-8 Hydrogen delayed cracking in a 4340 main landing gear pivot pin

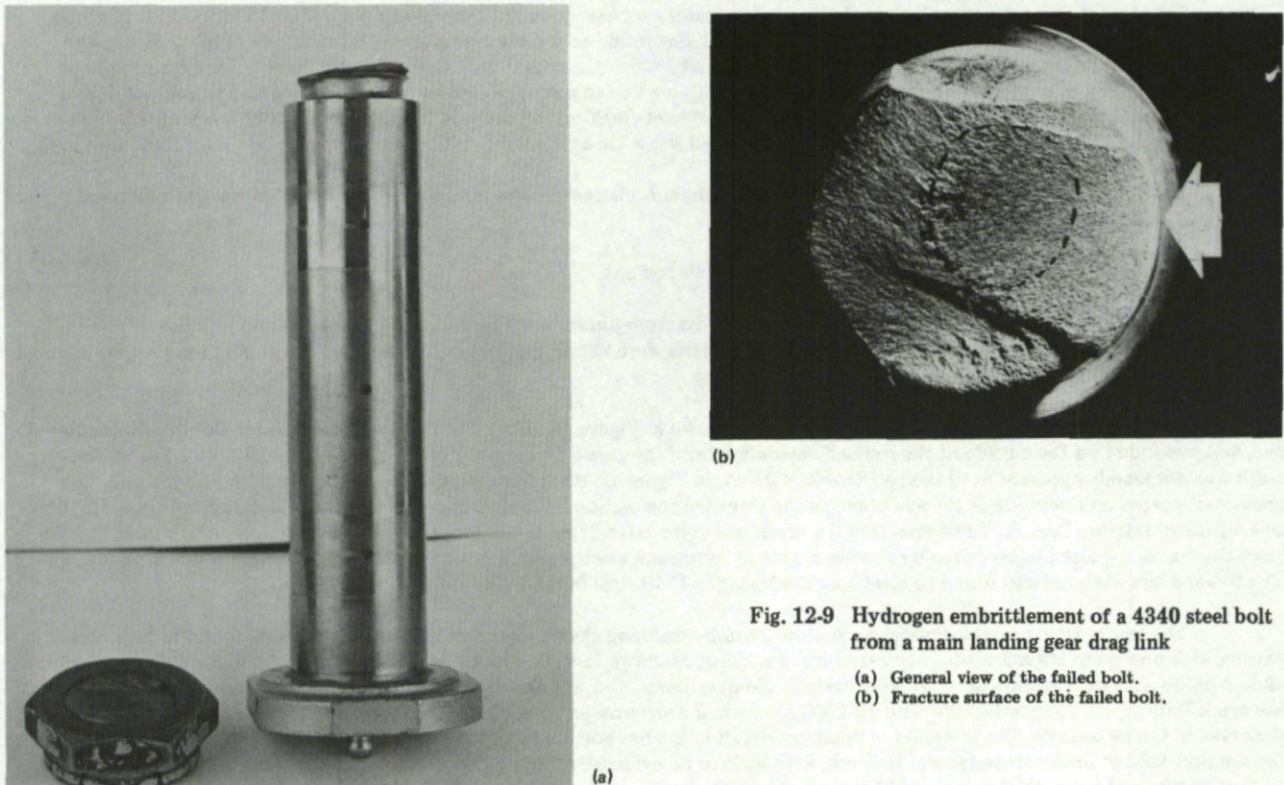
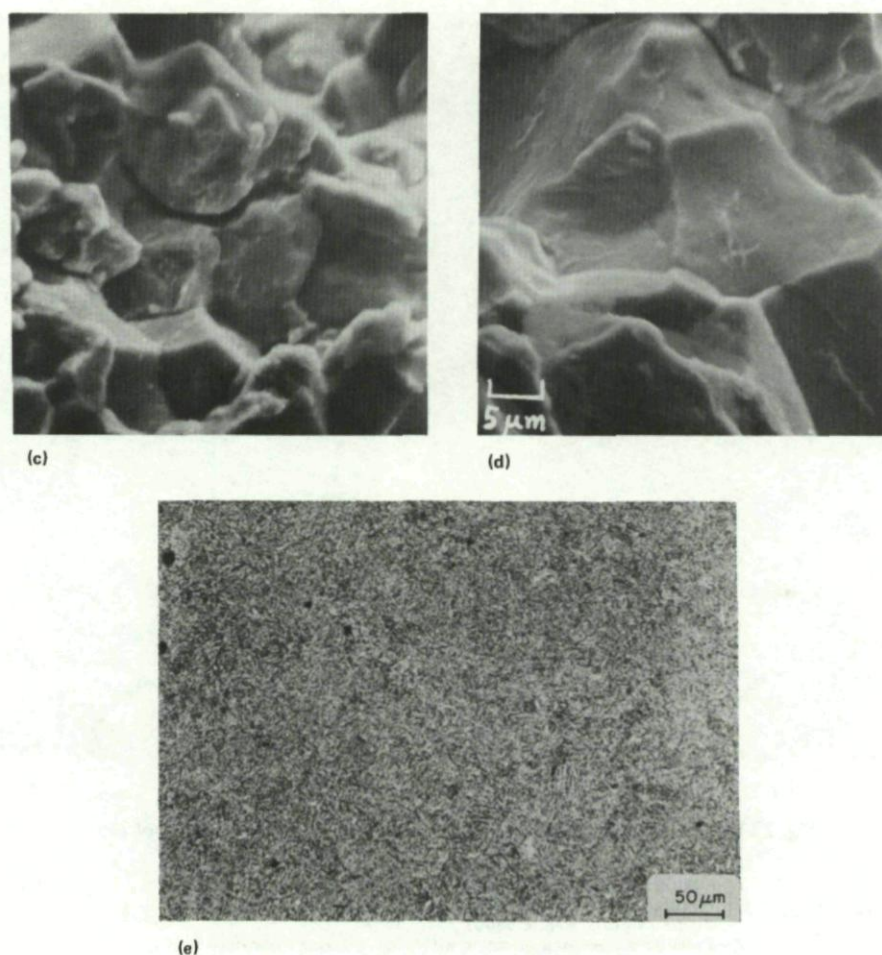
Fig. 12-9 Hydrogen embrittlement of a 4340 steel bolt from a main landing gear drag link

- (a) General view of the failed bolt.
- (b) Fracture surface of the failed bolt.

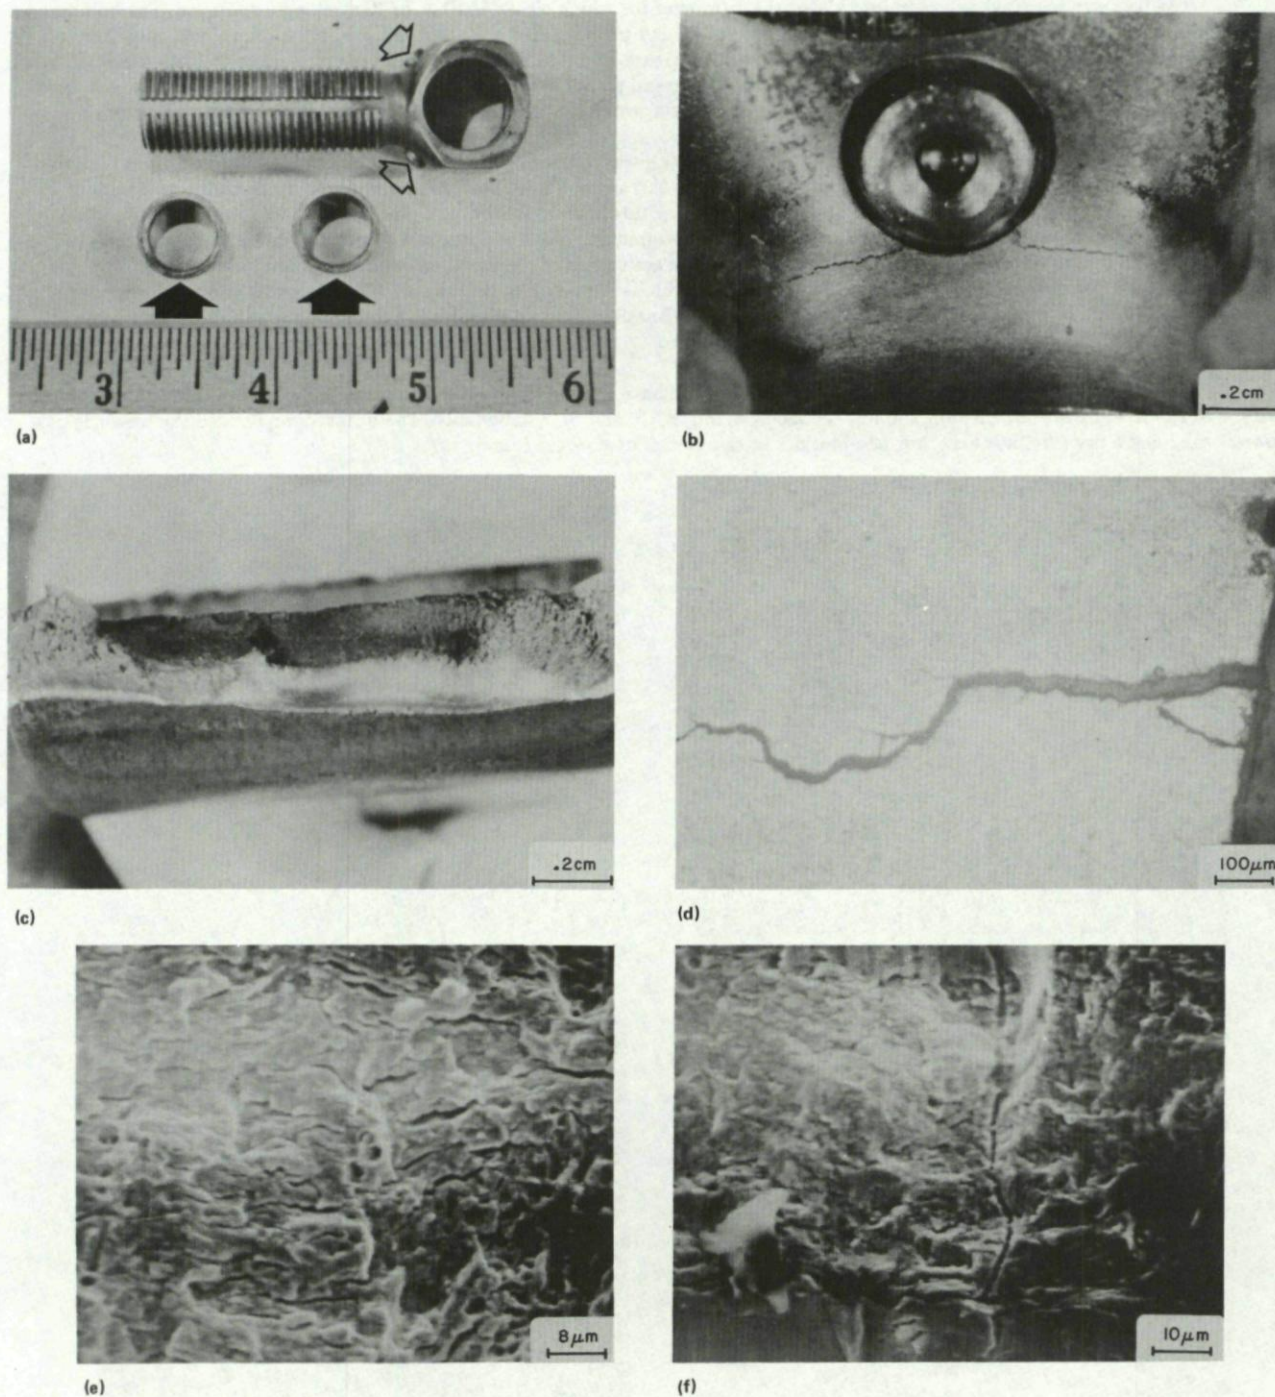
Fig. 12-10 Failure of a 4340 steel tie rod end

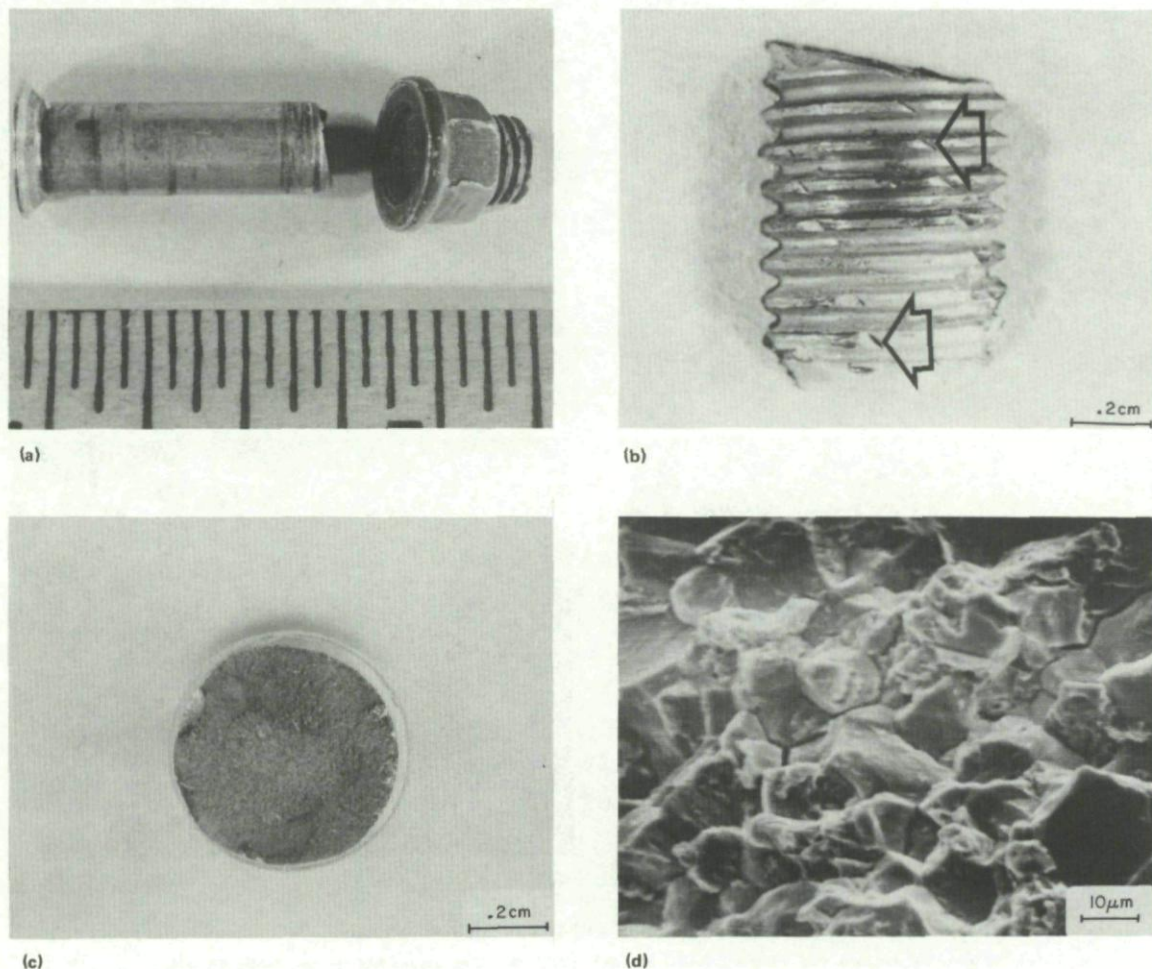
Fig. 12-11 Failure of a low alloy steel bolt

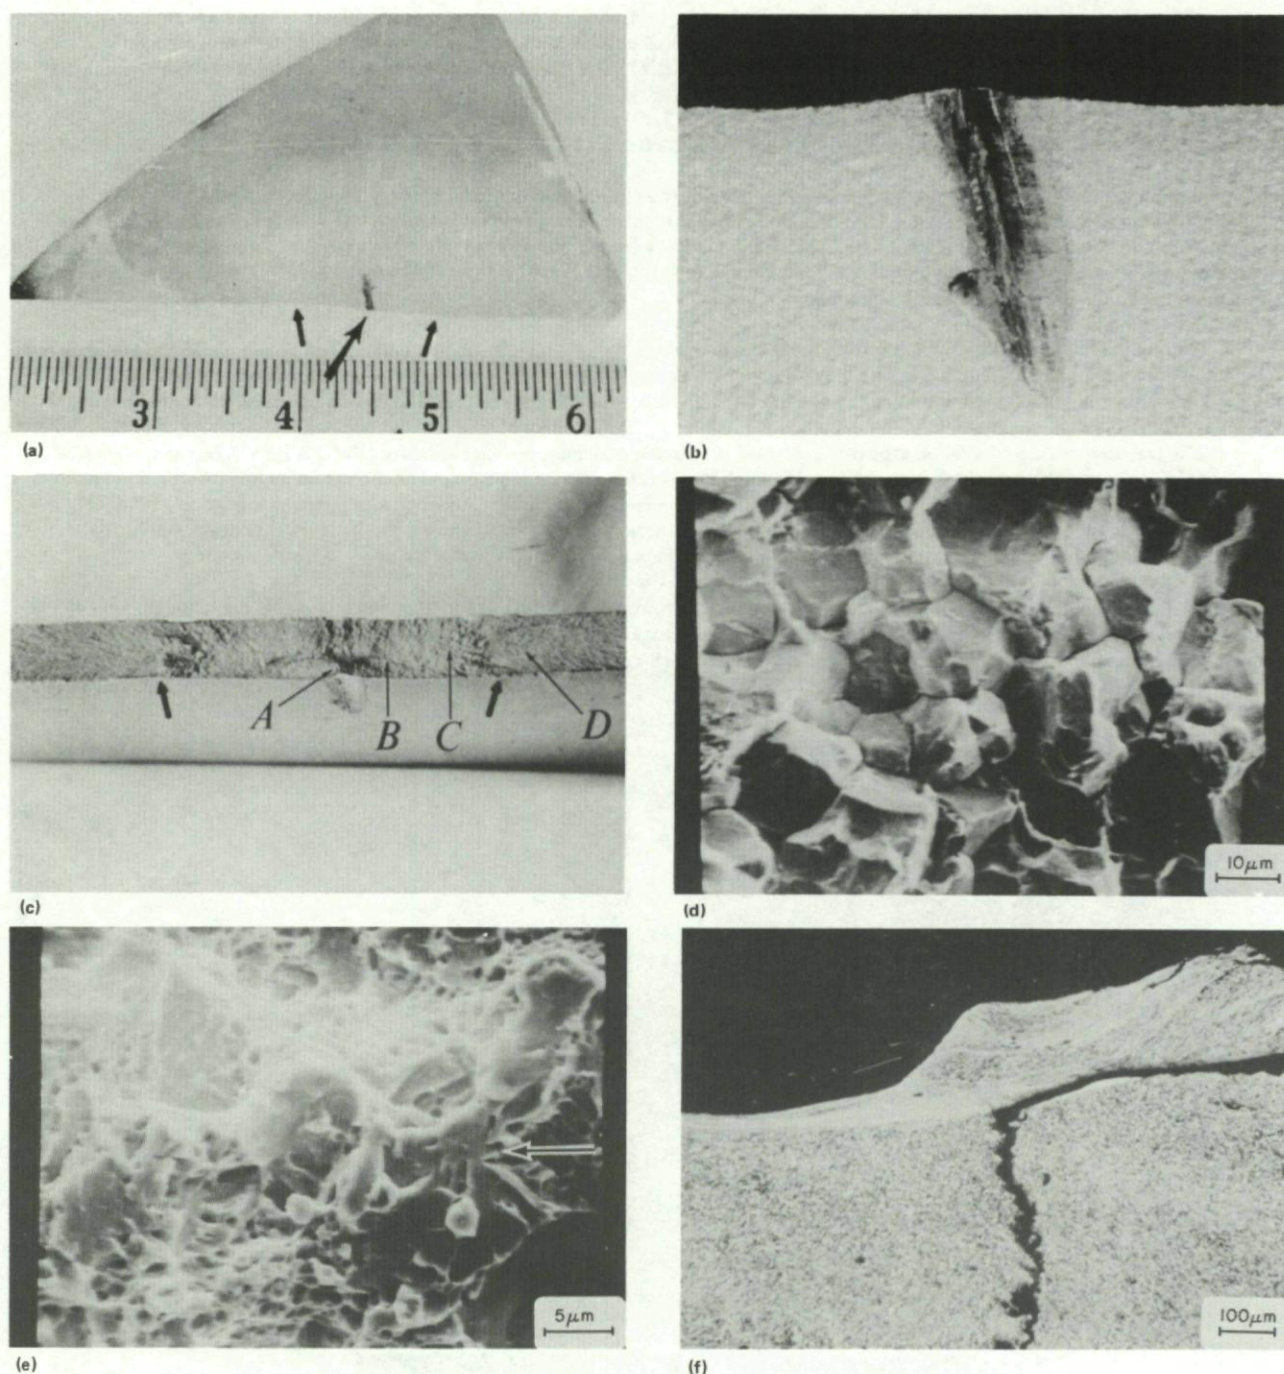
Fig. 12-13 Failure of a 4340 steel landing gear cylinder

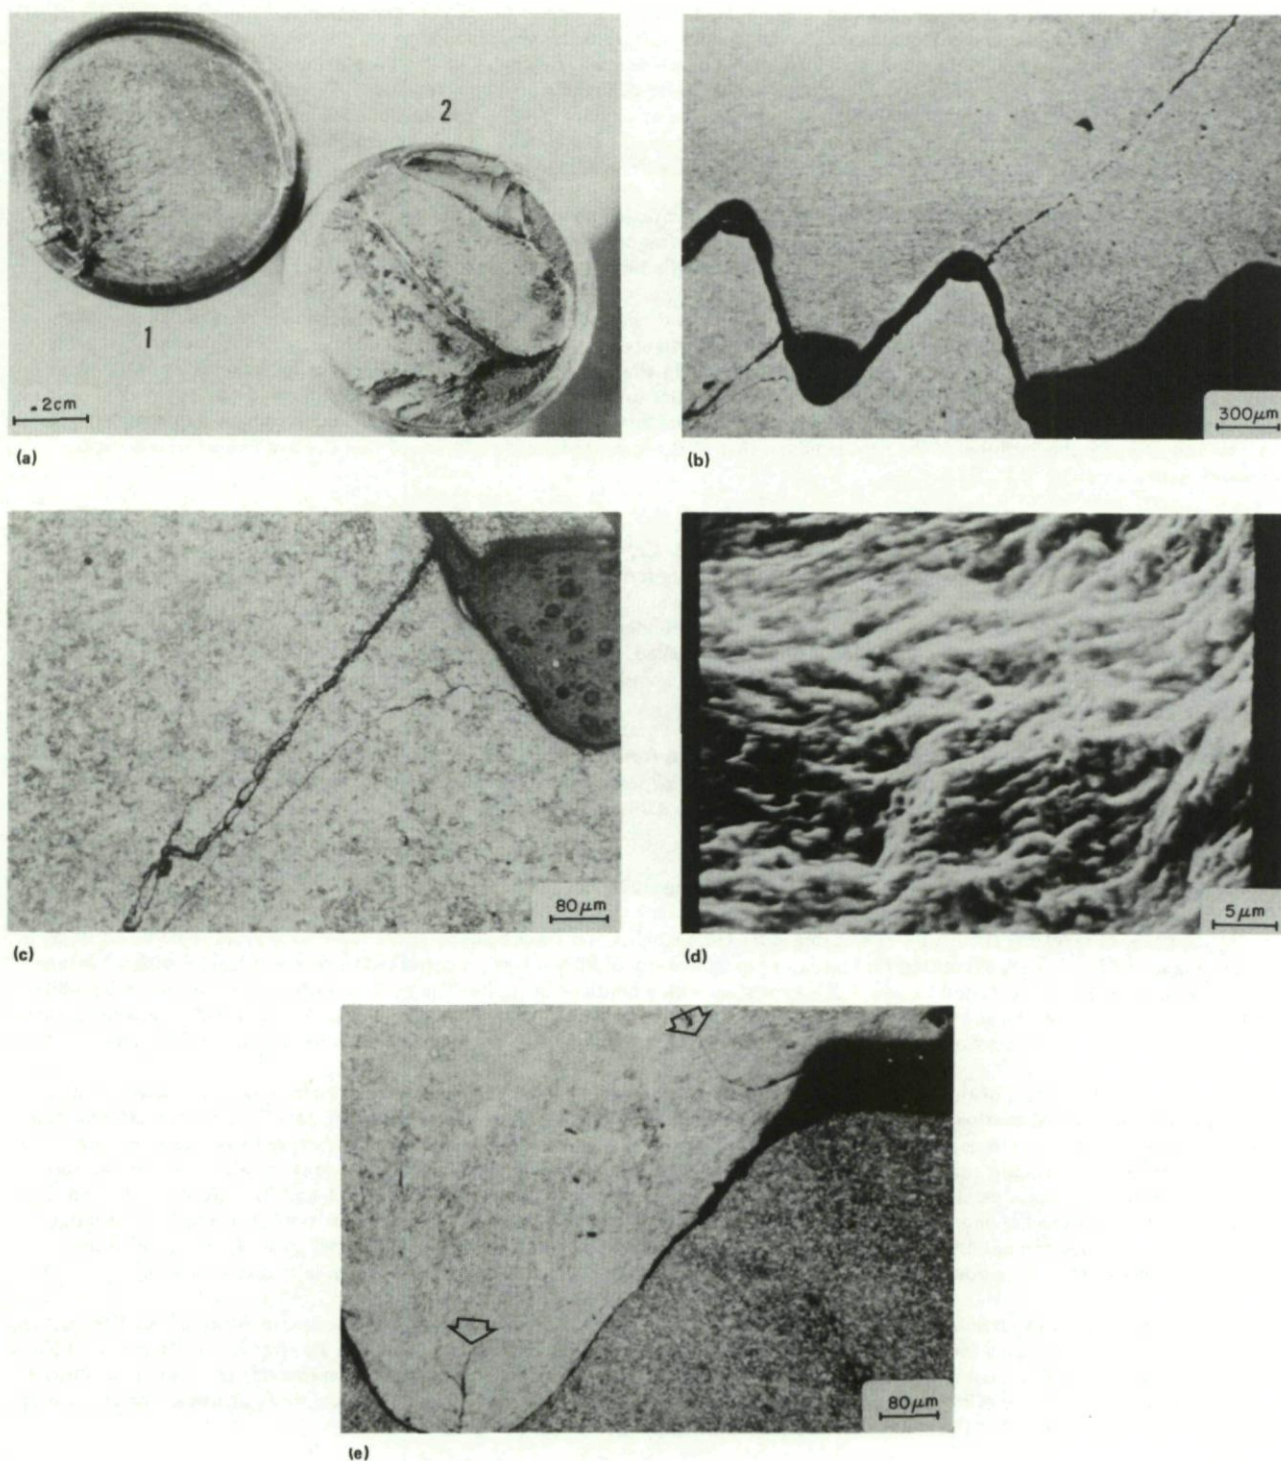
Fig. 12-14 Failure of two low alloy steel bolts

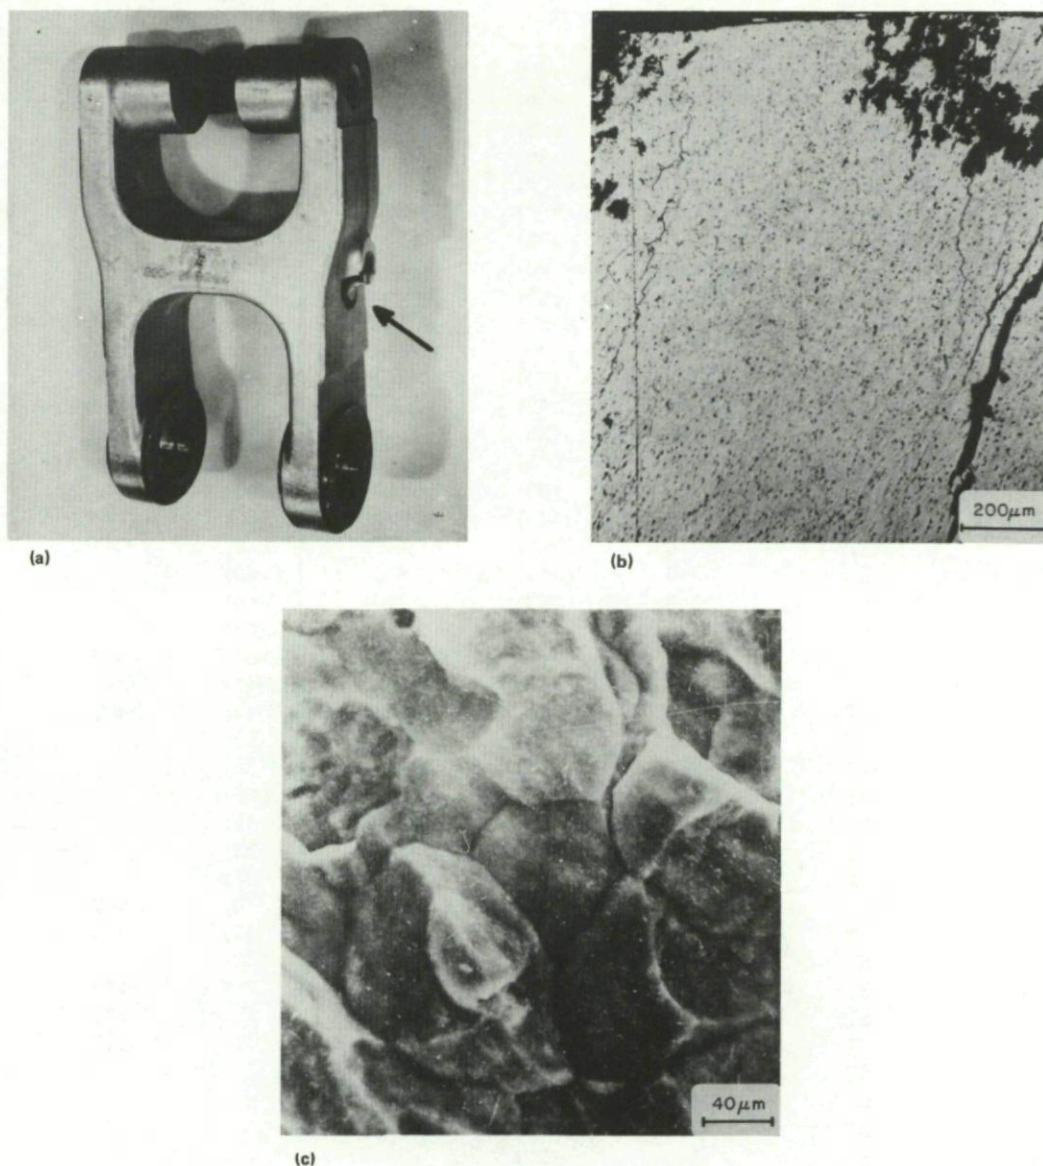
Fig. 13-7 Stress corrosion cracking occurring from corrosion pits and intergranular corrosion cracking in the parting plane of a 7079-T6 H-link.

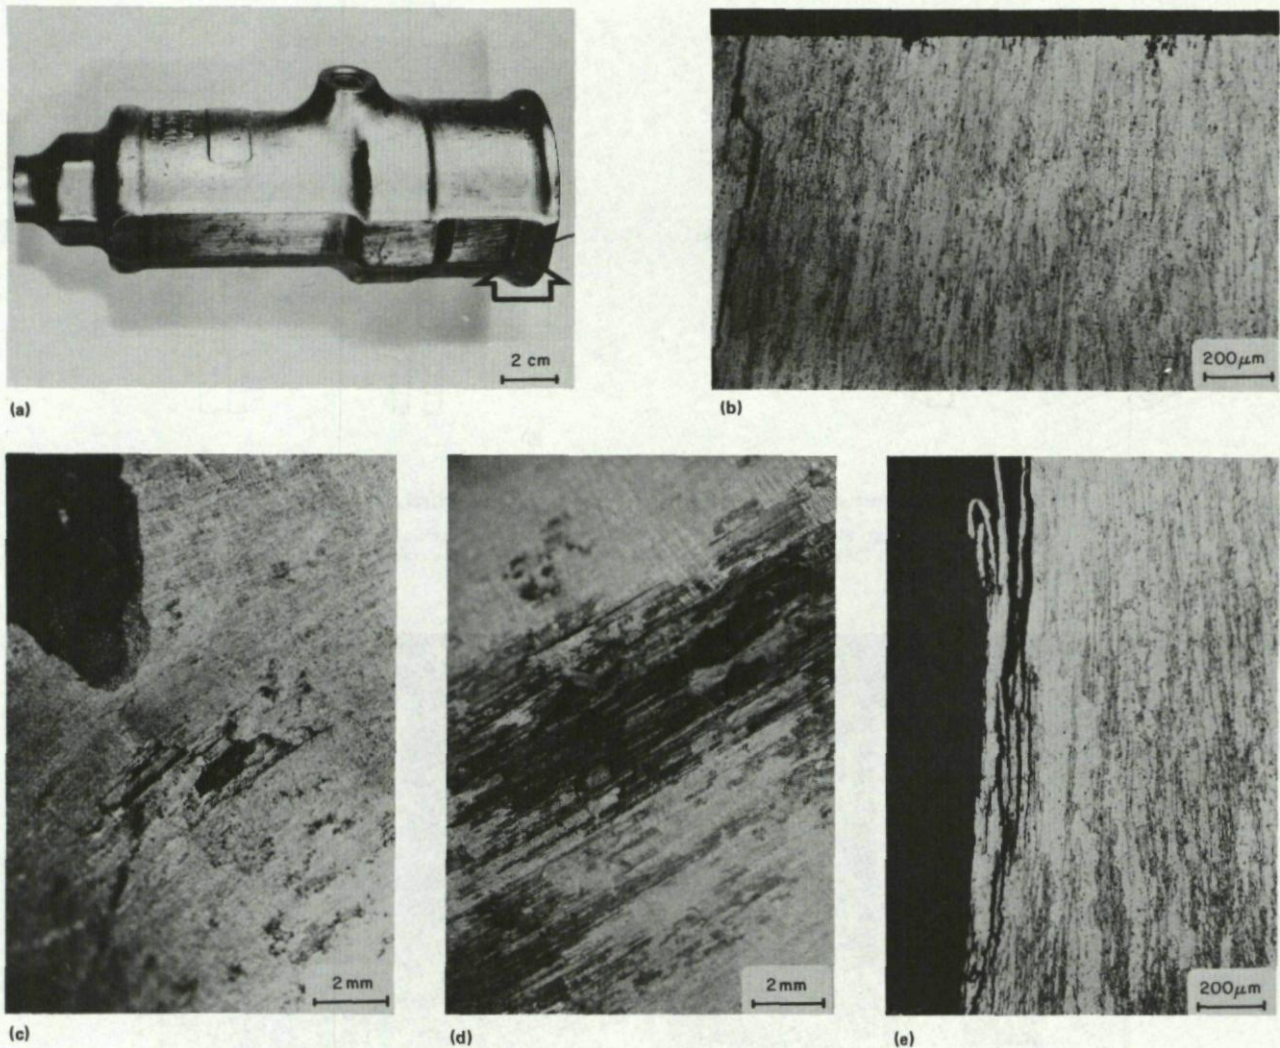
Fig. 13-26 Stress corrosion cracking in a 7079-T6 main landing gear locking cylinder, case history 13-1.

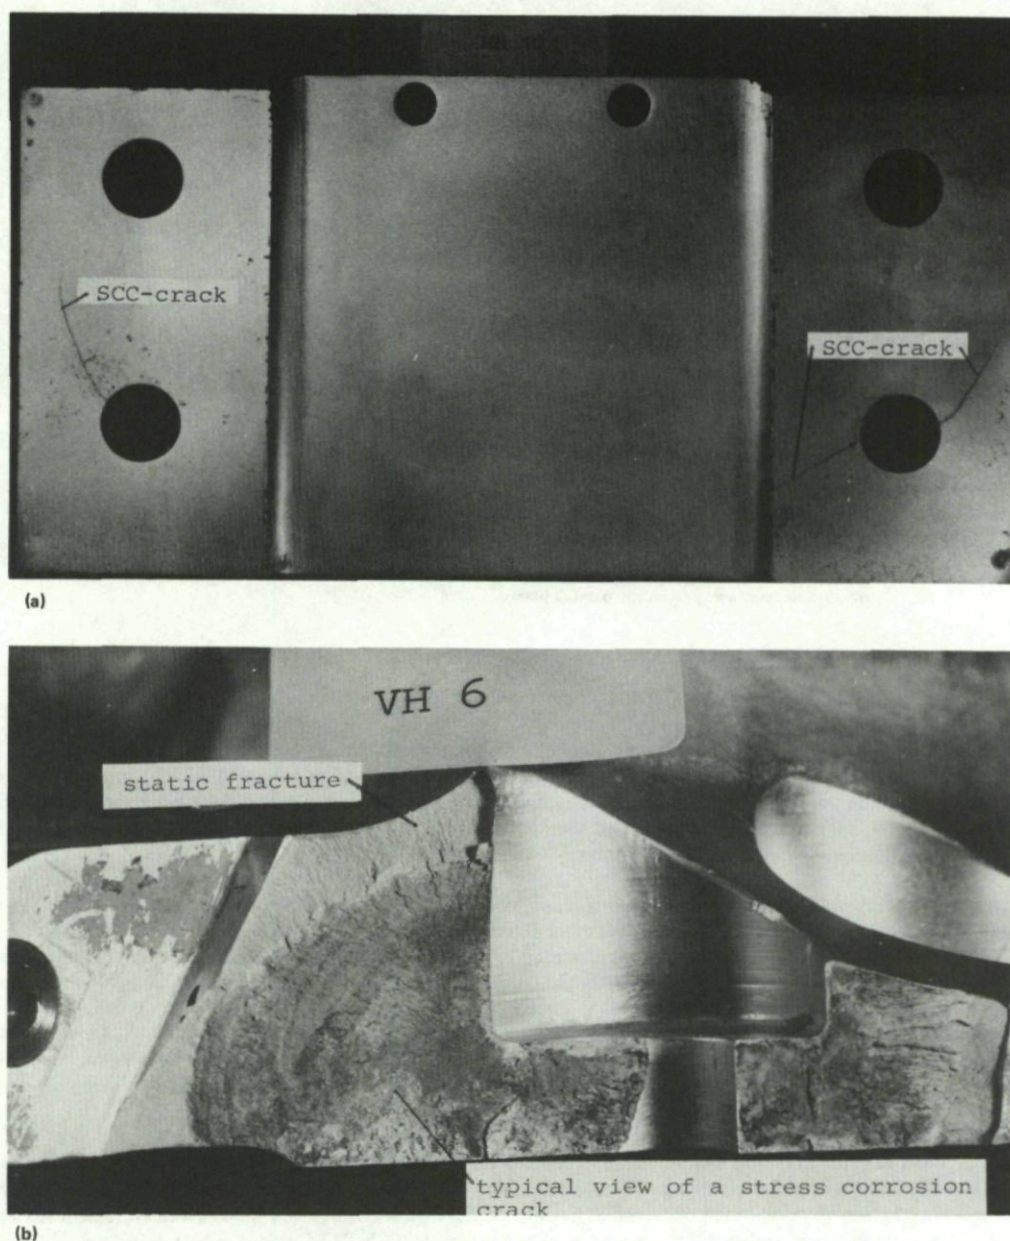
Fig. 13-28 Stress corrosion cracking in the 7079-T6 spars of a vertical fin, case history 13-2.

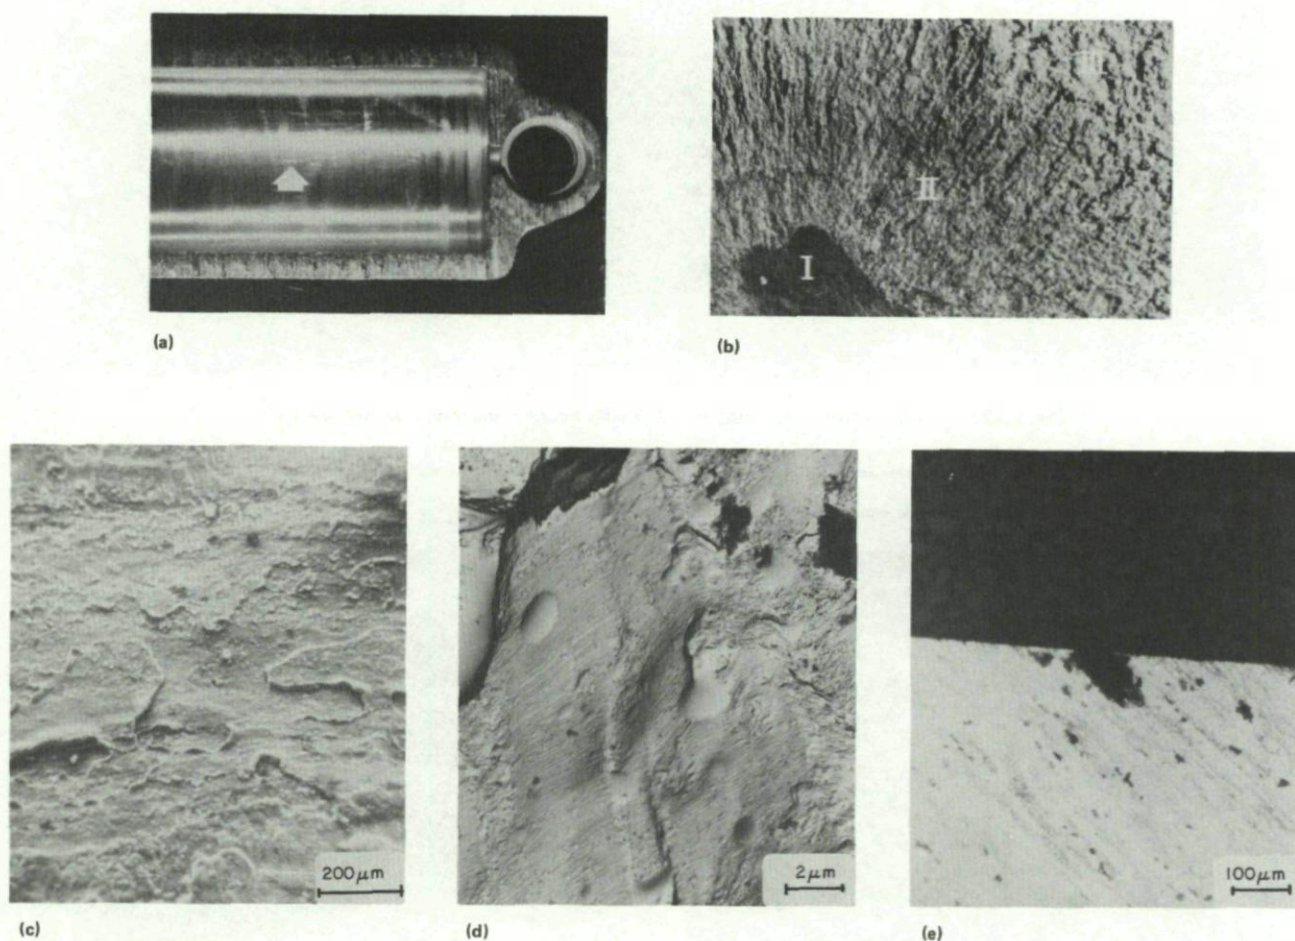
Fig. 13-31 Stress corrosion cracking of a 7075-T6 hydraulic cylinder, case history 13-5.

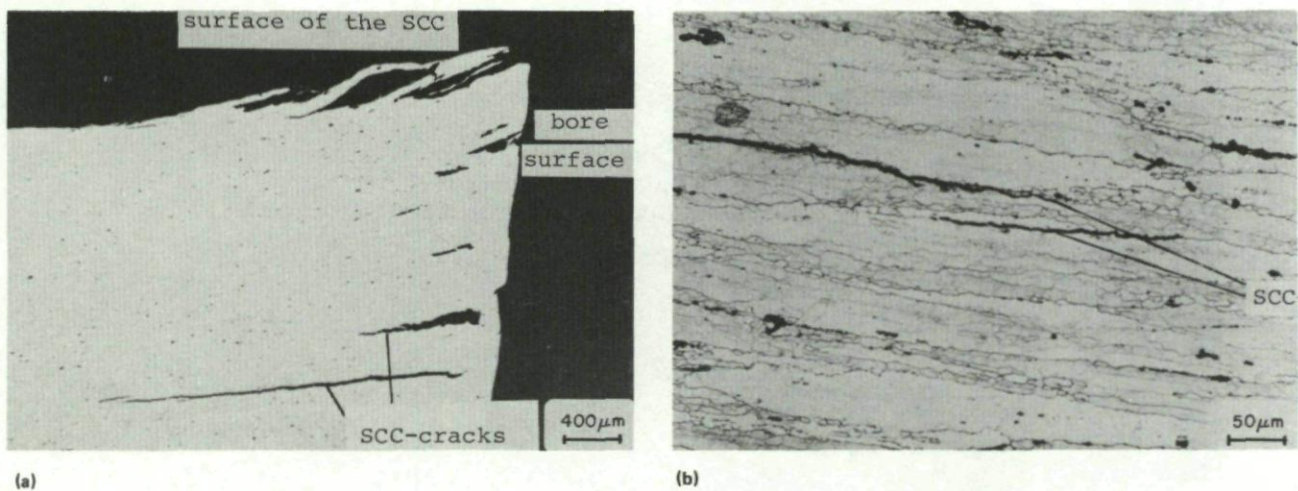
Fig. 13-37 Cross sections through the nose landing gear strut adjacent to the retraction cylinder bore and bolt hole, case history 13-7.

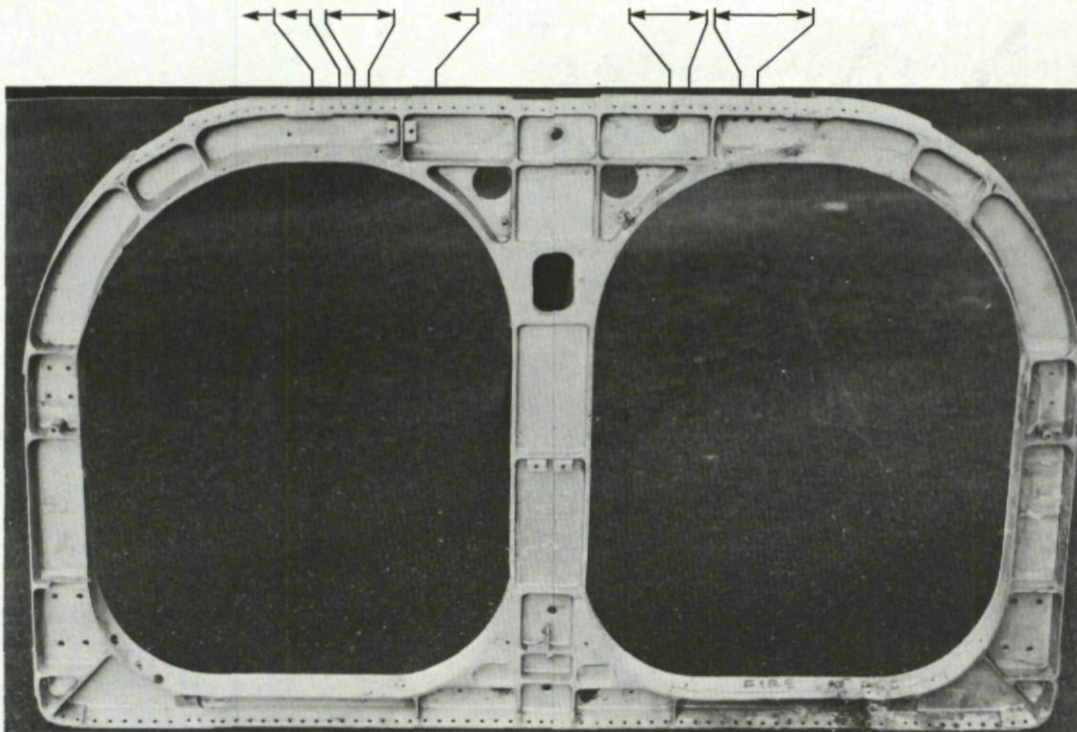
Fig. 13-39 Stress corrosion cracking in a 7075-T6 fuselage frame, case history 13-8. Arrows indicate the directions of cracking away from fastener holes.

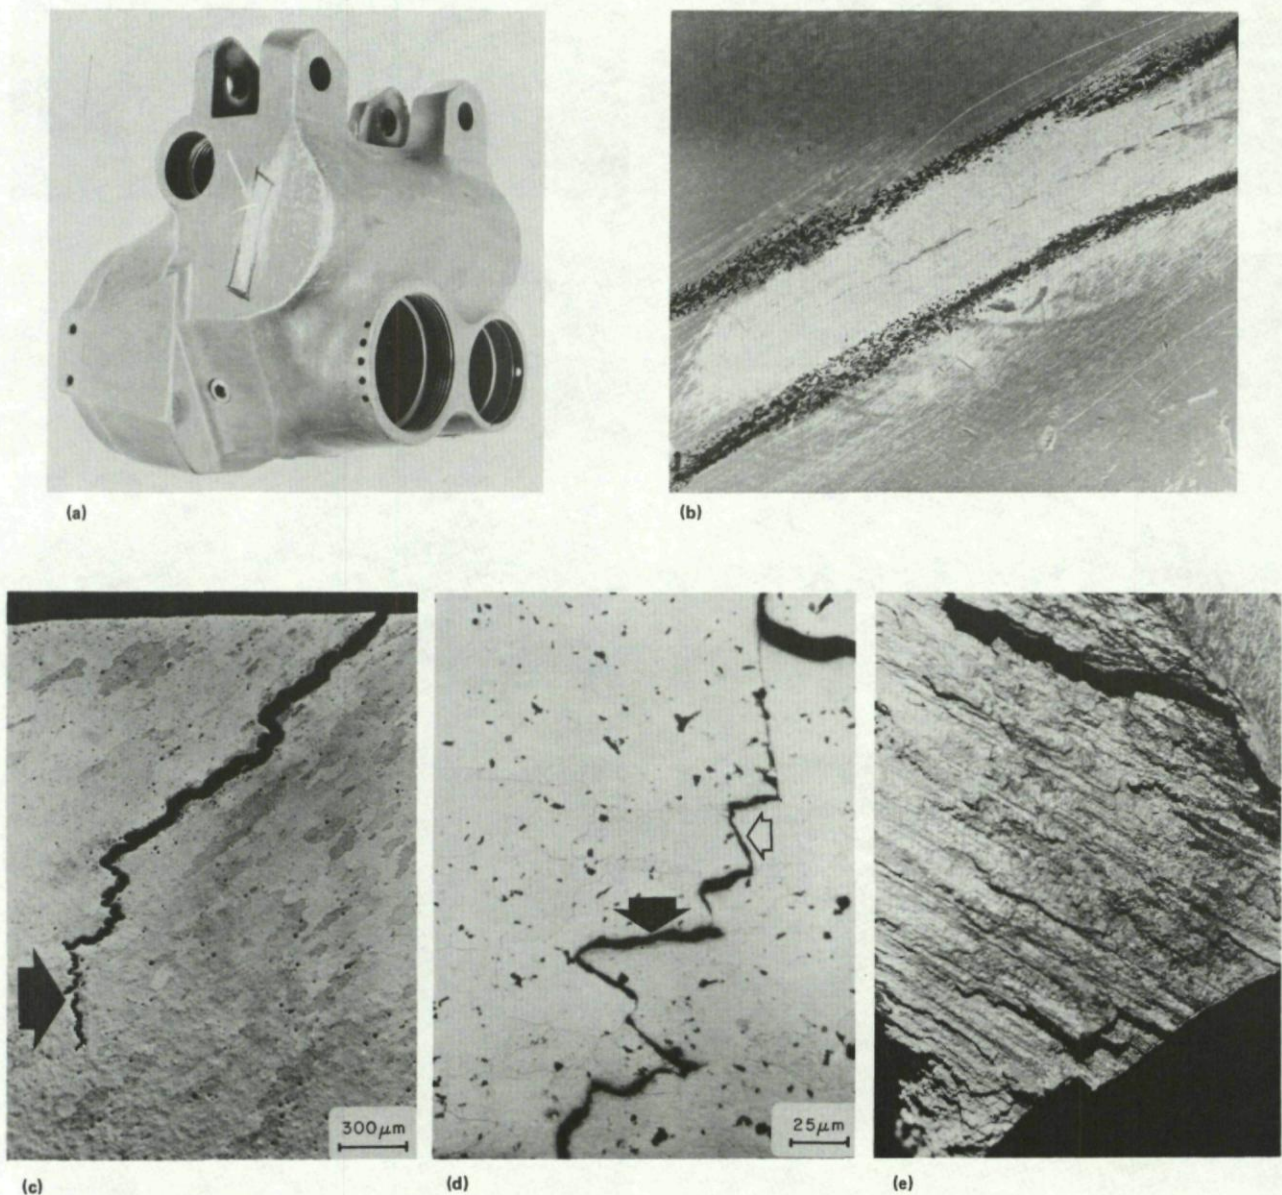
Fig. 13-44 Cracking in a 2014 aluminium nose wheel steering damper, case history 13-9.
