AGARD Corrosion Handbook Volume 1 Aircraft Corrosion: Causes and Case Histories

AIRCRAFT CORROSION: CAUSES AND CASE HISTORIES

W.Wallace
Head, Structures and Materials Laboratory
National Aeronautical Establishment
National Research Council Canada
Ottawa, Ontario, Canada

D.W.Hoeppner
Cockburn Professor of Engineering Design
Department of Mechanical Engineering
University of Toronto
Toronto, Ontario, Canada

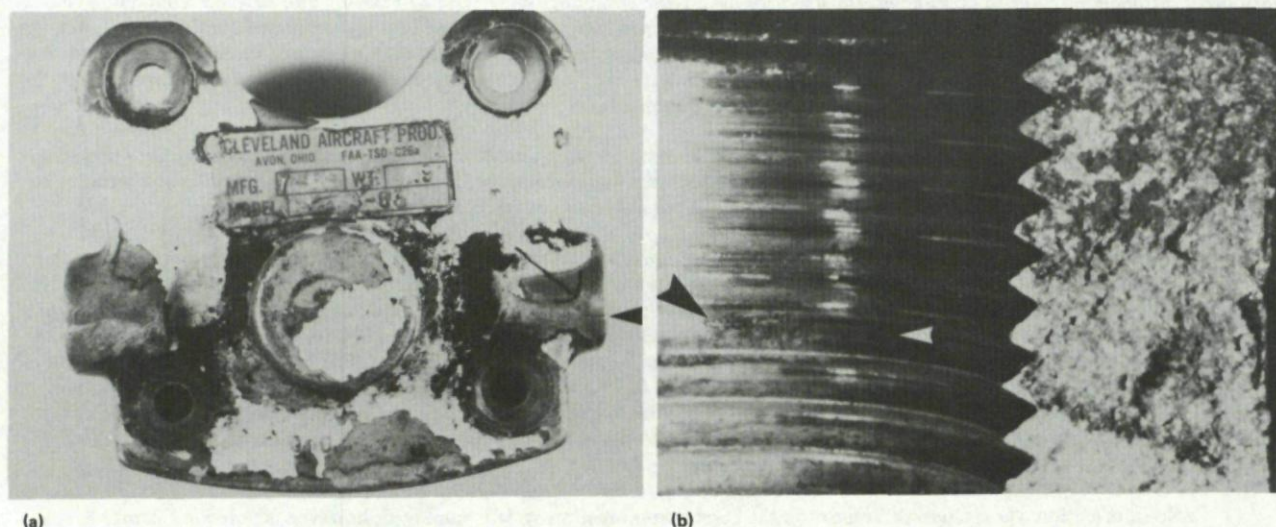
Fig. 13-46 Stress corrosion cracking of a magnesium alloy brake housing, case history 13-11.

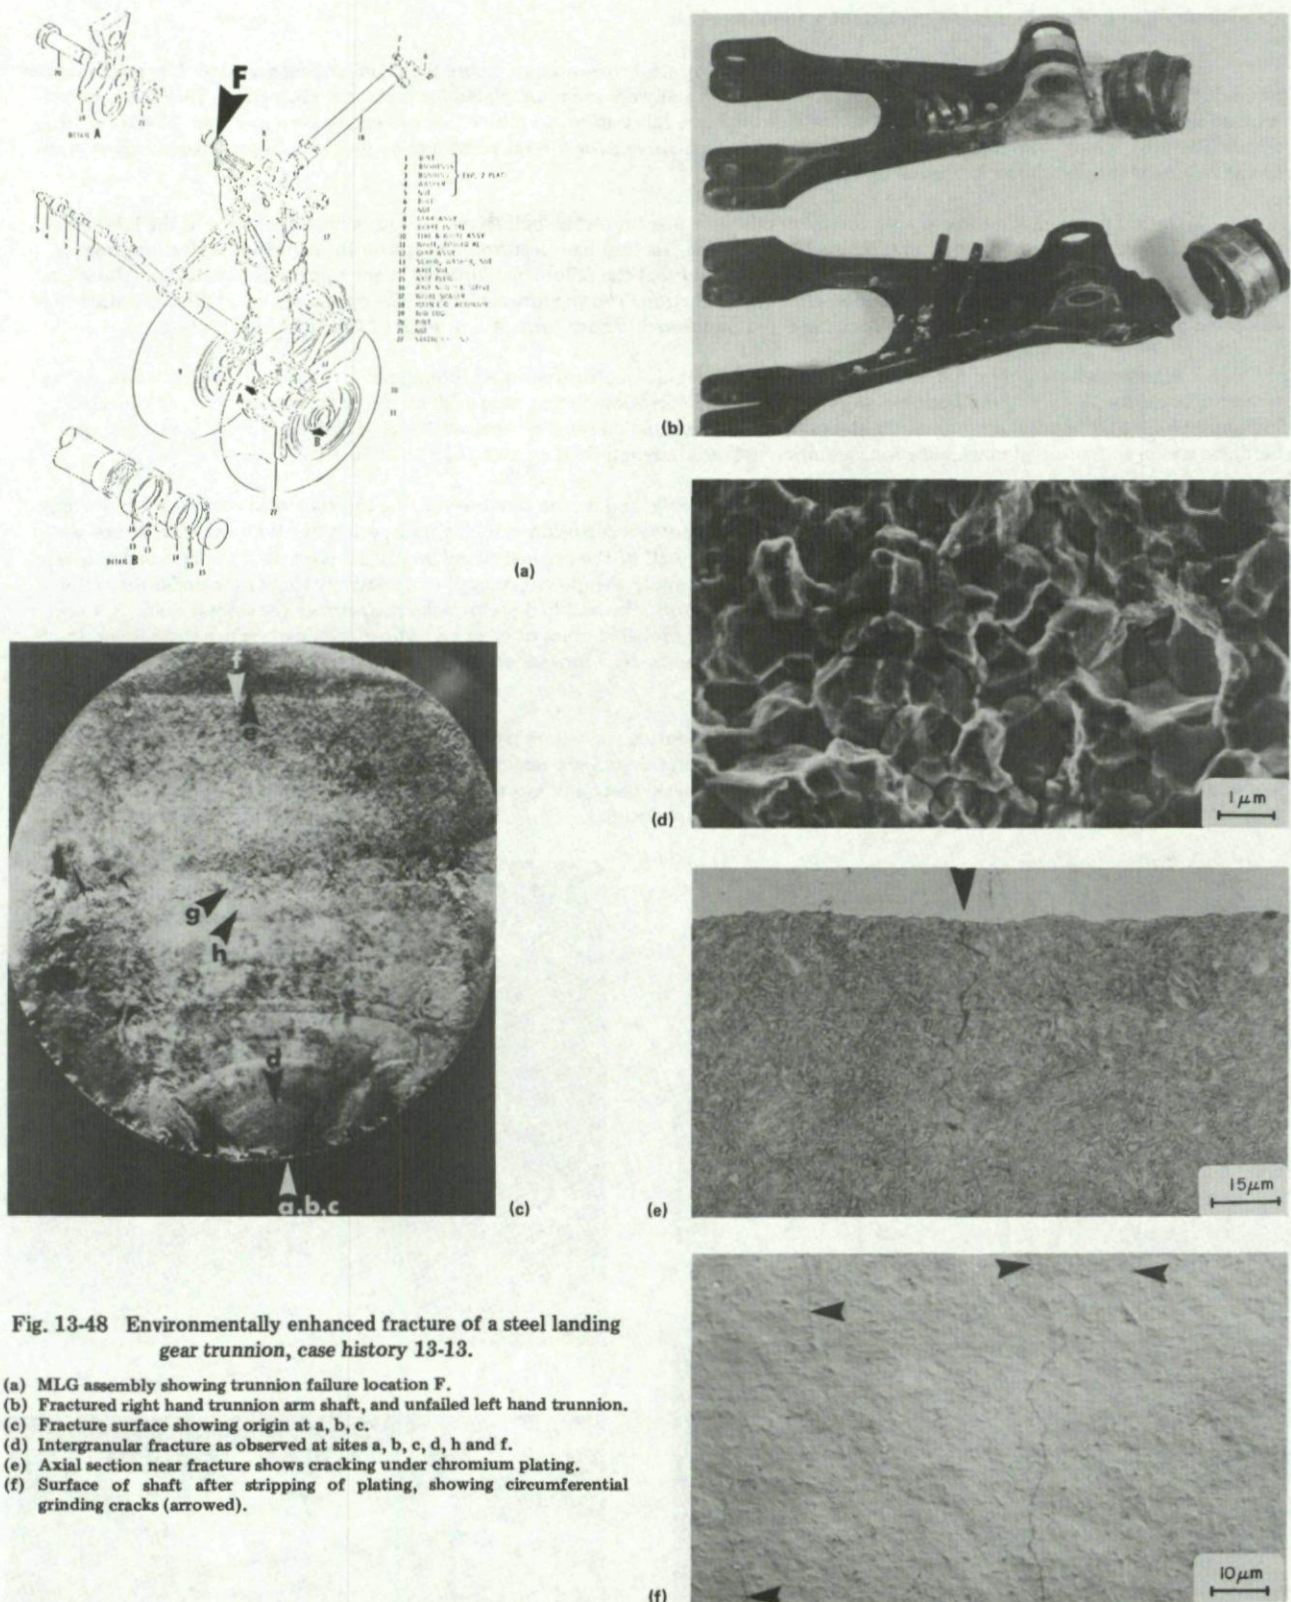
Fig. 13-48 Environmentally enhanced fracture of a steel landing gear trunnion, case history 13-13.

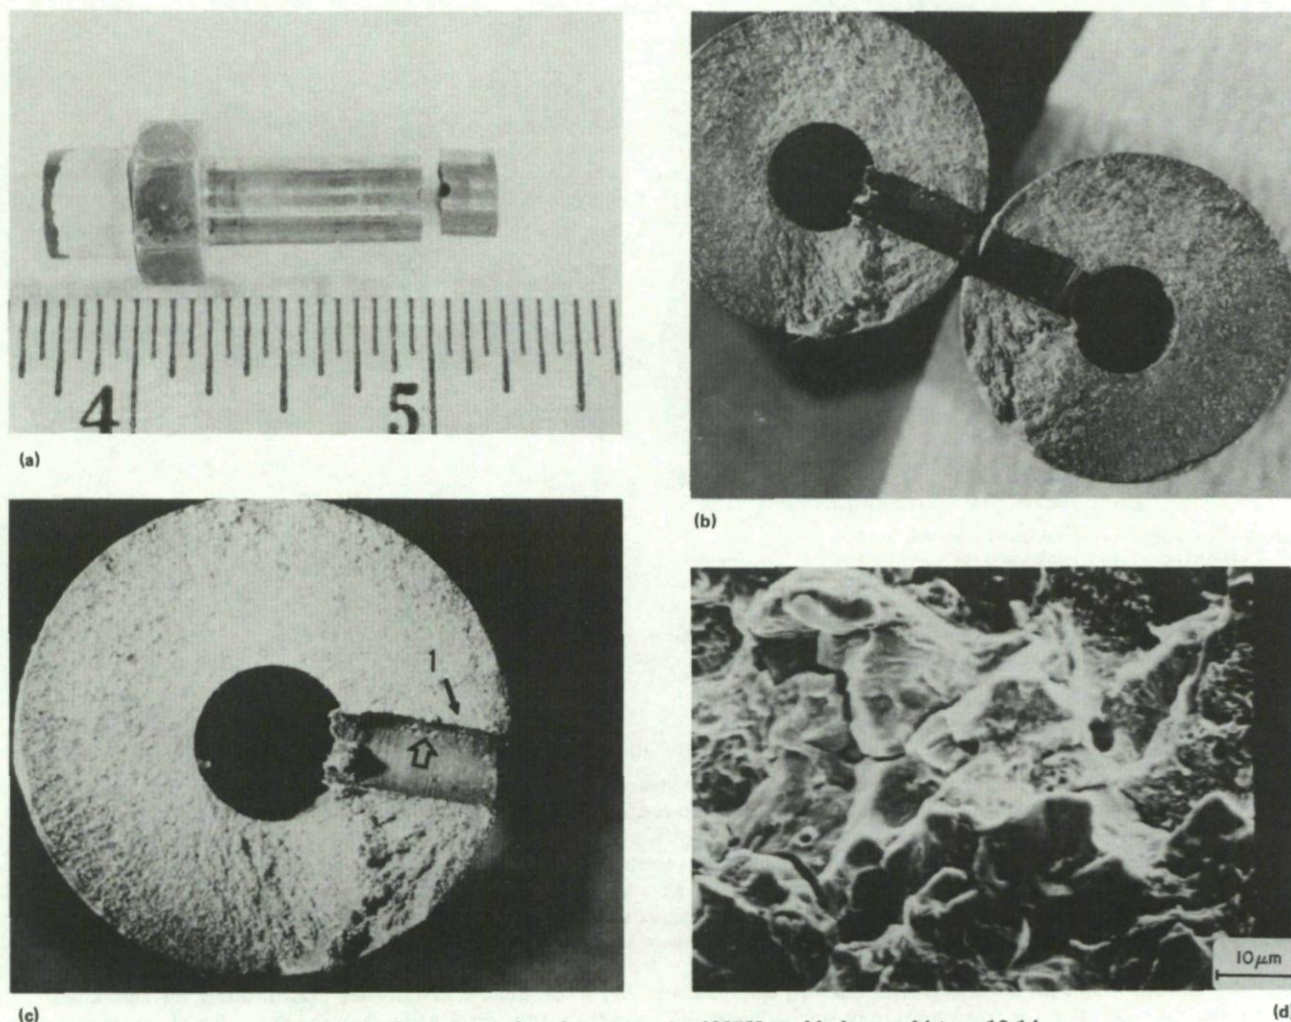
Fig. 13-49 Corrosion induced fracture of a 4335V steel bolt, case history 13-14.

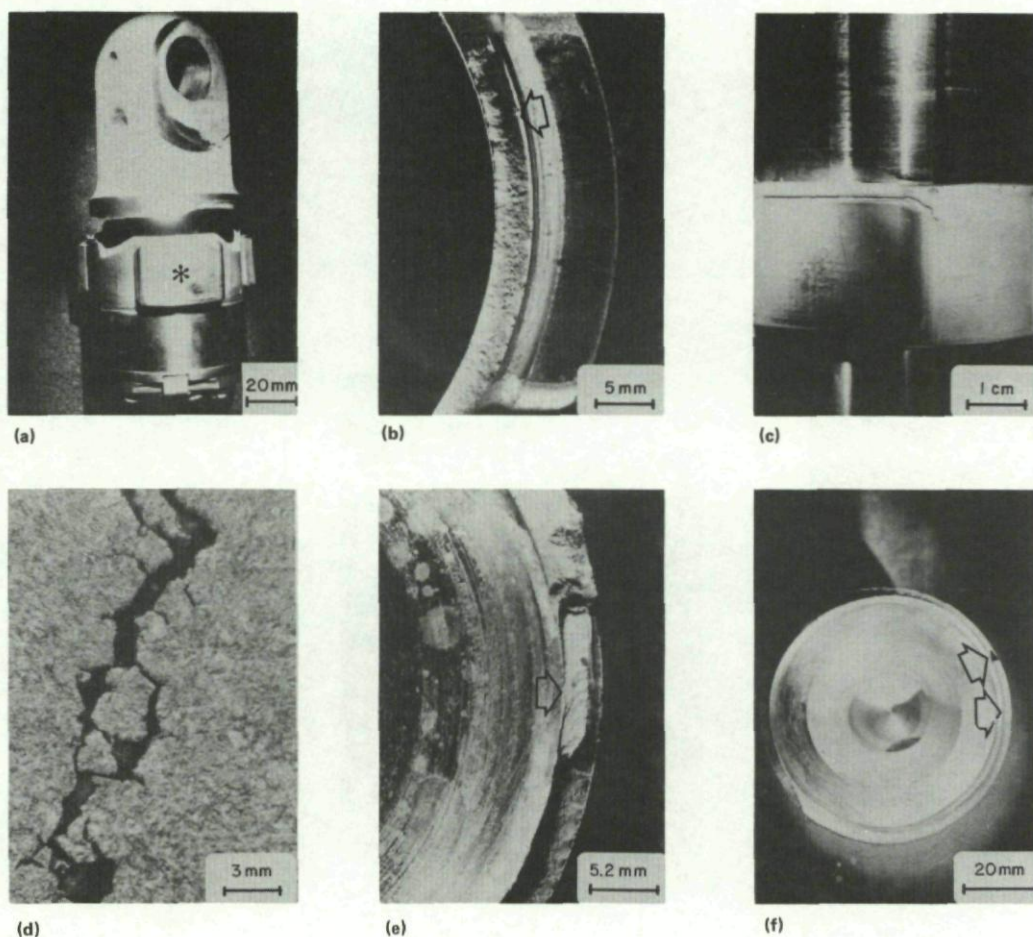
Fig. 13-51 Corrosion induced failure of four 4340 landing gear retraction cylinders, case history 13-16.

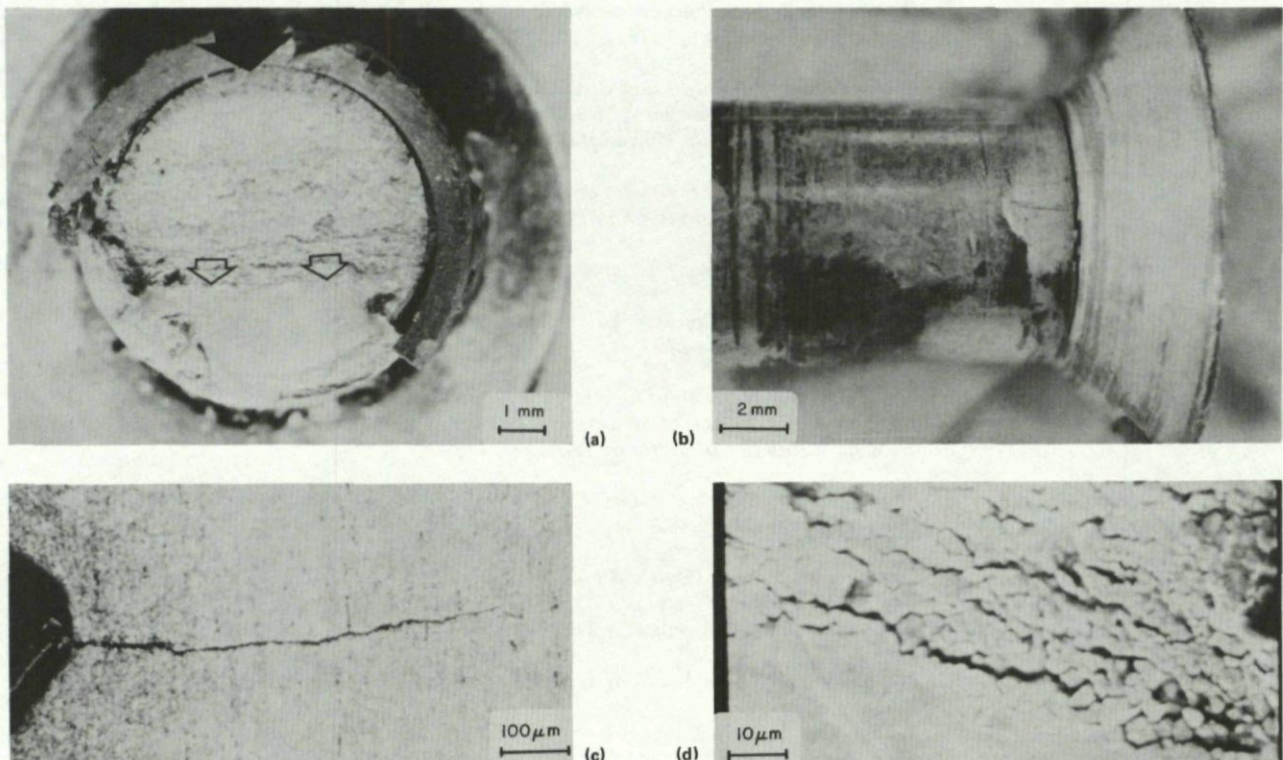
Fig. 13-52 Corrosion induced failure of a 1040 plain carbon steel bolt, case history 13-17.

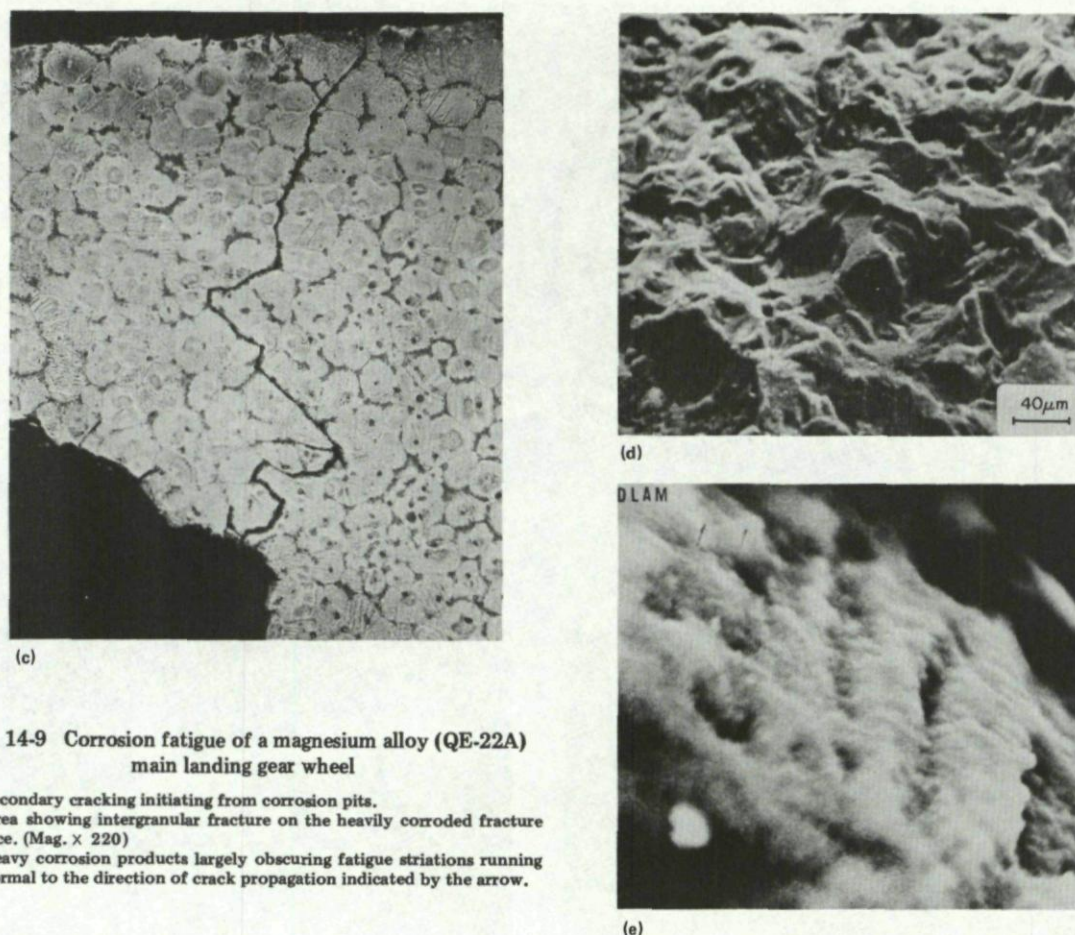
Fig. 14-9 Corrosion fatigue of a magnesium alloy (QE-22A) main landing gear wheel

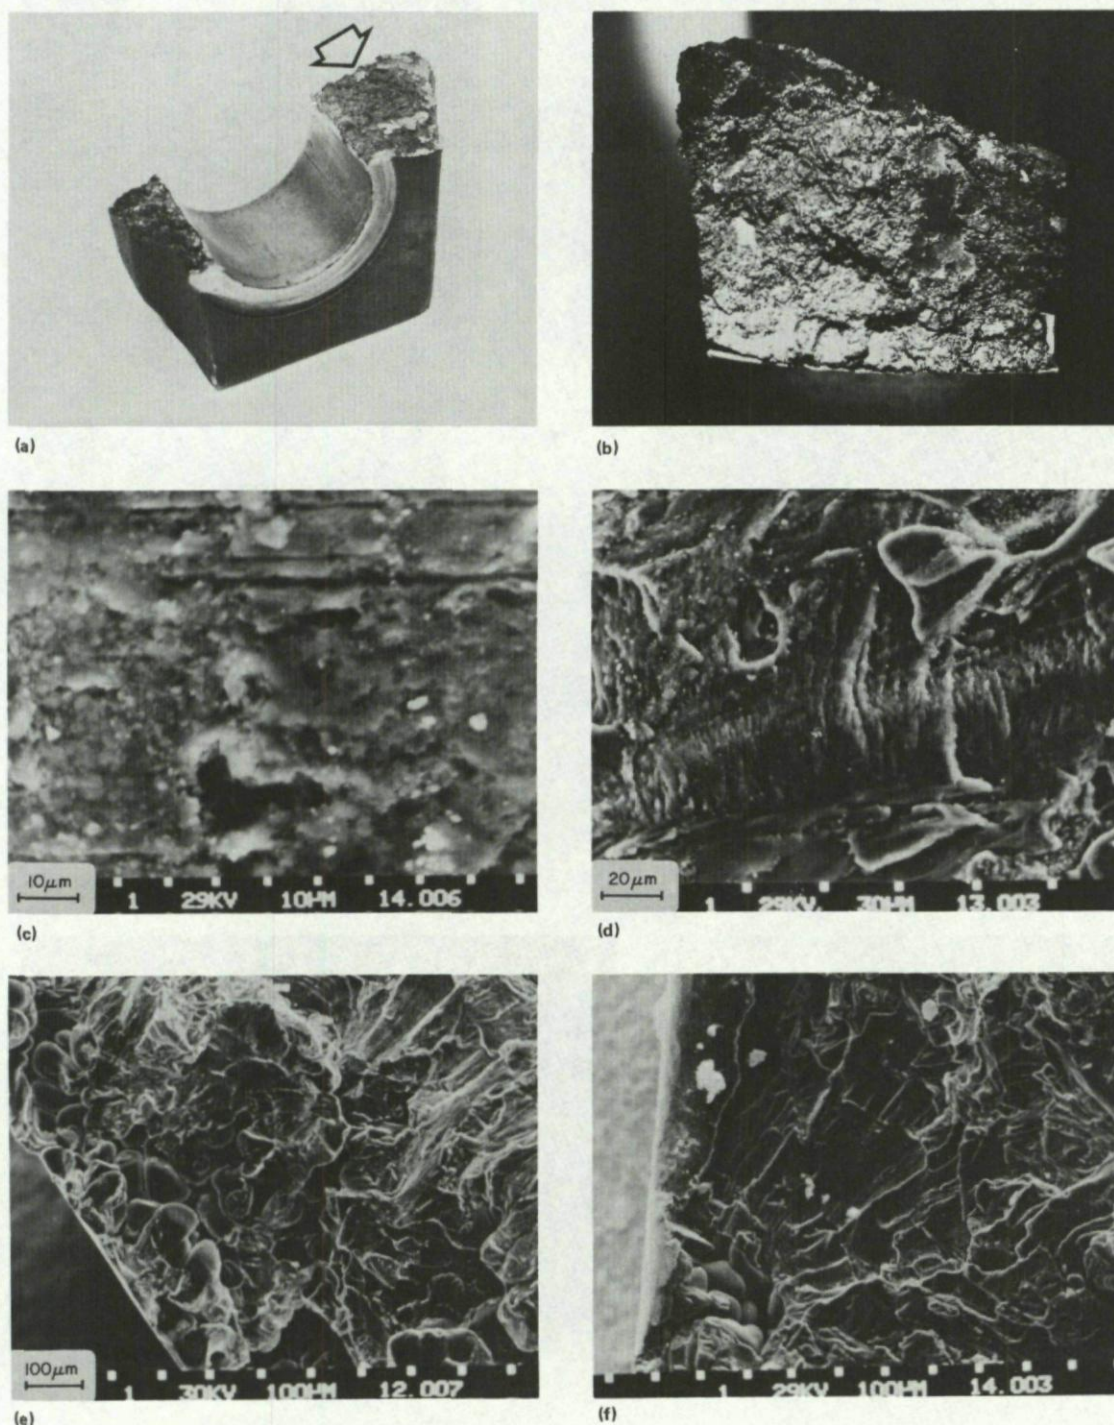
Fig. 14-11 Corrosion fatigue of a cast aluminium rocker arm journal bearing

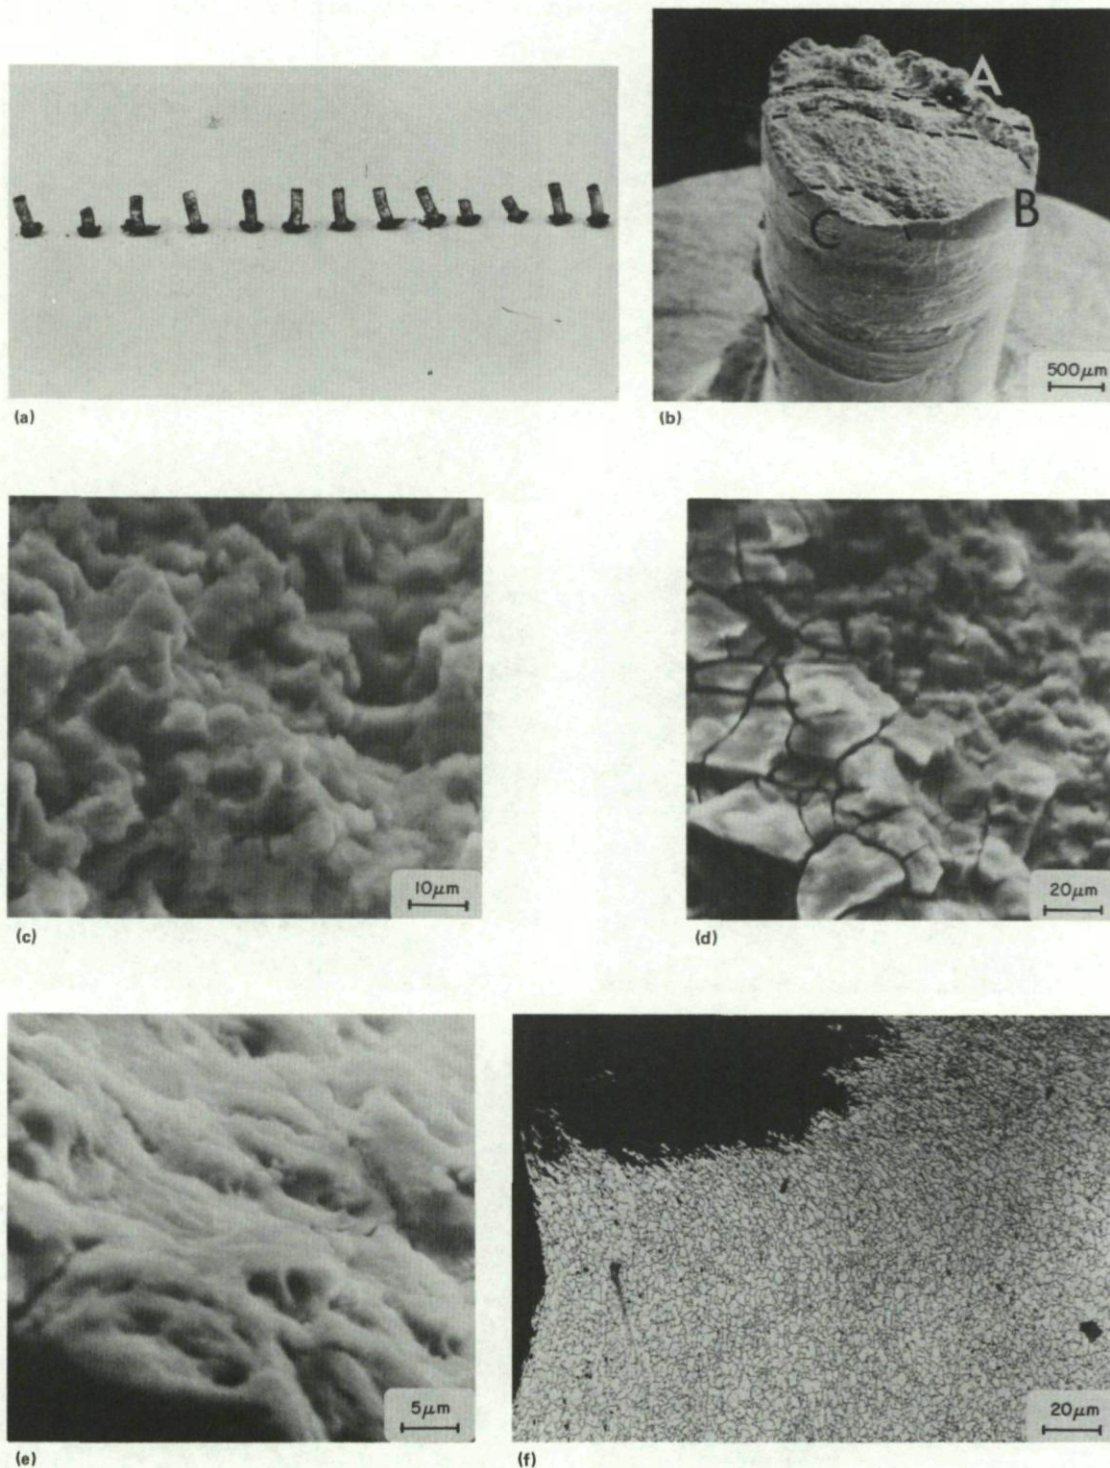
Fig. 14-12 Corrosion fatigue of 5052 aluminium alloy rivets

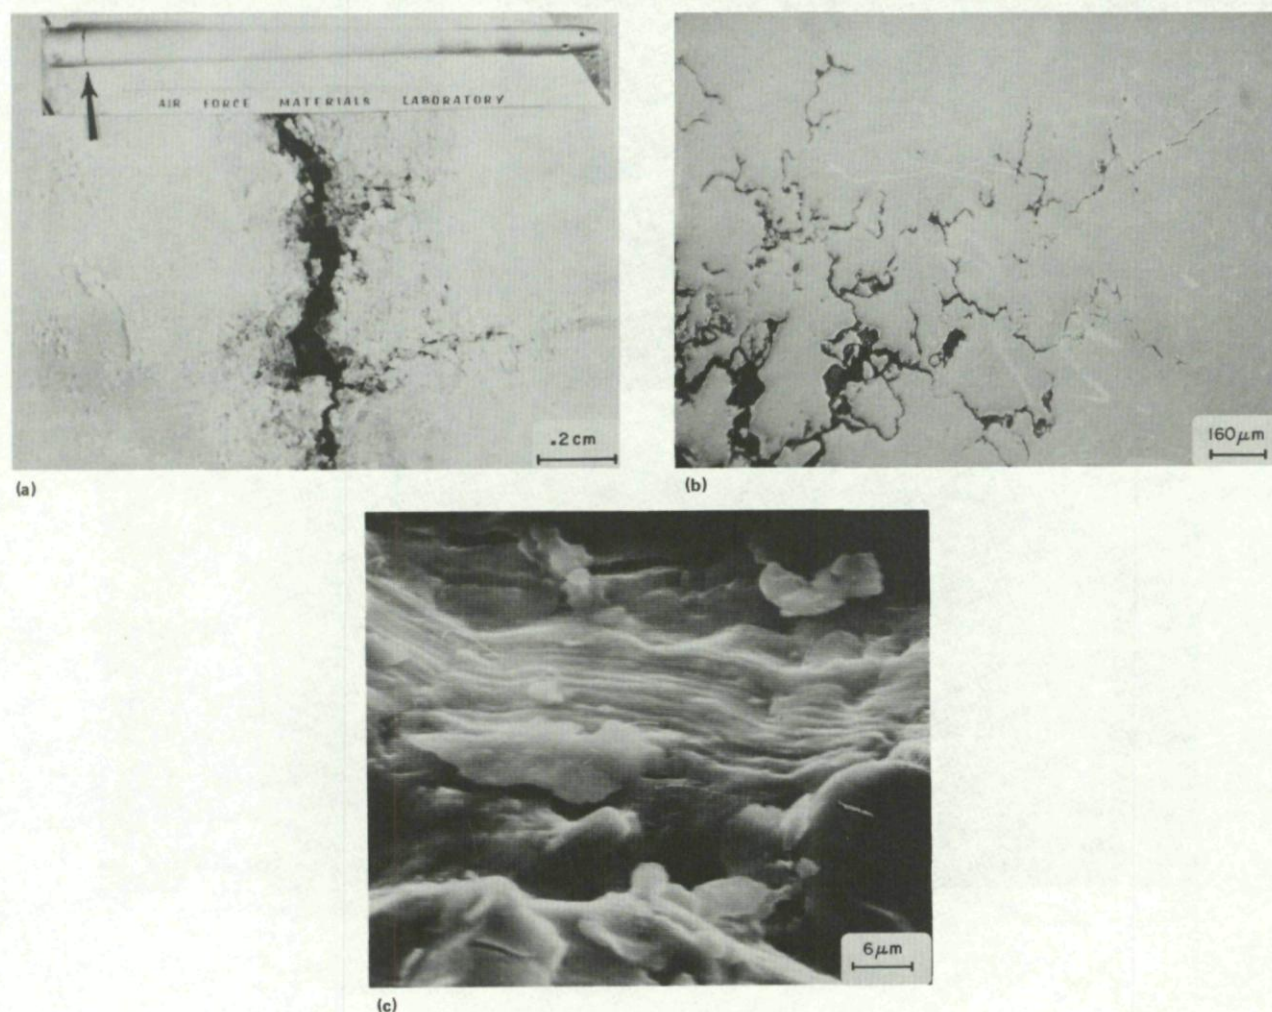
Fig. 14-13 Corrosion fatigue in a 6061 aluminium pitot support tube

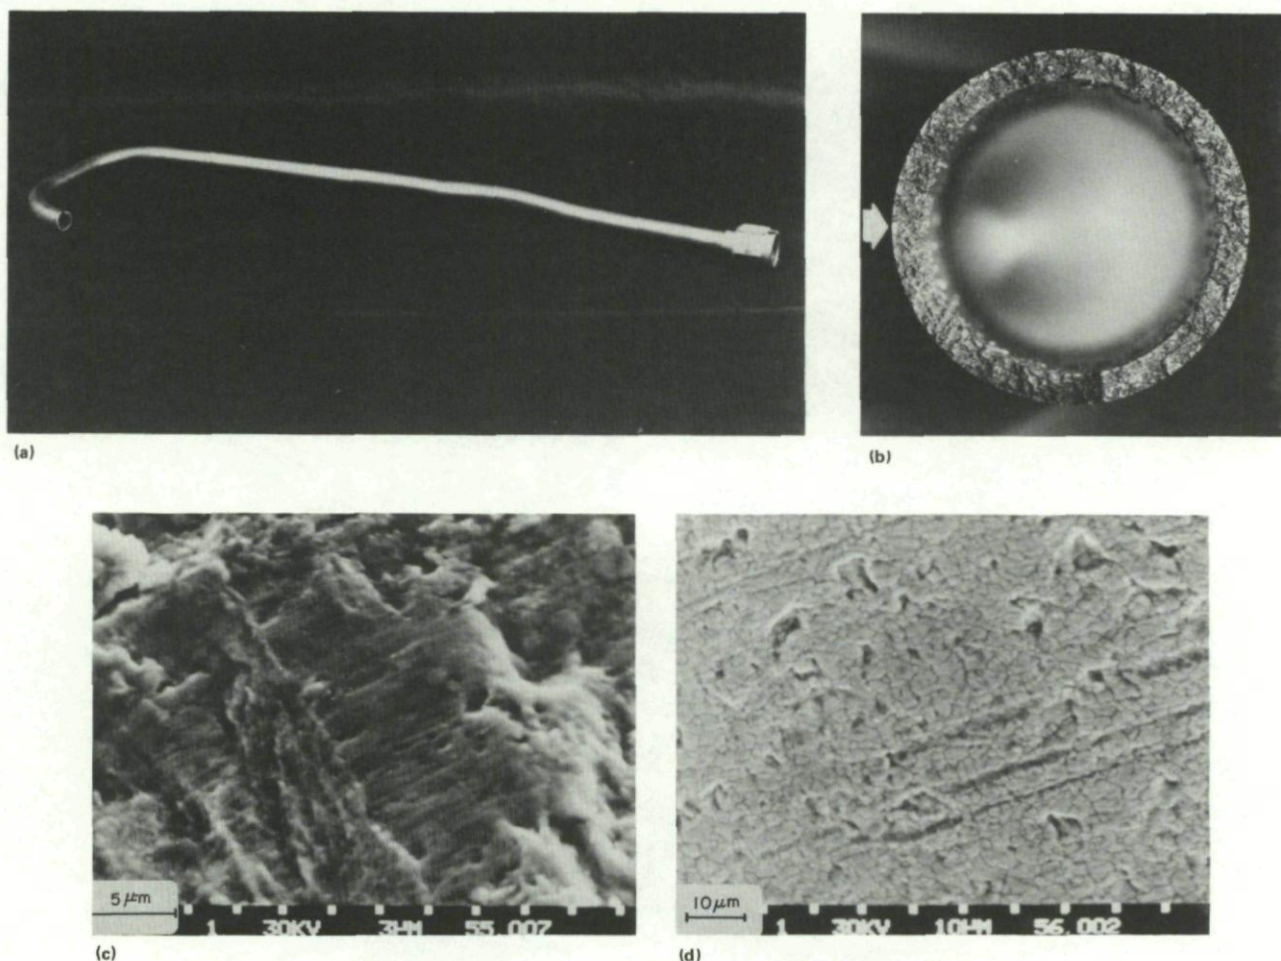
Fig. 14-14 Corrosion fatigue of a 321 stainless steel hose assembly

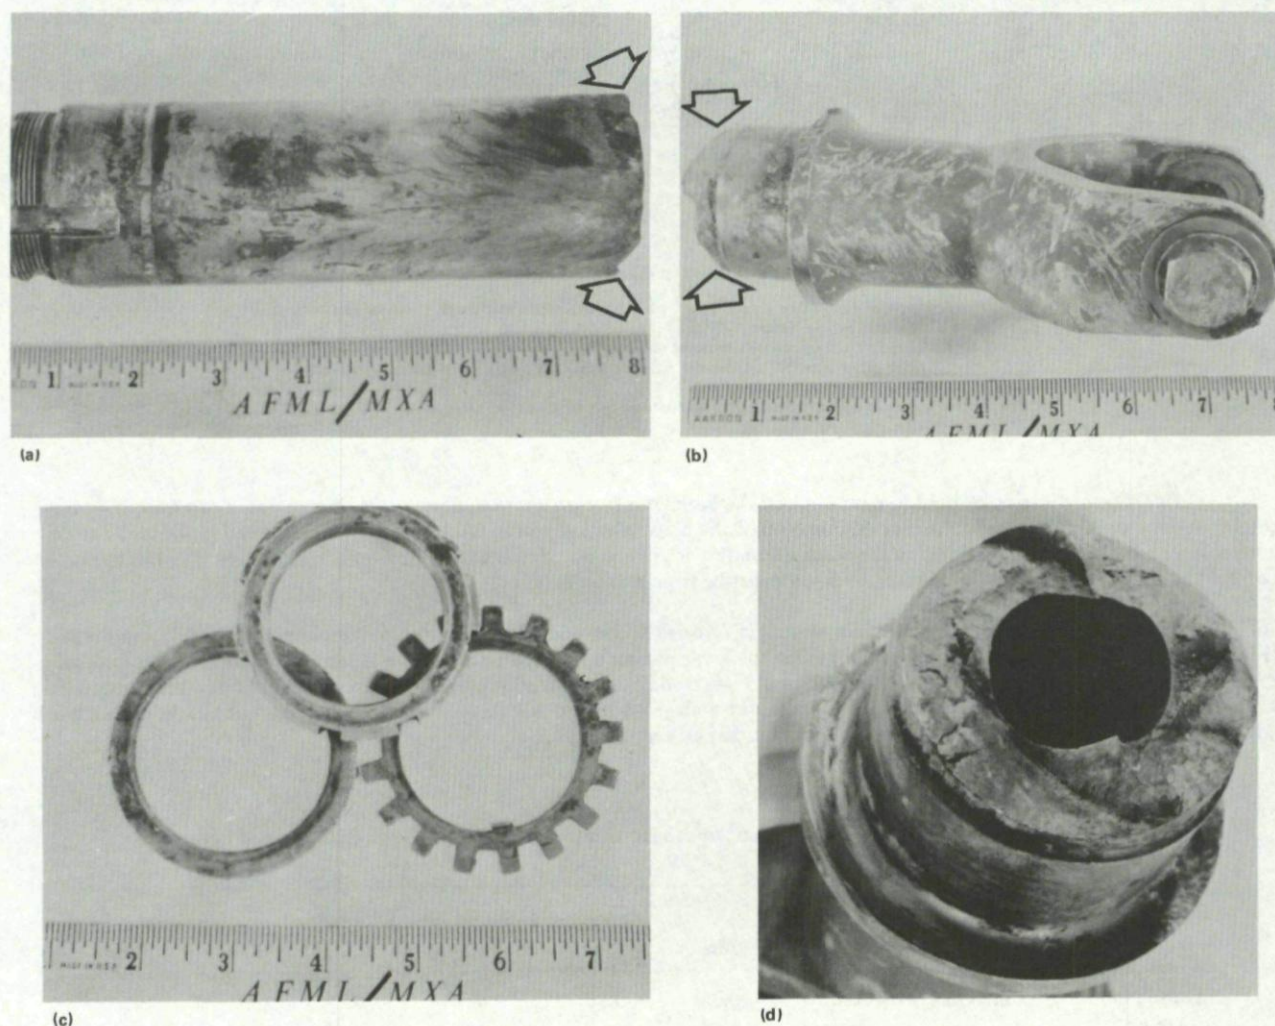
Fig. 14-15 Corrosion fatigue of a 4340 steel rotor attachment assembly

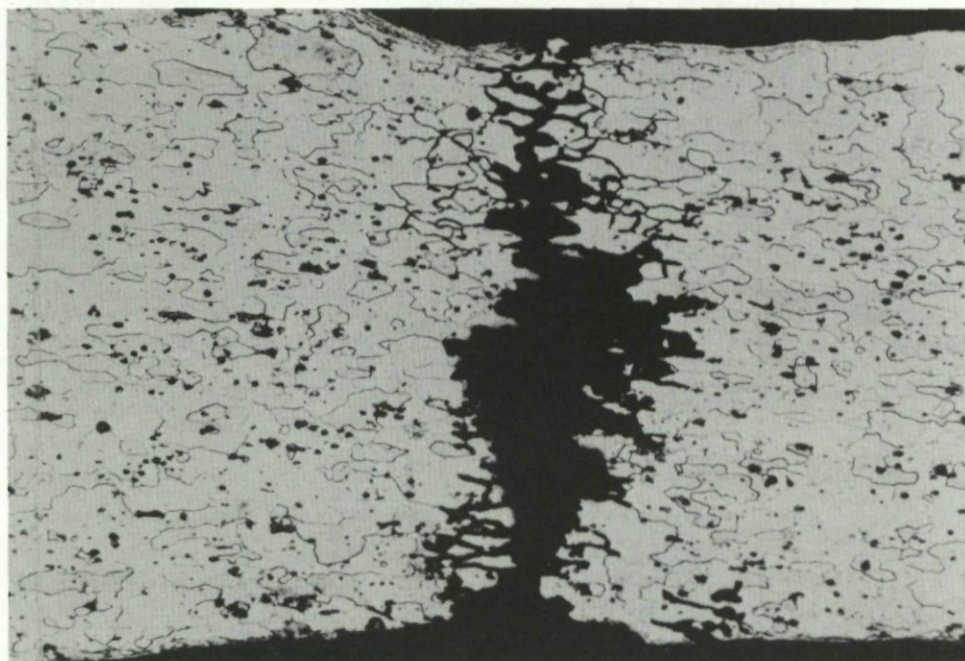
Fig. 15-6 Typical perforation corrosion caused by micro-organisms. Alloy: 2024 (Al-Cu-Mg)

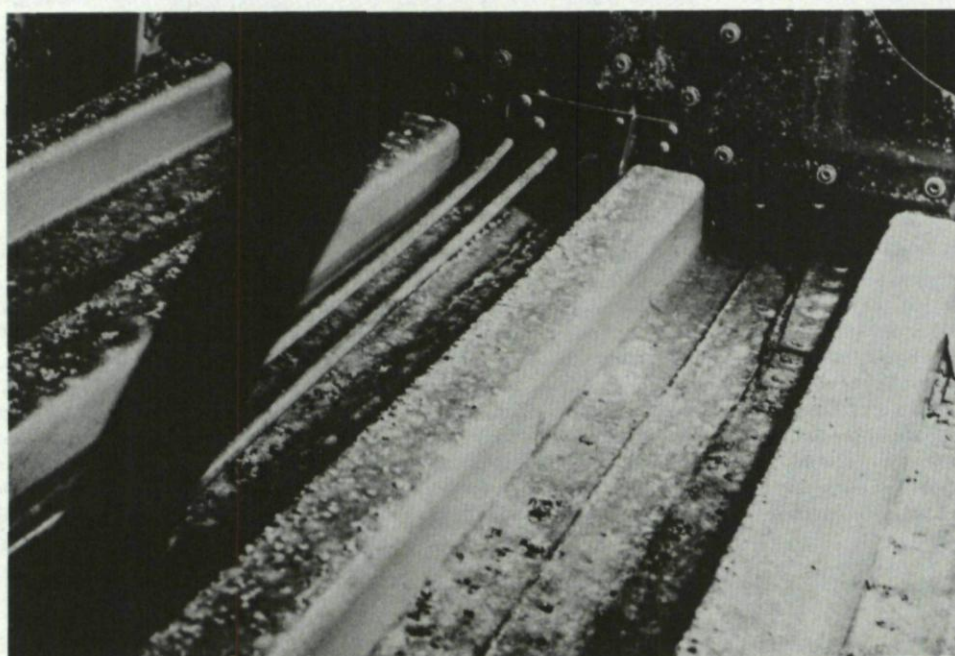
Fig. 15-8(a) Typical view of integral fuel tanks with microbiological corrosion

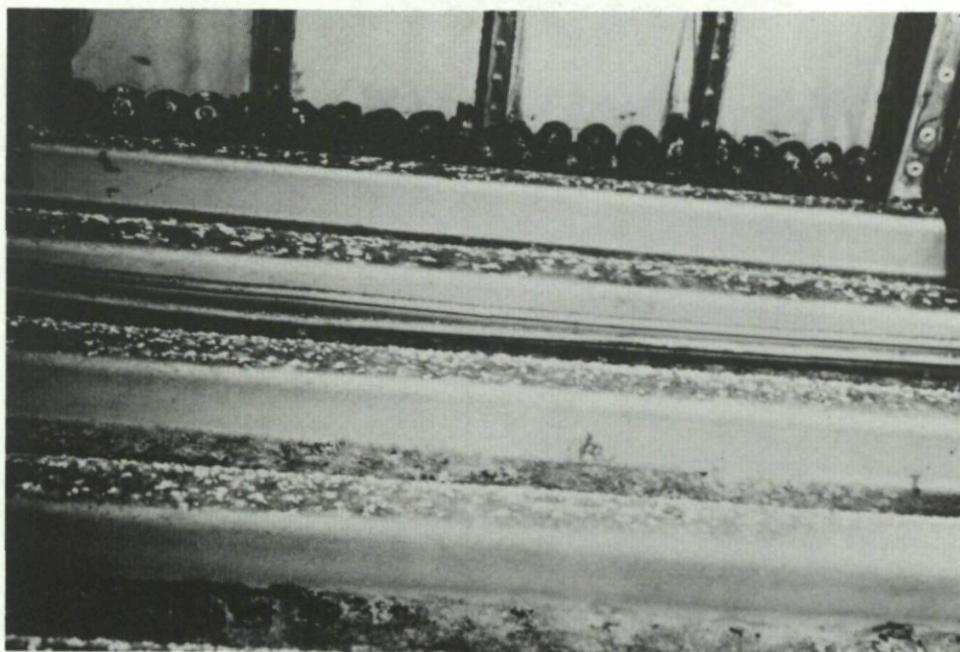
Fig. 15-9 Typical view of integral fuel tanks with microbiological corrosion
