S0300-B5-RPT-010

U.S. NAVY SALVAGE REPORT SPACE SHUTTLE COLUMBIA

Published by Direction of Commander, Naval Sea Systems Command

SEPTEMBER 2003

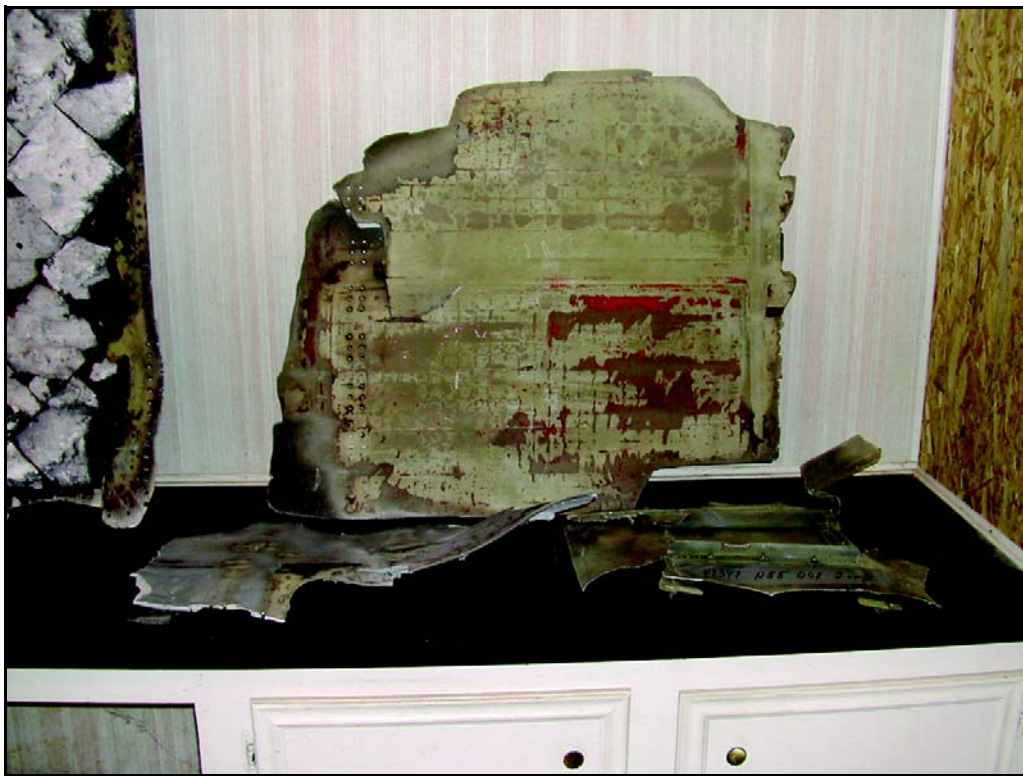
Tests were conducted over a two-week period during the operation to ensure the equipment being used was able to achieve the expected results. SUPSALV ordered the first series of tests on March 2 as the water search organization had yet to find any shuttle debris. NASA provided 4 pieces of shuttle skin material that had been recovered on land for controlled testing. The dive team tied these pieces to buoys and dropped them in approximately 20 feet of water in a relatively clear bottom in front of the Fin and Feather. These pieces ranged in size from the largest being 1 by 2 meters to the smallest measuring 0.4 by 0.5 meters. See Figure 3-14 for photos of these shuttle pieces. Search boats operating both multibeam system and a Marine Sonic side scan ran the test range. It was noted that detection of the largest target was possible, while detection of the smaller targets was uncertain.

Figure 3-14. Actual Shuttle Pieces Used as Test Targets.

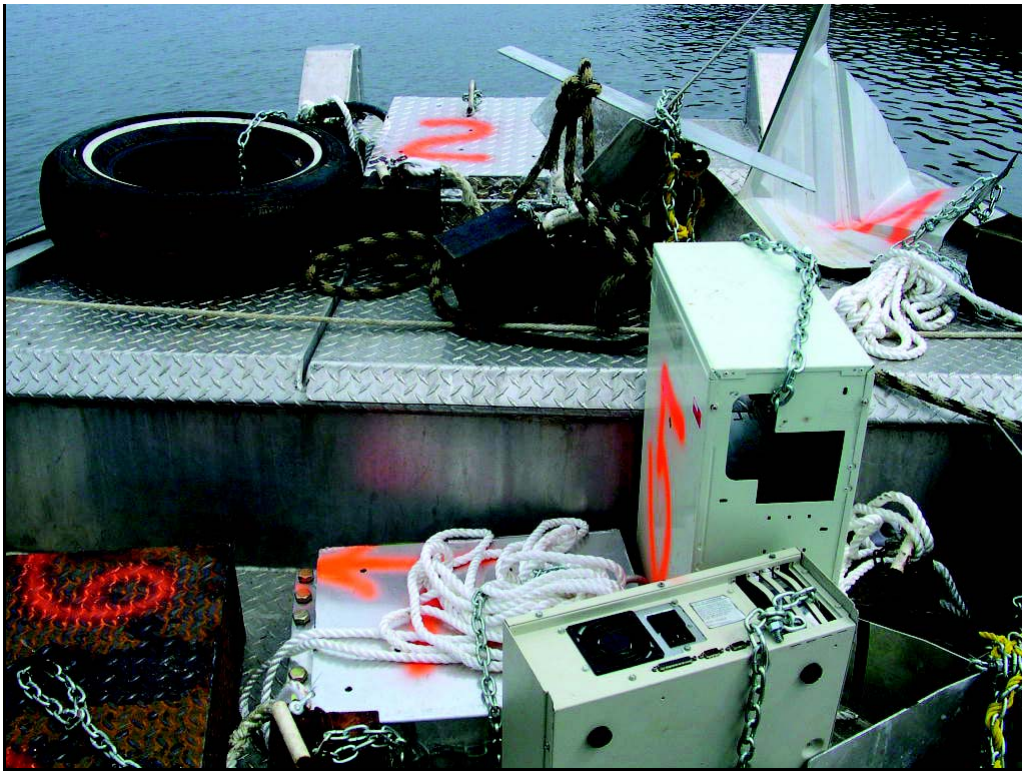
Figure 3-15. Sample Targets used for Controlled Test.

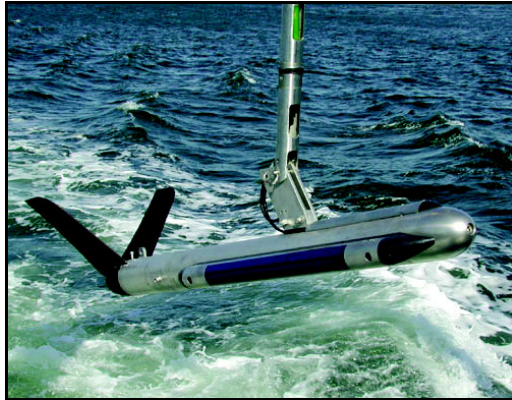
Klein 3000 Side Scan Sonar

Frequencies:	100 kHz (125 kHz +/- 1% act.), 500 kHz(445 kHz, +/-1% act.)
Beams:	Horizontal - 1 deg. @100 kHz, 0.2 deg @ 500 kHz, Vertical - 40 deg
Beam Tilt:	0, 10, 20 degrees, adjustable
Maximum Range:	450 meters @ 100 kHz; 150 meters @ 500 kHz
Depth Rating:	1,500 meters
Construction:	Stainless steel
Size:	122 cm long, 8.9 cm diameter
Weight:	29 kg in air
Options:	Sub-bottom profiler, Magnetometer, Attitude sensors: roll, pitch, heading, pressure, attitude, acoustic positioning responder, single frequency of 50 kHz
