Spacecraft System Failures and Anomalies Attributed to the Natural Space Environment

K.L. Bedingfield, R.D. Leach, and M.B. Alexander, Editor

SPACECRAFT SYSTEM FAILURES AND ANOMALIES ATTRIBUTED TO THE NATURAL SPACE ENVIRONMENT

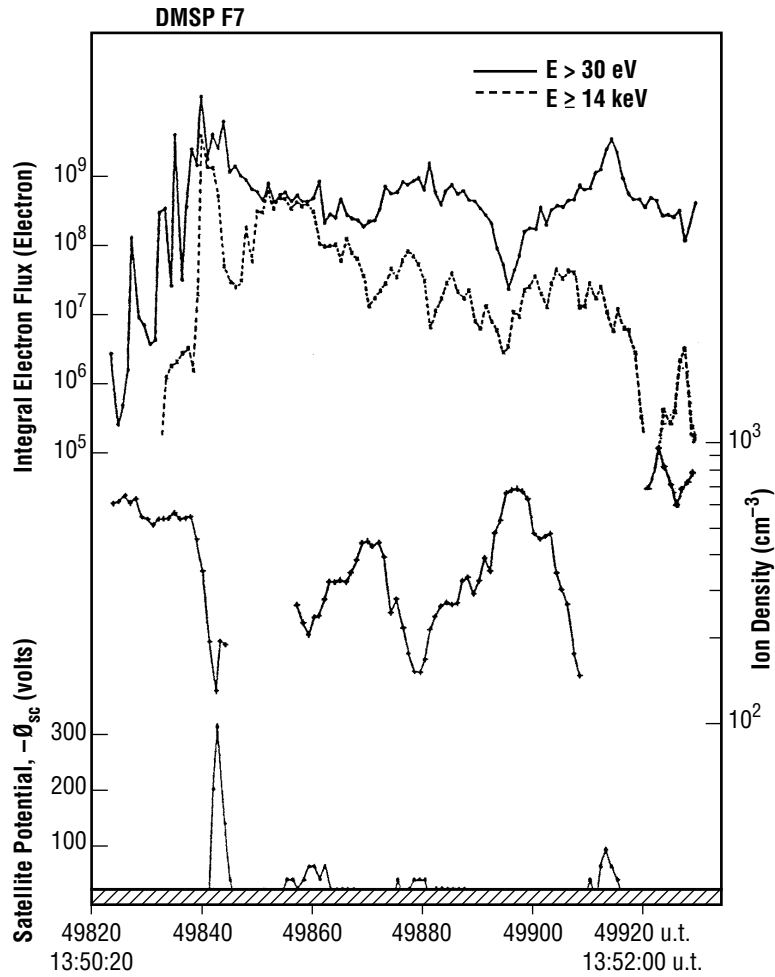
Figure 8. An example of the type of charging events encountered by the DMSP satellite F7 on November 26, 1983. DMSP 7 is a defense meteorological satellite flying LEO/polar.
