AGARD Corrosion Handbook Volume 1 Aircraft Corrosion: Causes and Case Histories

AIRCRAFT CORROSION: CAUSES AND CASE HISTORIES

W.Wallace
Head, Structures and Materials Laboratory
National Aeronautical Establishment
National Research Council Canada
Ottawa, Ontario, Canada

D.W.Hoeppner
Cockburn Professor of Engineering Design
Department of Mechanical Engineering
University of Toronto
Toronto, Ontario, Canada

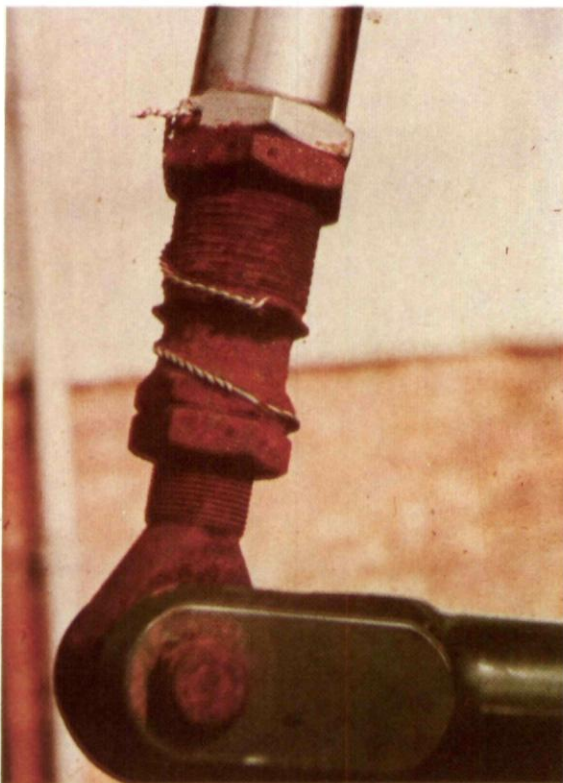
Most of the common engineering metals and alloys produce characteristic corrosion products which allow corrosion to be recognized fairly easily. Probably the best-known form of corrosion occurs on non-stainless iron and steel and is easily recognized by the familiar red iron rust (Figs. 7-1 and 7-2). Figure 7-1 shows rusting on a steel track rod adjuster and eye end, originally cadmium plated but operating in an exposed environment. The cadmium had presumably been totally sacrificed after loss on threads during assembly or maintenance. Use of a supplementary protective material should have prevented this. Figure 7-2 shows a steel jet pipe end cap liner which had been subjected to high temperature oxidation over a long period of time. In this figure the blistering and flaking of a surface protective coating is apparent, and the formation of red rust products in the underlying steel can be seen. The materials chosen for this application had simply proven unsuitable for the environment, though quite possibly they were the best available when the design was established. The fact that the aircraft life had been extended, and these components had been required to operate for much longer times than originally intended is also an important factor.

Fig. 7-1 Rusting on a steel track rod adjuster and eye after damage occurred to the protective cadmium plating

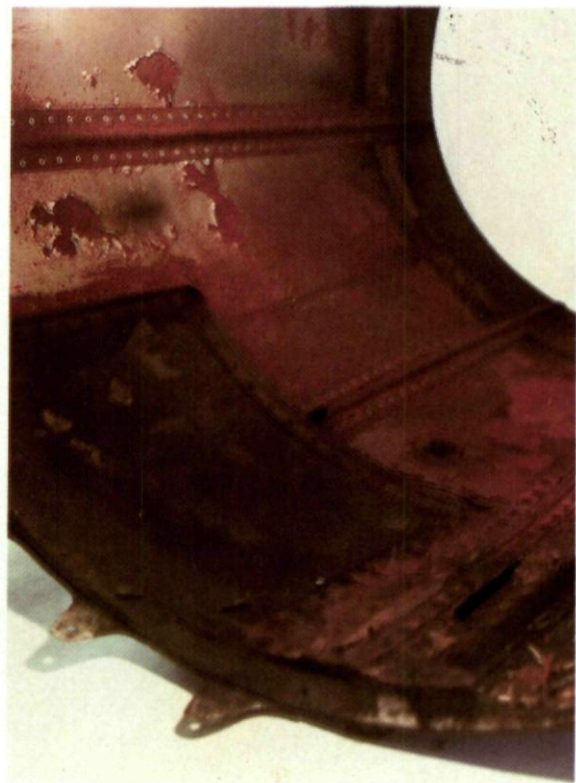
Fig. 7-2 Rusting in a jet pipe end cap liner following damage to its protective coating

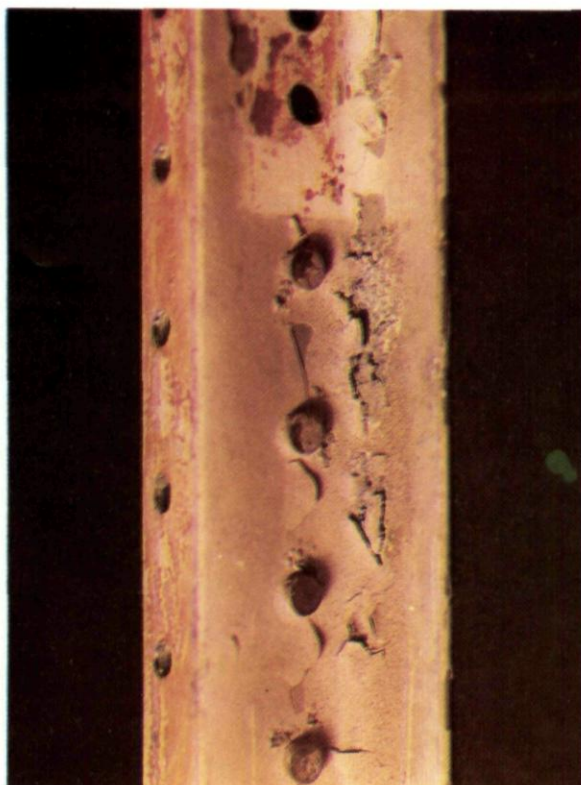
The corrosion products of aluminium and magnesium alloys are evident as white to grey powdery deposits, the latter are often of a fluffy or granular nature. Figure 7-3 shows the surface corrosion damage to an aluminium alloy stringer, where the chromate pre-treatment and primer coat had failed, probably through aging and exposure to moisture. Early identification of aluminium or magnesium corrosion is essential, and frequently the first indications are flaking or blistering of the surface finish. Figure 7-4 shows an area of general surface corrosion on a magnesium alloy skin of a helicopter on which the chromate pre-treatment had locally failed.

Fig. 7-3 Flaking of the chromate pre-treatment and primer on an aluminium alloy stringer and corrosion of the exposed metal

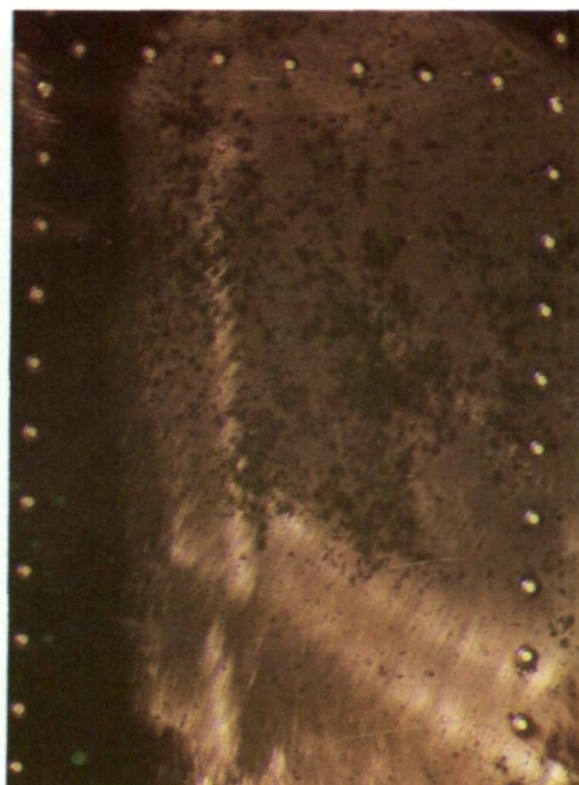
Fig. 7-4 Uniform corrosion in a magnesium alloy helicopter skin after damage to the chromate pre-treatment

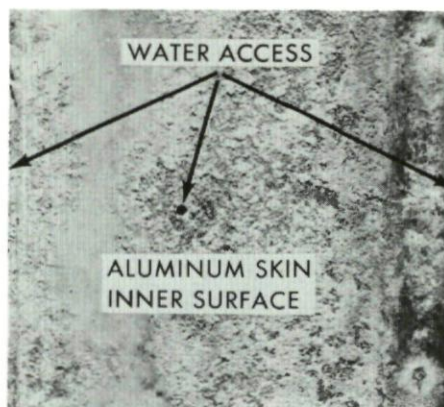
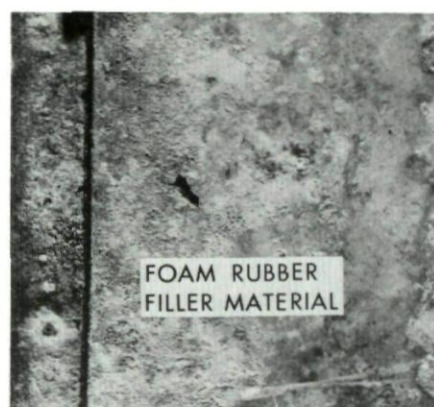
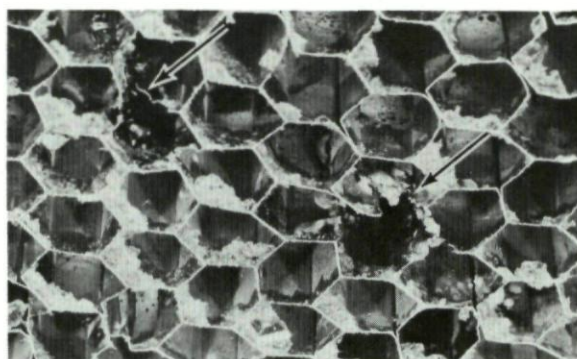
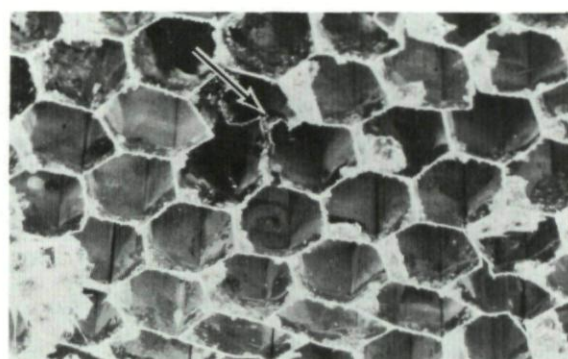
Fig. 7-5 Corrosion damage in an aluminium alloy honeycomb structure from a fighter aircraft

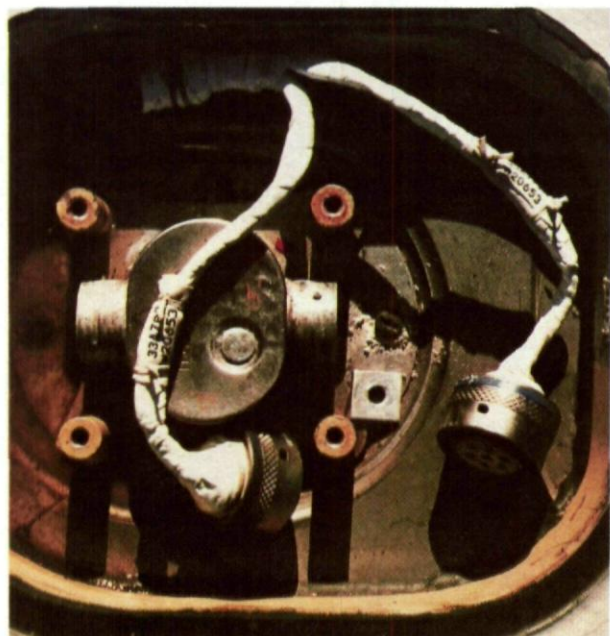
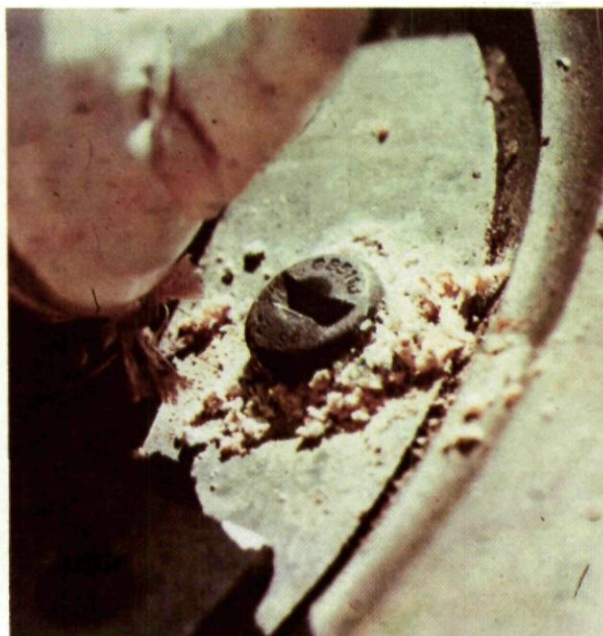
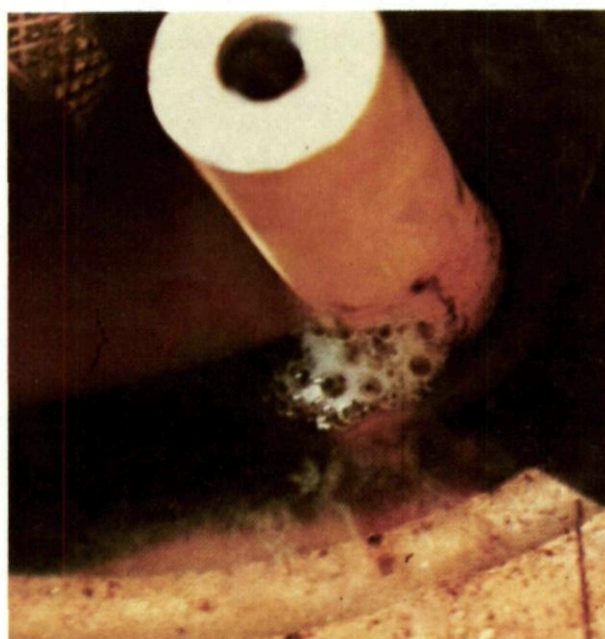
The need to prevent the ingress of water and other corrodents to internal structure and equipment is nowhere more important than with electrical and avionics equipment. In the interests of obtaining specific electrical characteristics, the materials used are often inferior in terms of corrosion resistance, and serious corrosion problems and often malfunction of equipment can occur if the equipment is not properly sealed. Figure 7-6(a-c) shows examples of corrosion of electrical equipment in a military aircraft due to water intrusion around the access door. The general reddish-orange discolouration of the compartment walls and floor, in Figure 7-6(a), indicates that uniform corrosion has occurred in these areas. The close-up photographs of Figure 7-6(b) and -6(c) show local eruptions of corrosion products around a screw and binding post, which are probably examples of galvanic corrosion and crevice corrosion.

Fig. 7-6 Corrosion in a container used to house electrical equipment

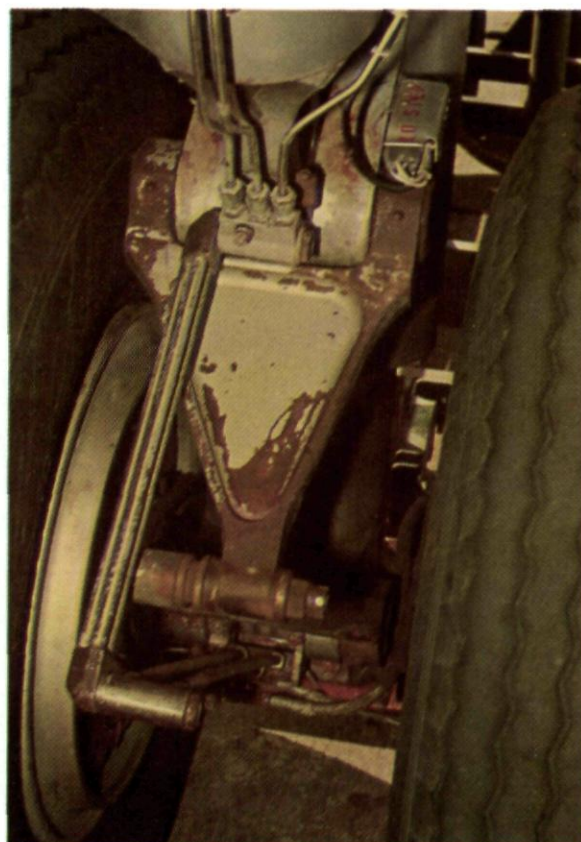
Erosion-corrosion problems can be quite severe in transport aircraft operating in hot desert climates. Though dry in the sense of having low rainfall, desert areas are nevertheless often very humid, especially at night. High temperatures accelerate corrosion, distort skin surfaces and crack protective finishes, while dust and sand often containing a high proportion of salt erode surface finish and also mix with oils, grease and hydraulic fluid to form extremely abrasive compounds. Loose stones and rocks thrown up from temporary landing strips damage protective finish leaving areas of bare metal open to corrosive attack. Figure 7-7 shows erosion-corrosion damage to the undercarriage components of a transport aircraft as a result of operation from a desert landing strip. Damage to the protective coating system by stone impact and sand erosion has led to exposure of the bare metal which then continues to deteriorate by a combination of corrosion and erosion.

Fig. 7-7 Erosion-corrosion damage on the undercarriage of a transport aircraft

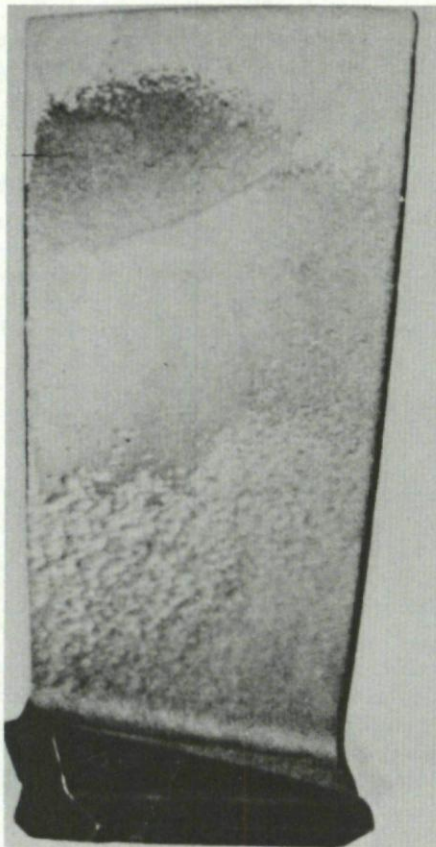
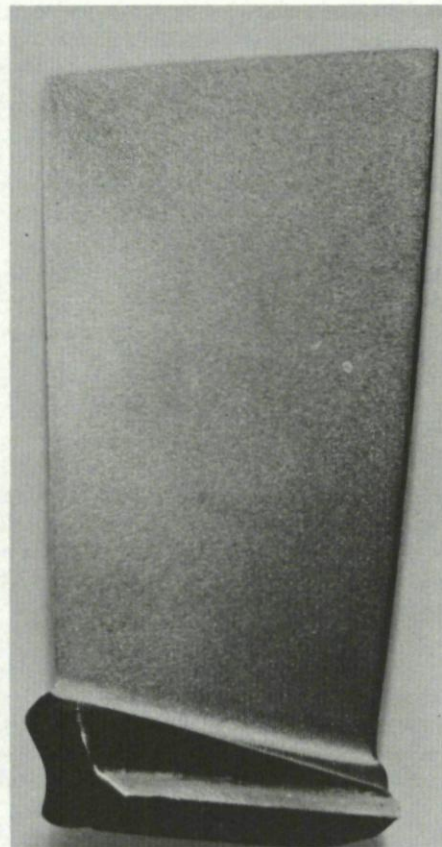
T-58 COMPRESSOR BLADES AFTER 16-1/2 HOURS EROSION TEST (CONCAVE SURFACE)

Fig. 7-8 Erosion-corrosion damage on the airfoil of a fighter aircraft compressor blade

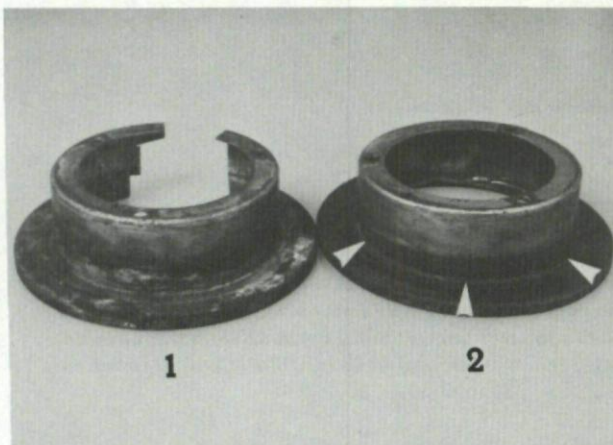
(a)

The brake disc assemblies were removed from both main wheels of a light single engine aircraft (Fig. 7-9(a)). Both brake disc assemblies were severely corroded in the fillet radius area between the disc and the sidewall, and there was a 12-15 mm band of corrosion around the outside surface of the wall as shown in Figure 7-9(a).

Fig. 7-9 Corrosion failure of a brake disc assembly

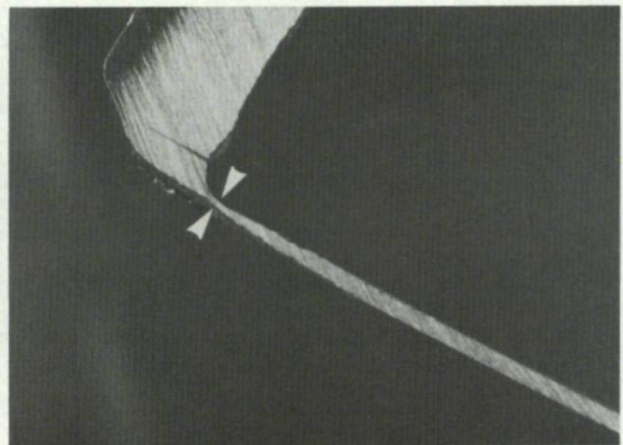
(b)

The brake disc assembly number 2 had failed around the sidewall circumference adjacent to the disc; this area was severely weakened due to corrosion to the extent that the wall thickness at the failed section was reduced to approximately one-quarter of the original thickness. Figure 7-9(b) shows the corresponding section through the disc and sidewall of the unfailed assembly, number 1. Even though this particular unit had not failed, a serious loss of material had occurred leading to a reduction of sidewall section thickness, as indicated by the arrows in Figure 7-9(b).

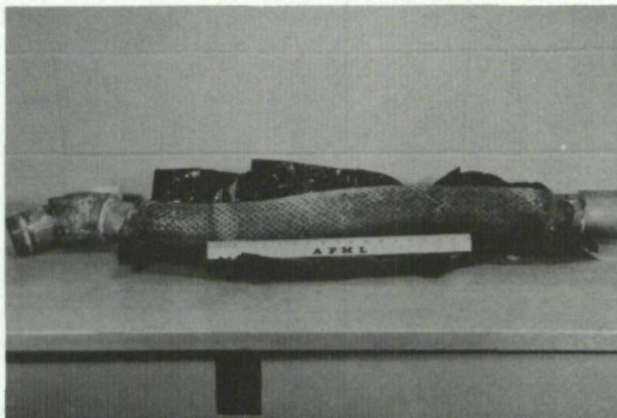
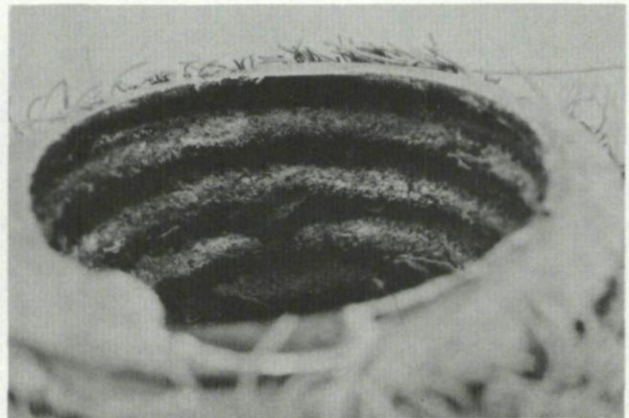
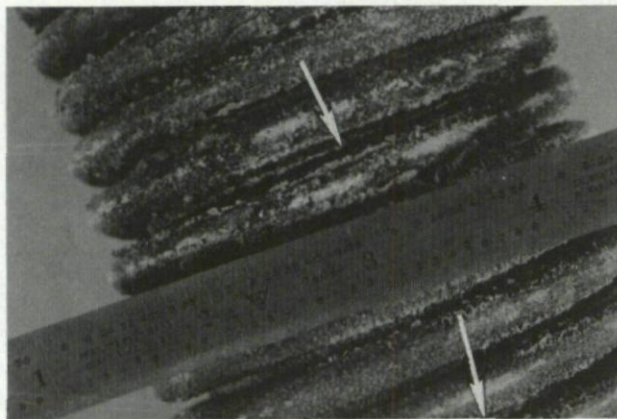
Visual examination of the flexible stainless steel pipe, Figure 7-11(a), revealed the outside surface to be covered with a light tan powdery residue or corrosion product. A dark brown residue was found on the inside surface when the pipe was sectioned (Fig. 7-11(b)). The wire mesh was stripped from the convoluted flexible pipe and large cracks were found running circumferentially around the inside or small radius bends of the convolutes (Fig. 7-11(c)).

Fig. 7-11 Hydrofluoric acid corrosion of an austenitic (316) stainless steel pipe

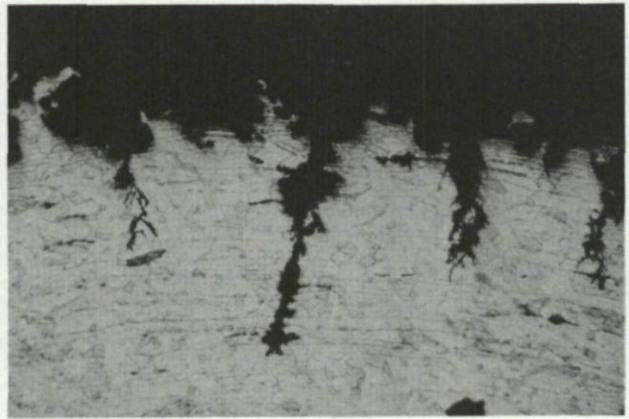
(d)

Microscopic examination of the convoluted pipe, Figure 7-11(d), showed that pitting had occurred beneath the corrosion products and that stress corrosion cracks had initiated at the base of the pits. The stress corrosion was observed only on the inside or small radius bends of the convolutes, while pitting was observed over the entire internal surface of the flexible pipe.

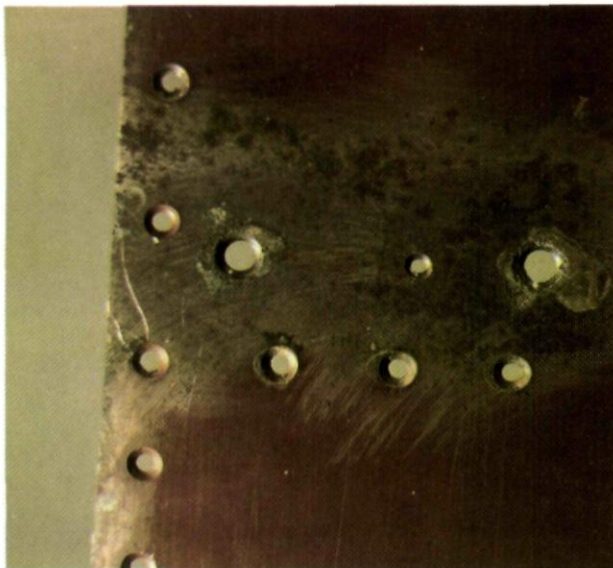
The example of Figure 8-2 shows dissimilar metal, or galvanic corrosion damage at fastener holes where steel bolts fastened through a magnesium alloy skin. The positions of these two materials in the electrochemical series, or galvanic series indicates that a high electrochemical potential would exist between them when in contact, and severe galvanic corrosion could be expected to occur.

Fig. 8-2 Galvanic corrosion around fastener holes used to locate steel fasteners in a magnesium alloy skin

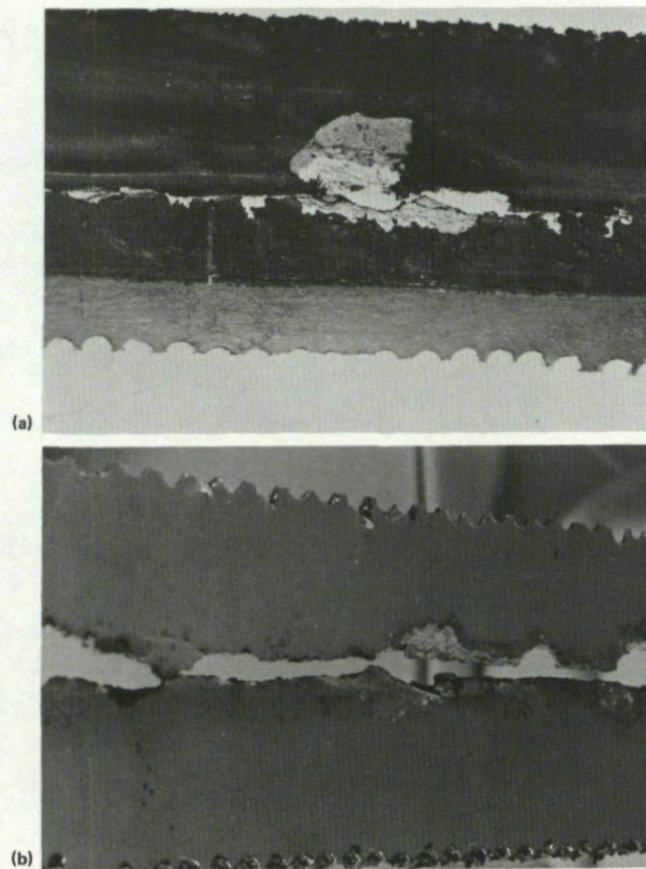
Severe corrosion was found during a visual inspection of the outer wings and tail of a light aircraft operating in the Mediterranean region. The corrosion was found along the edges of an anti-icing boot on the leading edges (Fig. 8-4(a)) and was associated with an exposed band of the cement used to bond the de-icing boot to the wing. The damage is shown at higher magnification in Figure 8-4(b), where flaking of the cement and corrosion in the underlying metal can be seen. More detailed visual inspection of the tail revealed the presence of a 25 cm long area of complete metal penetration in the corroded region, which formed a crack like discontinuity in the structure. The area affected by this penetration is shown in Figures 8-5(a) and 8-5(b). Figure 8-5(a) shows the damage visible on the exterior surface, while Figure 8-5(b) shows the same area viewed from the inside after the affected material was cut from the structure.

Fig. 8-5 Selected areas of corrosion from Figure 8-4

- (a) Penetration of the aluminium skin viewed from the outside.
 (b) Corrosion and penetration of the aluminium skin viewed from the inside.

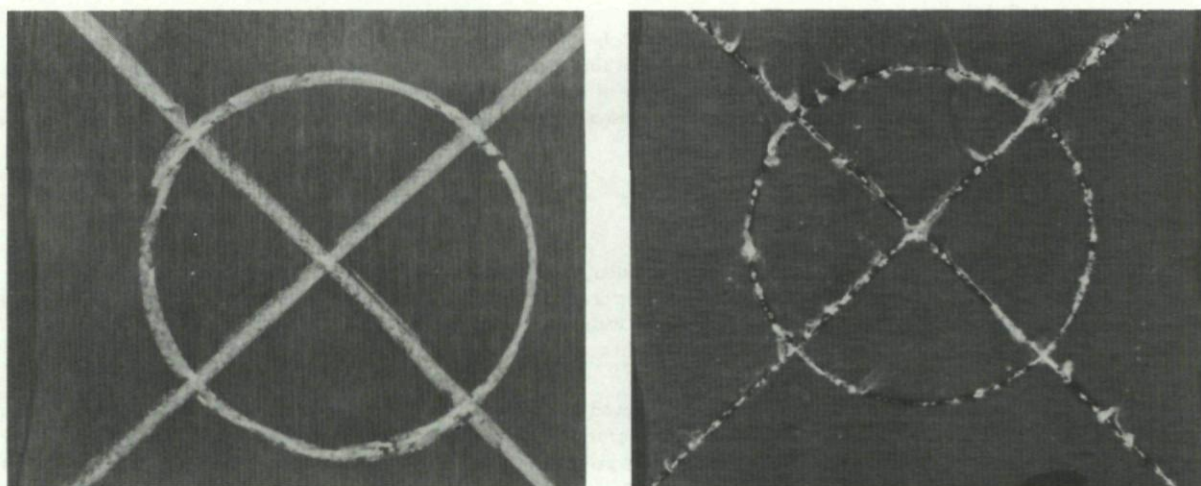
In order to verify that the lost disc might be associated with the pencil marking, laboratory specimens of the high strength aluminium alloy skin material were marked with a conventional graphite pencil and with a grease pencil, and were then exposed to salt mist accelerated corrosion testing. One week of exposure showed no effect on the grease pencilled panel (Fig. 8-9(a)) while the graphite pencilled panel showed severe corrosion damage (Fig. 8-9(b)).

Whether the reported "lost disc" actually fell out of the wing cannot be ascertained, but nevertheless the laboratory trials demonstrate unequivocally that severe galvanic corrosion can occur, even when a thin film of graphite comes in contact with a high strength aluminium alloy. Table 3-2 shows that graphite (carbon) is one of the most noble materials, and will give rise to a strong electrochemical potential when coupled with aluminium alloys. Marking of any aerospace hardware should only be performed with safety-checked markers, such as grease pencils.

Fig. 8-9 Galvanic corrosion in aluminium alloy wing skin due to conductive markers

- (a) Panel after 7 days exposure to salt mist when a grease pencil was used.
- (b) Panel after the same exposure when a graphite marker was used, showing galvanic corrosion.

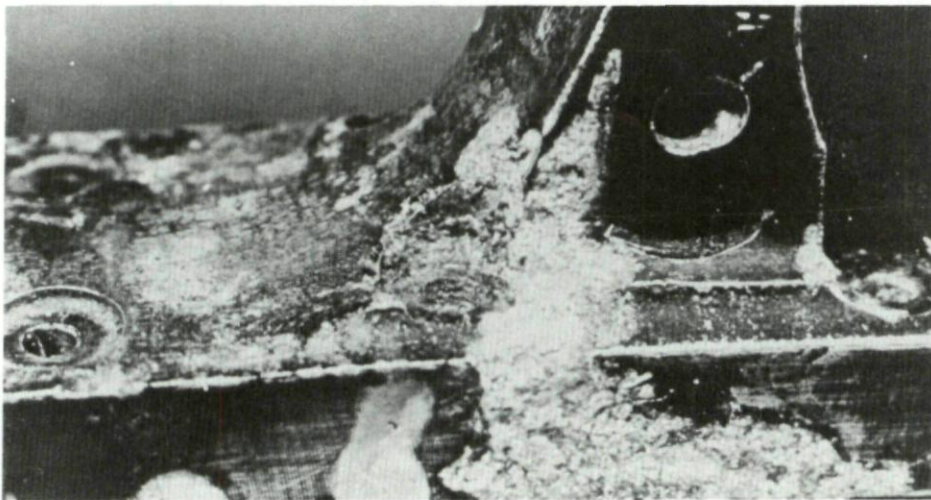
For active metals uniform exposure of a large surface area to a corrosive medium would tend to cause uniform corrosion. Pitting of an active metal will therefore occur as a result of local wetting, or defects in a protective coating which allow very localized exposure. A severe case of pitting corrosion damage to an active metal component is shown in Figure 9-1(a). The component was a magnesium alloy casting used as a helicopter structural cleat, and this was originally chromated and sealed. The protective treatment was damaged locally, possibly by the tools used in applying the fasteners, and not repaired. A similar example is illustrated in Figure 9-1(b) which shows a corroded magnesium alloy casting of a stringer end cap. This was also chromated and primed, but severe pitting corrosion occurred, probably due to failure of protection by aging and exposure to moisture.

Fig. 9-1(a) Severe pitting in a magnesium alloy casting

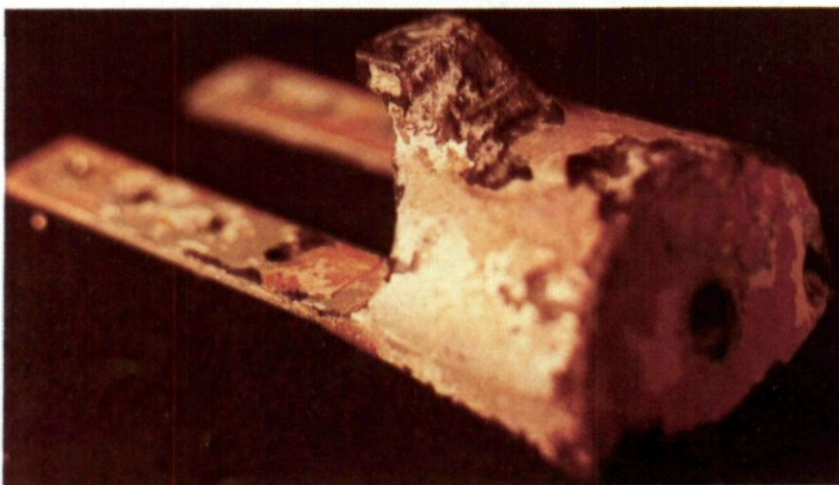
Fig. 9-1(b) Severe pitting in a cast magnesium alloy stringer end cap

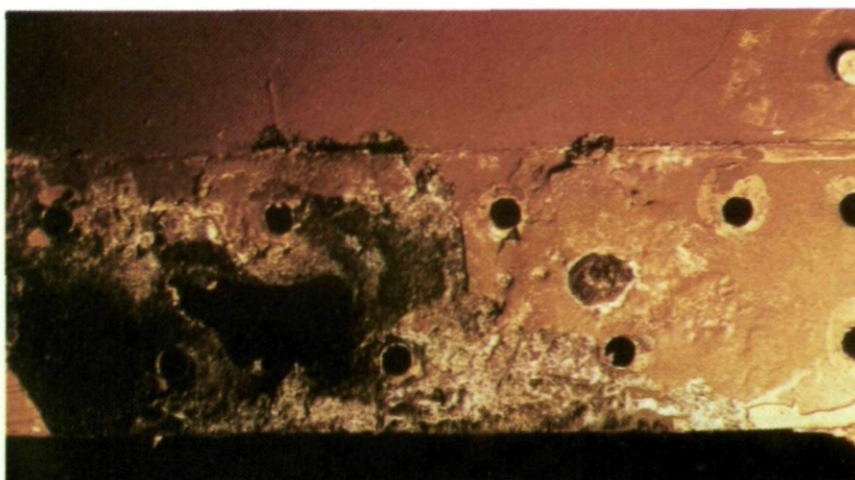
(a) Dismantled joint in a magnesium alloy panel.

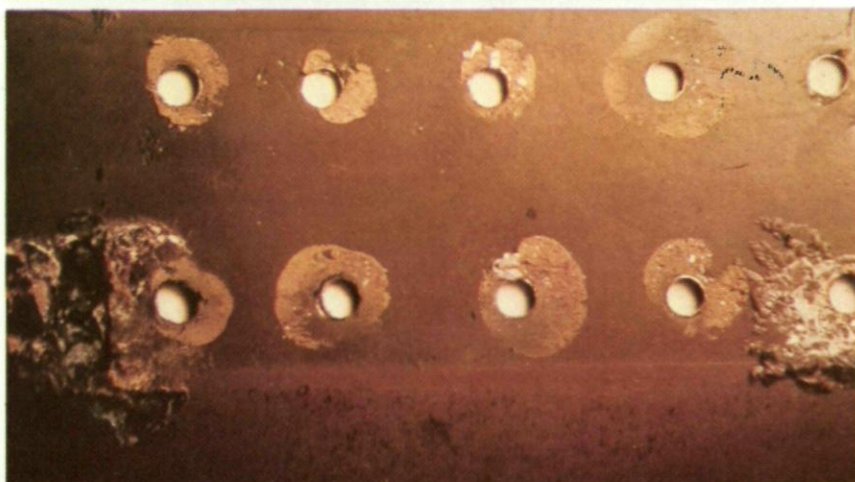
(b) Crevice corrosion in a magnesium alloy skin joint due to inadequate sealing.

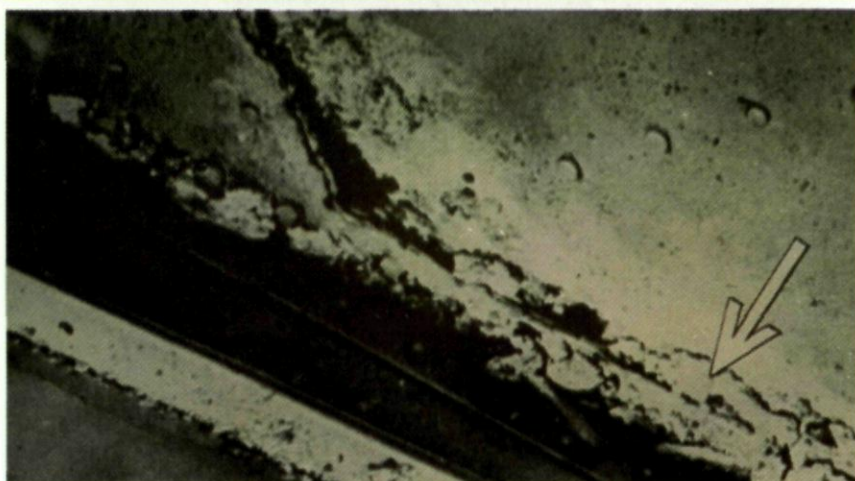
(c) Crevice and galvanic corrosion between a magnesium alloy floor panel and aluminium alloy frame member.

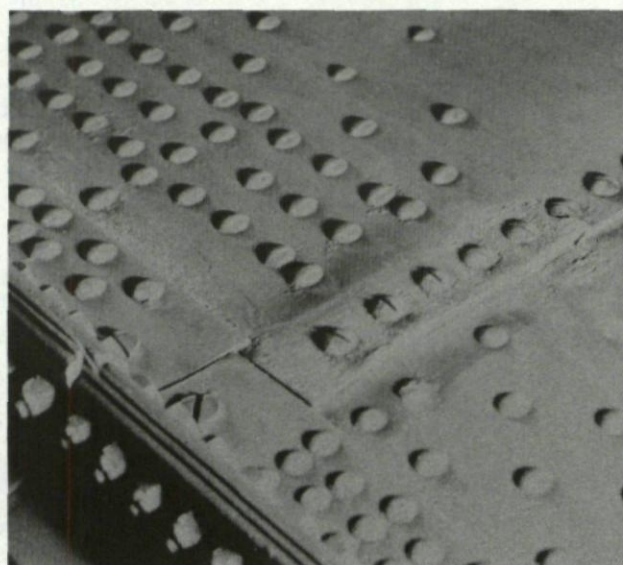
(a) Crevice corrosion in aluminium lap joint.

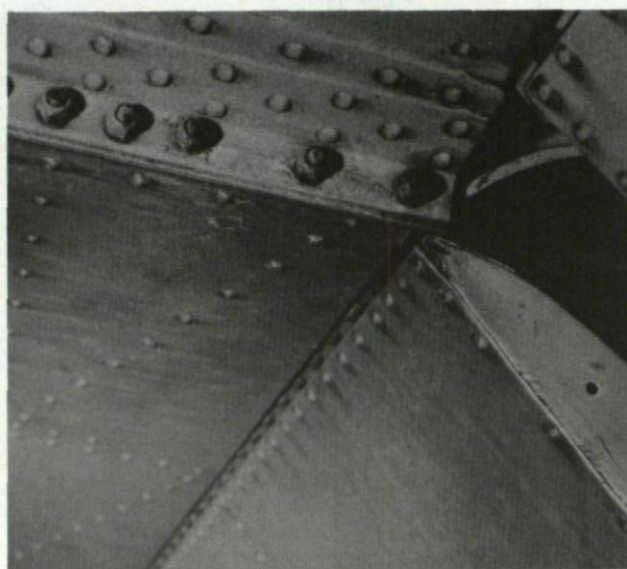
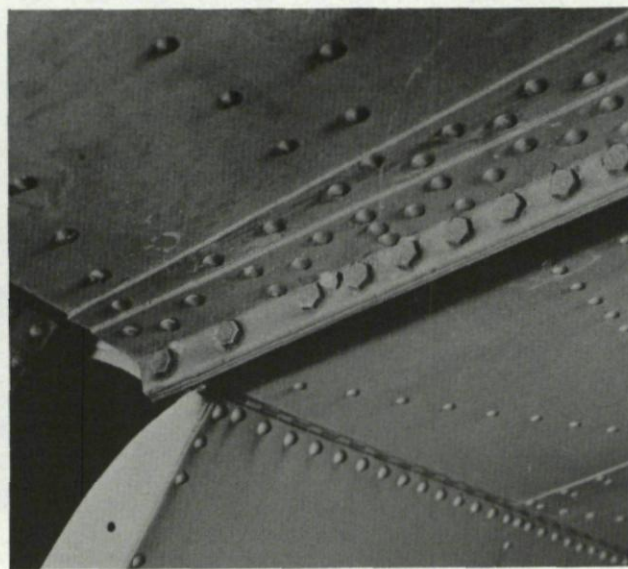
(b) and (c) Corrosion around bolts and under nuts in the under wing structure.

Crevice corrosion may be particularly severe with magnesium alloys since they are the most anodic of the common airframe structural alloys, however similar problems also exist with aluminium alloys. Figures 9-3(a), 9-3(b) and 9-3(c) show examples of crevice corrosion in the outer wing coupling flange of an older type small transport aircraft which had been operating in the Mediterranean region. The damage was observed during routine visual inspection, and subsequently x-ray inspection was used to measure the depth of corrosion in the different areas of structure. The structure was predominantly aluminium alloy sheet and flanges, with steel fasteners, and the structure was protected by a titanium dioxide (TiO_2) pigmented paint finish. Crevice corrosion is evident between the aluminium alloy flanges and sheet, and at the aluminium lap joints (Fig. 9-3(a)). Corrosion cavities were also observed under the bolts and nuts (Figs. 9-3(b) and 9-3(c)), and the corrosion can be seen to extend beyond the area of contact of the fasteners. Measurements of the depth of corrosion showed that this was greatest under the heads of the bolts and nuts, rather than at the immediate edges of the fastener holes. This suggests that the crevice effect was probably at least as significant as the galvanic effect in this case. The corrosion repair work led to this aircraft being out of commission for a reported "long period", although the precise details were not available. The repair work involved the use of a pigmented zinc chromate primer and top coat, in place of the TiO_2 finish used originally.

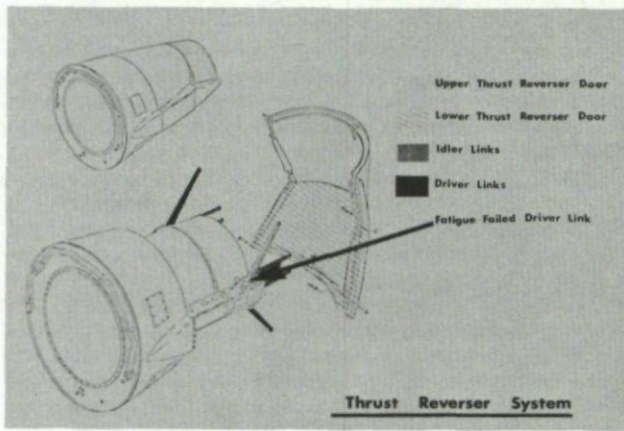
(a)

A large commercial jet lost the thrust reverser doors from one of its engines in cruise flight, but nevertheless landed safely. Subsequent investigation showed one thrust reverser door driver link had fractured, allowing the leading edge of the door to spring up into the 550 knot airstream. Figure 9-5(a) shows the general arrangement of the thrust reverser system with the failure location indicated by an arrow. The resulting air loads on the thrust reverser had torn the doors away from the aircraft. Closer inspection showed that the link failed in fatigue, but the fatigue crack initiated at pitting corrosion sites in the link surface. The latter was coated by a protective molybdenum disulphide type dry film lubricant. Figure 9-5(b) shows the broken driver links, with the primary fatigue fracture indicated by arrows.

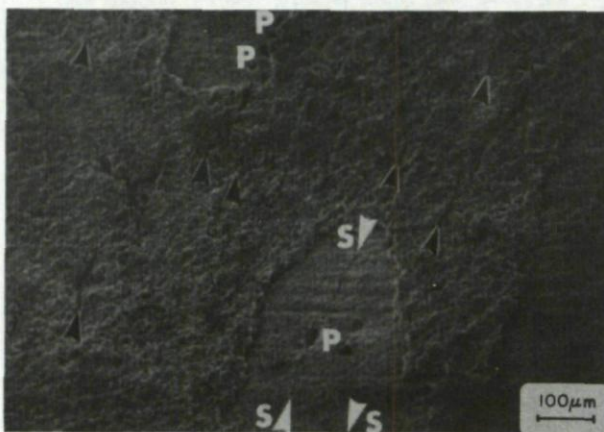
(c)

Scanning electron microscopic (SEM) examination of the surface near the fracture showed that the coating was fissured, and that pits were being formed at the roots of these fissures. Small fatigue cracks were growing from almost every such pit, and all were parallel to the major fracture surface. These features are shown in Figure 9-5(c).

Prevention could be accomplished by lowering the very high stress level in the link, or by preventing the corrosion pitting of the link. However, the corrosive medium in this case could not be eliminated since combustion products will inevitably condense on the part. The most practical immediate approach to preventing further failures was to strip the coating from all existing links, inspect for corrosion or cracks, and recoat the sound links with an improved coating while maintaining an ongoing inspection programme to identify early signs of corrosion. In the longer term, a redesign of the link system to reduce the service stresses would also be beneficial.

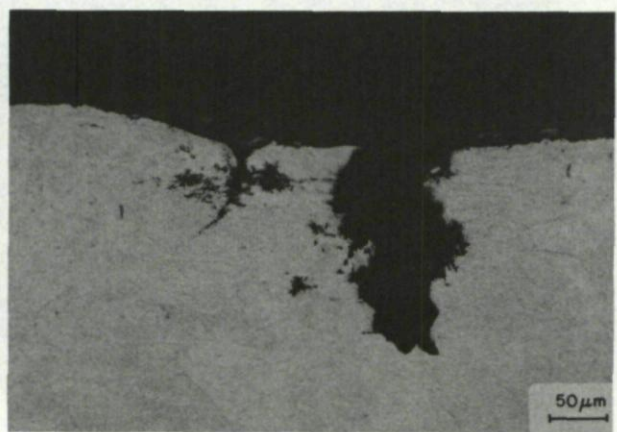
(d)

Since the operating cyclic stress was close to the yield stress for this 422 type stainless steel link, any pit represented a sufficient stress concentration site to rapidly initiate high stress, low cycle fatigue. Pitting was the result of entrapment of fuel combustion by-products and moisture, collecting in fissures in the coating and attacking the stainless steel. A cross-section through a typical pit is shown in Figure 9-5(d).

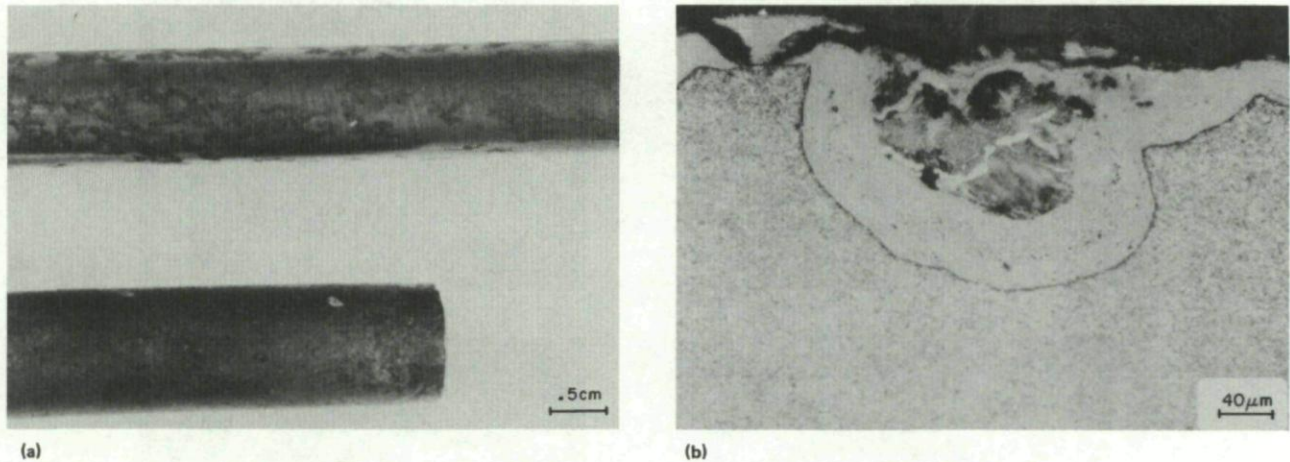
Fig. 9-8 Pitting induced failure of an engine exhaust valve

A light single engine aircraft suffered in-flight engine failure and was destroyed in the subsequent forced landing. Engine teardown revealed engine seizure was the result of an exhaust valve failure. The valve stem fractured in fatigue, the crack initiating at pitting corrosion sites on the valve stem. The push rod also showed extensive pitting corrosion. Both parts are shown in Figure 9-8(a).

Figure 9-8(b) shows a typical pit in the valve stem, filled with a complex series of corrosion products containing iron, chromium and silicon oxides, and aluminium, copper, lead, sulphur and bromine compounds. Pitting near the fracture was so severe as to overlap the pits and reduce the section diameter by approximately 0.25 mm. Since this engine continued to run for some time after the valve head had separated and had fallen into the cylinder head, extensive secondary damage resulted from the valve head ingestion and eventually seized the engine.

Teardown revealed extensive pitting of several other valves and push rods. The engine was found to have been inactive for long periods, during which the engine oil was not drained and replaced by inhibiting oil. This improper maintenance resulted in pitting corrosion of the valves and push rods from acid compounds formed in the old engine oil.

- (a) Pitted push rod (top) and pitted and fatigue fractured valve stem (bottom). (Mag. $\times 2$)
 (b) Typical corrosion pit in the valve stem near the fracture face. Nital etch. (Mag. $\times 250$)

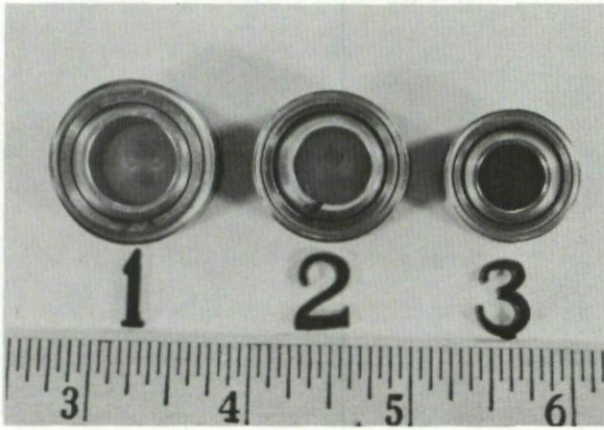
(a)

Visual inspections led to the discovery of cracking in several chromium plated type 440C martensitic stainless steel wing flap hinge bearings. Three of the suspect parts were submitted for laboratory examination, and these are shown in Figure 9-9(a).

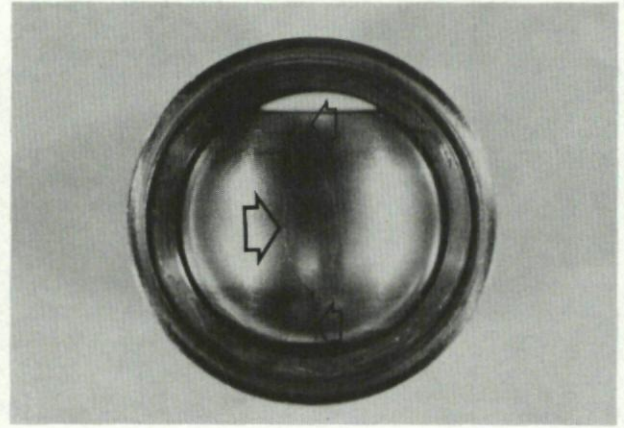
(b)

Bearings 1 and 2 were found to be cracked, while bearing 3 was found to be uncracked. In bearing No. 1, two separate cracks were found; one crack took the path shown in Figure 9-9(b), while the second crack, which is not shown, ran straight across the bearing cross-section. Bearing No. 2 showed the crack path seen in Figure 9-9(c). Further visual examination of the bearing crack fractures showed the cracks were flat and slightly fibrous, as indicated in Figure 9-9(d). The fracture face of bearing No. 2 differed slightly from the two fractures seen on bearing No. 1 in that there was a chip missing on the outer edge of the bearing.

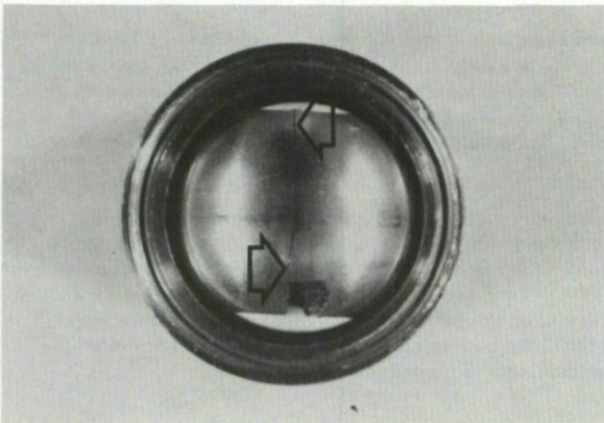
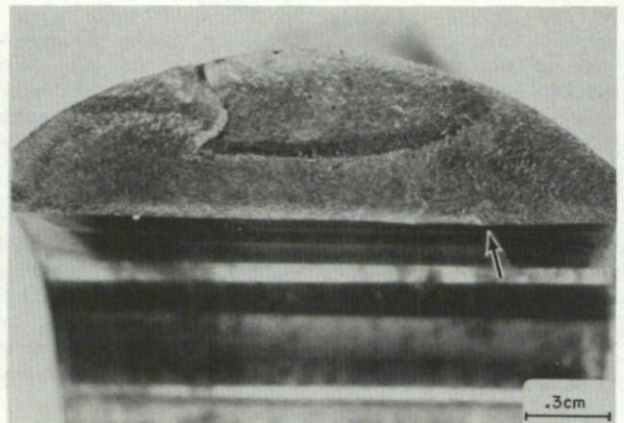
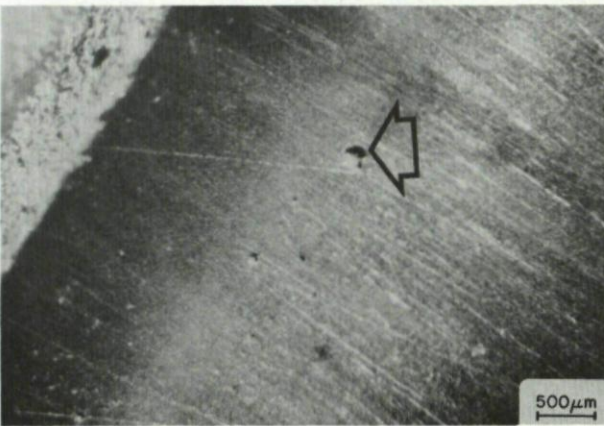
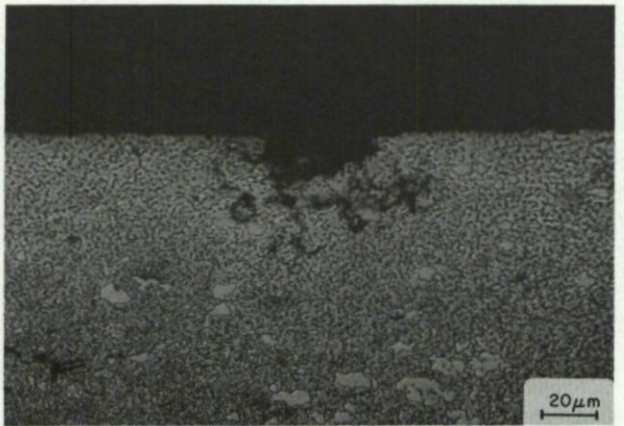
- (a) Three hinge bearings from a fighter aircraft.
- (b) Bearing number 1, showing crack configuration.
- (c) Bearing number 2, showing crack pattern and fragment missing at end of crack.
- (d) Fracture face of second crack in bearing number 1. Arrow shows probable crack initiation area. (Mag. $\times 5$)
- (e) Corrosion pits on the inner diameter of a bearing which are typical of all three bearings submitted. (Mag. $\times 20$)
- (f) Cross-section of corrosion pit found on bearing showing intergranular cracking at the base of the pit. Picric acid etch. (Mag. $\times 500$)

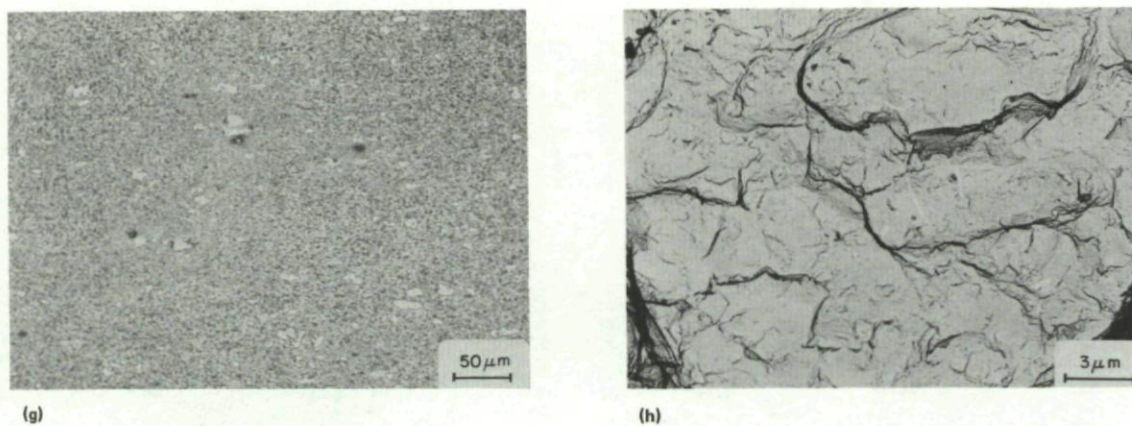
Fig. 9-9 Pitting induced failure of some 440C stainless steel hinge bearings (Cont'd)

- (g) Microstructure typical of all three bearings. Picric acid etch. (Mag. X 200)
 (h) Electron fractograph of bearing number 1 showing intergranular mode of fracture. (Mag. X 3960)

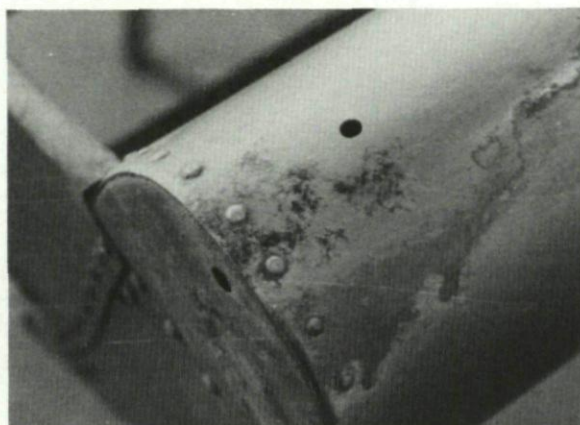
(a)

This aircraft had also been operating in the Mediterranean region, and the corrosion damage was again detected during visual inspection. The structure in this case was made from 2024 aluminium and had been protected by a nitro-alkyd resin paint system. Areas of corrosion damage are shown in Figure 9-14(a), and in Figure 9-14(b) after removal of the paint system. The corrosion was largely superficial, although penetration had occurred in one area. The surface corrosion showed the thread-like meanderings of filiform corrosion, and appeared to have originated in the fastener holes, as indicated in Figure 9-14(b).

A strontium chromate epoxy primer and polyurethane finish were recommended to replace the nitro-alkyd protection system used previously.

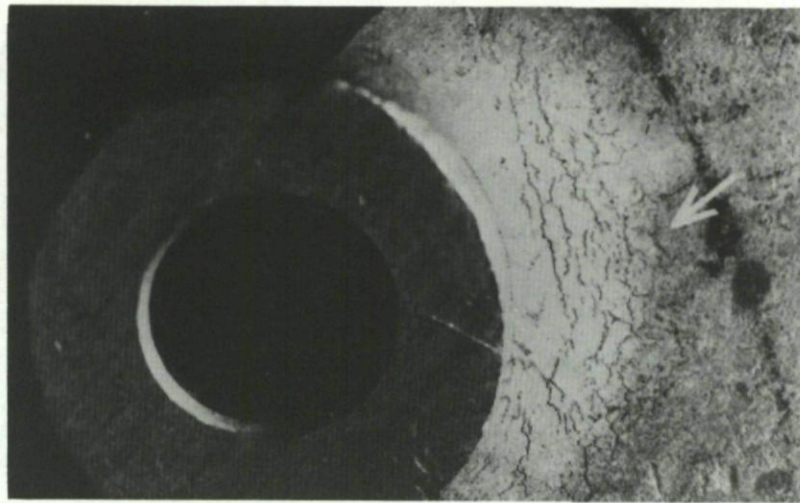
(a)

Intergranular corrosion is a highly localized form of dissolution which affects the grain boundary regions in a polycrystalline metal. The corrosive attack can produce a network of corrosion or cracking on the metal surface, occasionally dislodging whole grains, or it may penetrate deeply into the metal leaving behind very little visible evidence of the damage. An example of a network of fine surface cracking is shown in Figure 10-1(a), where the part is a forged aluminium alloy hydraulic valve.

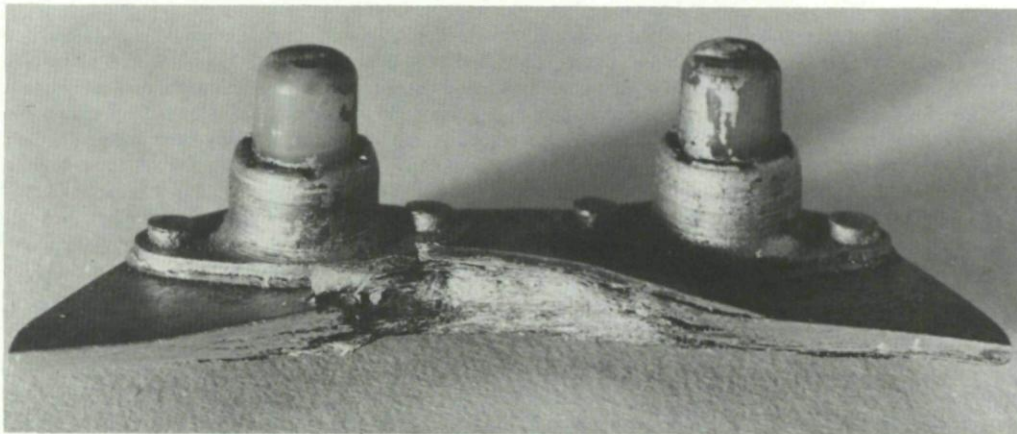
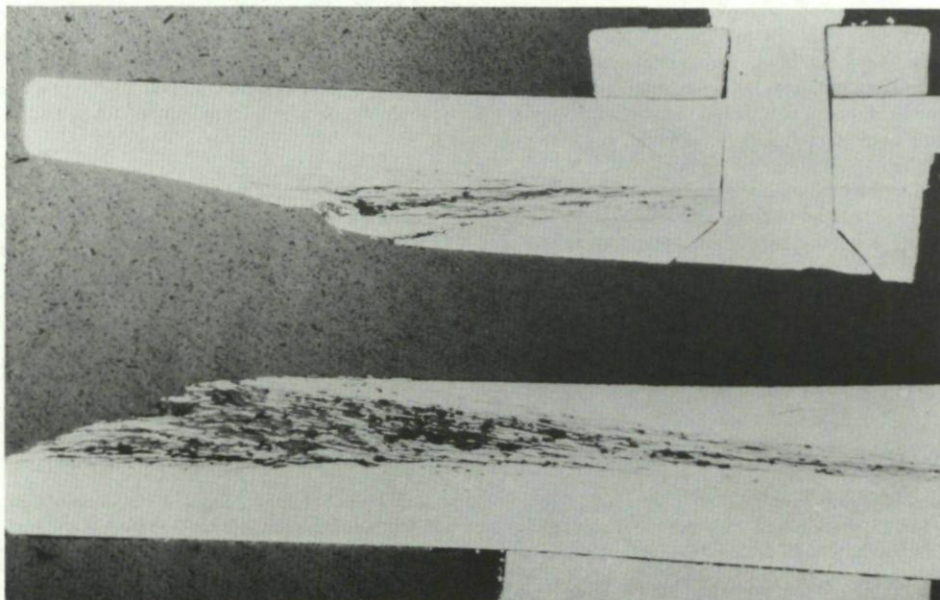
In heavily rolled or extruded products where the grains are flattened and elongated in the direction of working, the presence of intergranular corrosion can lead to layering and flaking, producing a delamination effect with surface grains being pushed out by the underlying corrosion products. This is known as exfoliation corrosion, and is essentially a severe form of intergranular corrosion occurring in the direction of grain flow. Examples of exfoliation are shown in Figures 10-1(b) and 10-1(c). Figure 10-1(b) shows a specimen cut from the edge of an access hole in a aluminium alloy skin panel, and reveals the severely destructive effect of exfoliation. This damage occurred due to the use of a susceptible rolled alloy with inadequate protection to the flat land of the access holes, combined with operations in a maritime environment. Figure 10-1(c) shows the voluminous dark corrosion products forming in the intergranular fissures and the substantial delamination occurring in the skin.

- (a) Intergranular surface cracking in a forged aluminium alloy valve.
- (b) Exfoliation corrosion in an aluminium alloy skin.
- (c) Cross-section through an aluminium alloy skin showing dark corrosion products and delamination due to exfoliation.
