AGARD Corrosion Handbook Volume 1 Aircraft Corrosion: Causes and Case Histories

AIRCRAFT CORROSION: CAUSES AND CASE HISTORIES

W.Wallace
Head, Structures and Materials Laboratory
National Aeronautical Establishment
National Research Council Canada
Ottawa, Ontario, Canada

D.W.Hoeppner
Cockburn Professor of Engineering Design
Department of Mechanical Engineering
University of Toronto
Toronto, Ontario, Canada

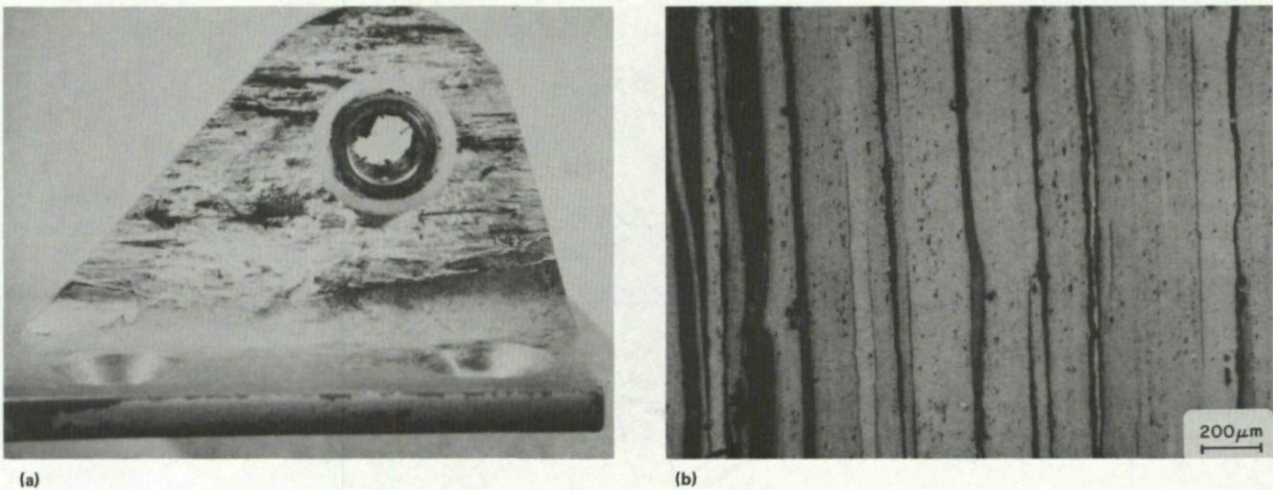
Fig. 10-2 Exfoliation corrosion in an aluminium alloy stabilizer bracket

The left hand rear stabilizer bracket from a light single engine aircraft was found, during a routine inspection, to be severely corroded, as indicated in Figure 10-2(a). The steel bearing bushing was isolated from the bracket by a nylon sleeve, but atmospheric moisture and contaminants had collected on the bracket's horizontal surface and seeped into the bracket-to-nylon interface.

The bracket had been machined from an aluminium alloy extrusion, and consequently the end grains were exposed around the nylon sleeve. Intergranular corrosion occurred, which because of the extremely elongated grain structure, propagated as exfoliation corrosion, as indicated in Figure 10-2(b). As the corrosion attack continued, the exfoliated grains separated and general surface corrosion of the exposed and unprotected core grains also occurred, as seen in Figure 10-2(a). The other surfaces of the bracket were protected by a chemical conversion coating and were uncorroded.

In this example, inadequate design and maintenance were both a problem. It is necessary to ensure that corrosive agents do not have the opportunity to attack exposed end grains. While the nylon sleeve around the steel bushing prevented galvanic corrosion,

the interface between the nylon bushing and the aluminium was not sealed to prevent corrosive medium seepage. Since the horizontal orientation of the corroded surface seen in Figure 10-2(a) retained moisture-born corrosants, regular inspection was required to allow early detection of corrosive attack.

- (a) Heavy surface corrosion of the stabilizer hinge bracket.
- (b) Cross-section through the bracket showing the corroded surface grains at the right, and corrosion of elongated grain boundaries only. Keller's etch. (Mag. $\times 50$)

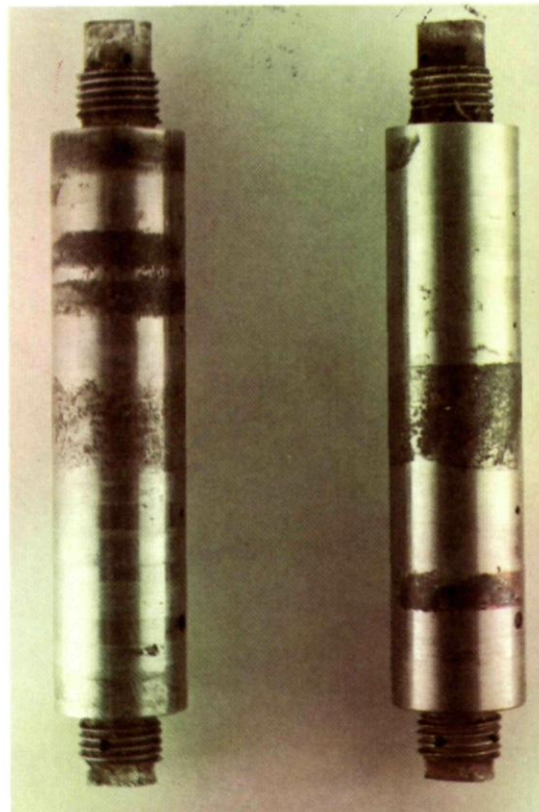
Fig. 11-1 Fretting damage in two flying control hinge pins

Figure 11-1 shows fretting damage in two flying control hinge pins, in the form of broad bands of deep pitting with associated accumulations of corrosion products. In service these pins would experience a combination of large amplitude displacements associated with deliberate movements of the control surfaces, and small amplitude displacements associated with normal aircraft vibrations in steady-state flight. Thus the damage observed may be due to a combination of wear and fretting corrosion. These problems are probably due to lack of adequate lubrication to alleviate the rubbing action.

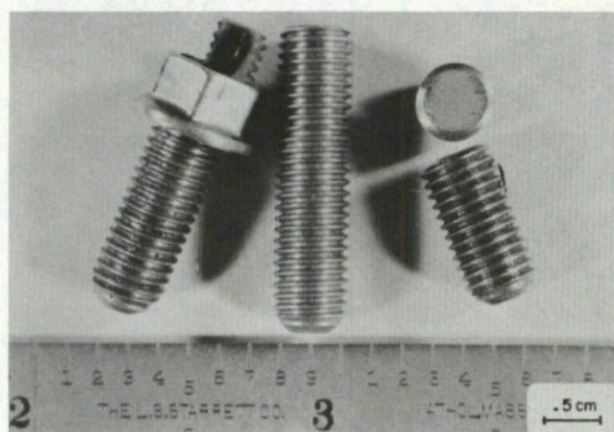
(a)

Several setscrews from a single batch failed in service in the clutch assembly of a military helicopter. Samples of the failed setscrews were submitted for laboratory examination along with a number of unused and intact setscrews from the same batch. The setscrews, shown in Figure 12-12(a), were 25 mm \times 6.35 mm \times 28 cadmium plated steel and were used for clutch adjustments. The procurement specifications allowed the use of 4032, 4037, 4137, 4140, 8630 or 8740 low alloy steels, having a hardness in the range R_c 45-53, and required cadmium plating to be used.

Fig. 12-12 Hydrogen induced failure of some 4037 steel setscrews

The subject batch of setscrews was recalled from service to preclude future embrittlement failures. It was thought that the hardness of the setscrews was excessively high for the specific application even though allowed by the specifications. It was recommended to lower the hardness of the setscrews in order to improve their toughness and resistance to service induced embrittlement.

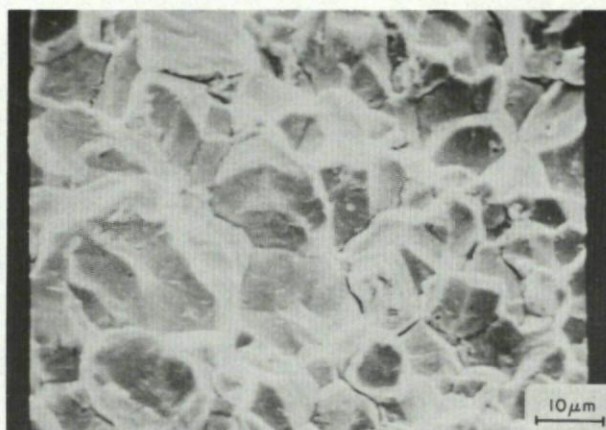
(b)

The fracture surface of a failed setscrew exhibited predominantly intergranular fracture (Fig. 12-12(b)), but some areas of ductile dimples and secondary cracking were evident (Fig. 12-12(c)). These features suggested that hydrogen embrittlement may be involved. An unused setscrew was loaded in tension until failure occurred at 23.14 KN. Another setscrew was loaded to 19.58 KN, or 85% of the ultimate load, and held under sustained static load. The setscrew failed in 51 hours, the fracture face again exhibiting a mixed mode brittle intergranular and ductile dimpled appearance. This behaviour confirmed hydrogen embrittlement.

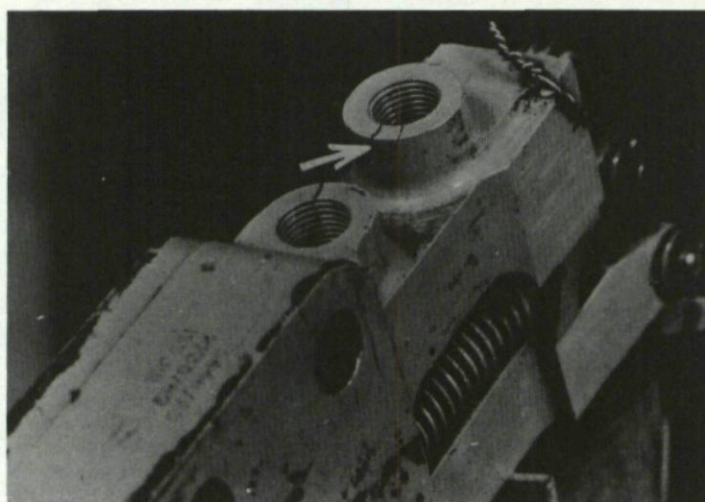
Stress corrosion is a particularly insidious form of corrosion since it will often occur with little or no visual evidence of surface corrosion such as discolouration or the build up of noticeable corrosion products. This is illustrated in Figure 13-1(a), which shows stress corrosion cracking in the bosses of a forged aluminium alloy component. The cracks can travel over long distances with time, as indicated in Figure 13-1(b), and as they propagate they lower the residual strength of the affected part. Figure 13-1(b) shows stress corrosion cracking which initiated at corrosion pits in the flat lower surface of an undercarriage leg, the corrosion pits having served as local stress raisers. Stress corrosion cracks may propagate deeply into thick section parts, as indicated in Figure 13-1(c), while the visible surface crack length may often be quite small. The banded appearance of the fracture surface in Figure 13-1(c) is an indication that crack growth occurred in a slow, time dependent manner, and macroscopically the fracture surface may resemble

- (a) Cracks in the bosses of a forging.
 (b) SCC in an undercarriage leg.
 (c) Stress corrosion fracture surface in an aluminium forging.

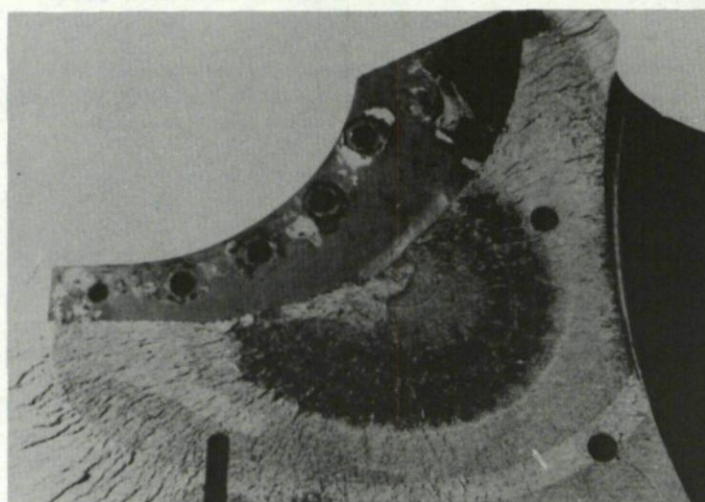
(c)

fatigue. The part shown in Figure 13-1(c) was a high strength aluminium-zinc alloy forging and the stress corrosion cracking was attributed to poor forging and heat treatment practice which produced a microstructure susceptible to SCC. The part was also thought to have contained high residual stresses as a result of poor machining practices, and the corrosive environment experienced in service was the final parameter leading to SCC.

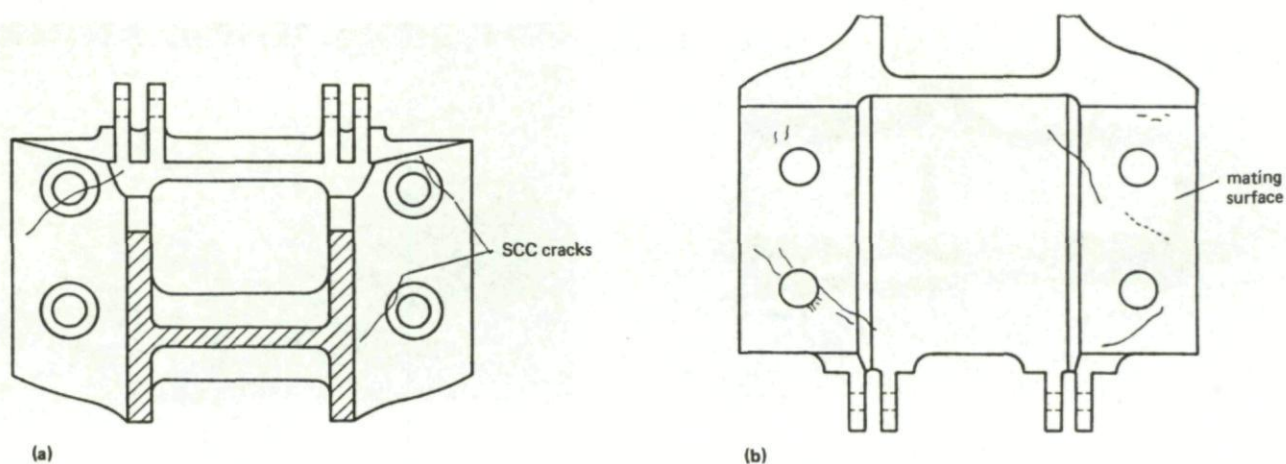
Several cracks were found in the front and rear spars of a fighter aircraft during a routine inspection using eddy current methods. The locations of the cracks in the parts are shown schematically in Figures 13-27(a) and 13-27(b), which show the front and rear spars respectively. The spars were made from 7079 die forgings, and were artificially aged to the peak strength condition according to the specification QQ-A-367. All surfaces of the spars had been shot peened after machining, and had been treated with a chromate conversion coating and a single layer of zinc chromate primer.

The spars were removed from the aircraft to allow closer visual inspection and the cracks could be seen clearly to be up to several centimetres long as indicated in Figure 13-28(a). Many of the cracks were found to propagate from fastener holes as indicated in Figures 13-27 and 13-28. The front and rear spars were mounted in a jig, and loaded statically to cause failure so that the crack surfaces were revealed. A typical fracture surface observed in the front spar is shown in Figure 13-28(b), and this shows a dull fan-shaped region which appears to have initiated in the radius at the base of a bolt access hole as indicated by the arrow, and a lighter area which was produced by the static overload fracture. The dull area was typical of stress corrosion cracking showing evidence of corrosion and arrest lines indicating that cracking had occurred progressively over a period of time. Metallographic examinations showed that the material had a fine-grained recrystallized microstructure, and the cracks were found to run along grain boundaries, as is expected with stress corrosion cracking in this class of alloy.

It was concluded that the cracking was due to stress corrosion which had occurred because of the use of a stress corrosion prone alloy. While the spars had received corrosion protection treatments, damage to the surface coatings during the installation of bolts had exposed bare metal and stress corrosion had occurred as a result of the high humidity and high sustained tensile stresses arising from fastener installation. To overcome this problem the spars were machined from 7075-T73 forgings, which as discussed in Section 13-5 provide high resistance to stress corrosion cracking. The surface protection system used previously, including shot peening to develop compressive residual stresses, followed by chemical conversion coating and zinc chromate priming, was retained. An alternative solution involving the use of 7175-T736 was also considered in order to maintain high strength, equivalent to or higher than the original 7079-T6 values, together with improved stress corrosion resistance.

Fig. 13-27 Stress corrosion cracking in the 7079-T6 spars of a vertical fin, case history 13-2.

- (a) Sketch of the front spar showing the location of the cracks.
 (b) Sketch of the rear spar showing the location of the cracks.

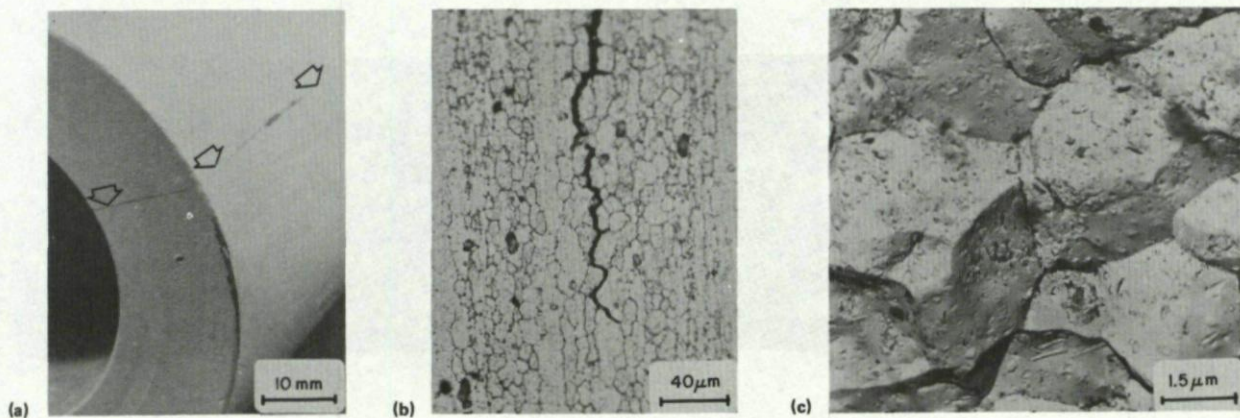
During a major repair of a fighter aircraft a crack was found in the pivot bearing housing at the top end of the vertical stabilizer beam. Figure 13-29(a) shows the crack as it was found by dye penetrant inspection. Figure 13-29(b) shows a metallographic cross section through the tip of the crack, and this shows that the crack follows grain boundaries aligned along the length of the bearing. Figure 13-29(c) shows a replica transmission electron micrograph of the fracture surface, which again reveals the intergranular nature of the fracture surface.

Fig. 13-29 Stress corrosion cracking in a 7079-T6 bearing housing, case history 13-3.

- (a) End of the bearing housing showing the location of the crack.
- (b) Metallographic section through the tip of the crack showing the intergranular nature of cracking.
- (c) Electron micrograph showing the intergranular fracture topography.

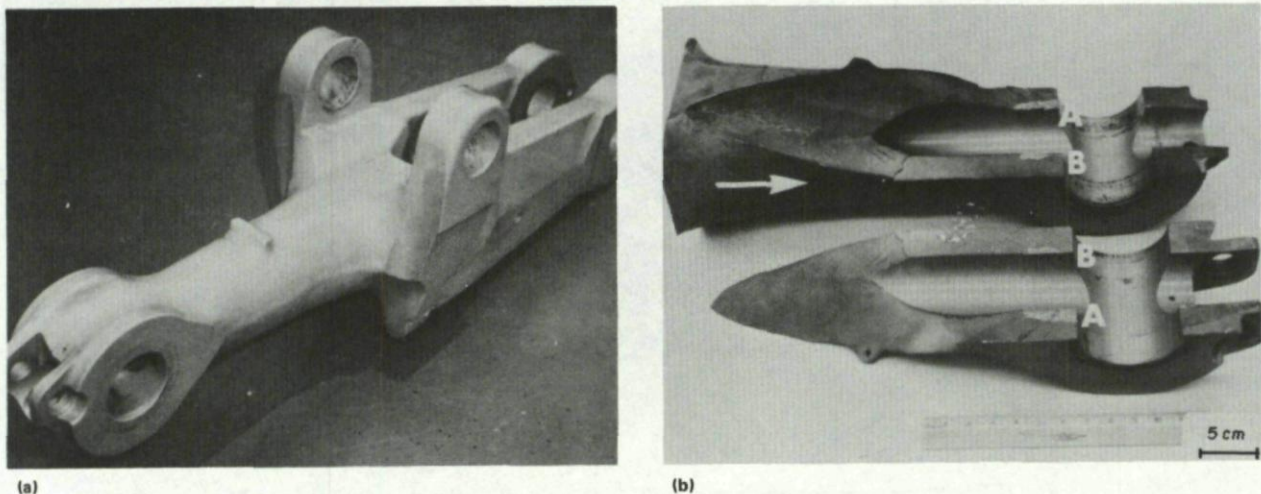
The main landing gear bogie of a large turboprop transport aircraft failed on touchdown, fortunately without causing a serious accident. The part was found to be made from a 7075-T6 forging of the type shown in Figure 13-30(a), and was found to have split along the forging parting plane as indicated in Figure 13-30(b). The tip of the white arrow in Figure 13-30(b) indicates the position of the crack tip in the parting plane, and therefore indicates the maximum extent of cracking in the parting plane. The longest crack was nearly 30 cm long at failure, but since the forging surface had been fully shot peened, the surface residual compressive stresses had prevented the growing cracks from breaking through to the surface and hence revealing themselves to surface inspection. Cracking initiated at the main axle bore, where the most susceptible end grain boundaries on the forging parting plane were exposed by the machining process. Cadmium plated steel bushings were mounted in the main axle bore by interference fit, and corrosion pits were found in the aluminium forging underneath the bushings. Thus even though cadmium plating was used, there appears to have been a sufficiently high galvanic potential in the presence of moisture to initiate pitting attack which led in turn to stress corrosion cracking. The stresses driving SCC in this part were due to the interference fit bushings and residual stress resulting from the post-forge heat treatment operations.

Fig. 13-30 Stress corrosion cracking in a 7075-T6 main landing gear bogie, case history 13-4.

- (a) New and unused bogie.
- (b) Failed bogie beam showing the crack initiation sites (A and B) underneath the shrunk-in steel bushings for the main axle bearings. The arrow tip indicates the maximum extent of the crack in the parting plane.

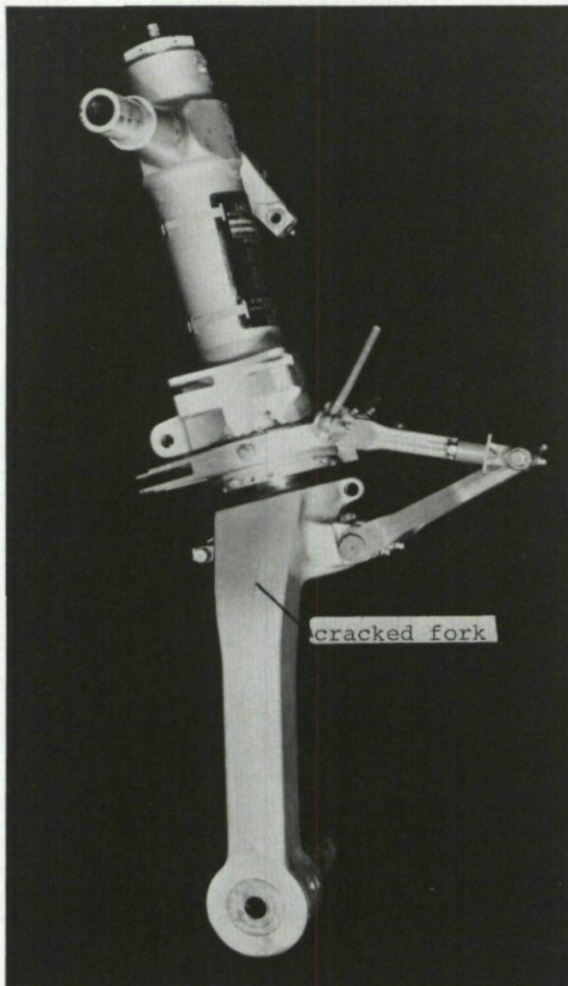
During a post-flight visual inspection of a fighter aircraft a long crack was found in the nose landing gear fork. The part is shown in Figure 13-32, and the crack which can be seen in this figure was found to lie in the parting plane of the aluminium alloy forging. The forging was made from 7075-T6 and its surfaces were treated with a single coat of wash primer plus two coats of acrylic paint.

Fig. 13-32 Stress corrosion cracking in a 7075-T6 nose landing gear fork, case history 13-6.

- (a) Complete landing gear assembly.
- (b) Close-up of the fork outer surface showing the crack.
- (c) Close-up of the fork inner surface showing the crack.

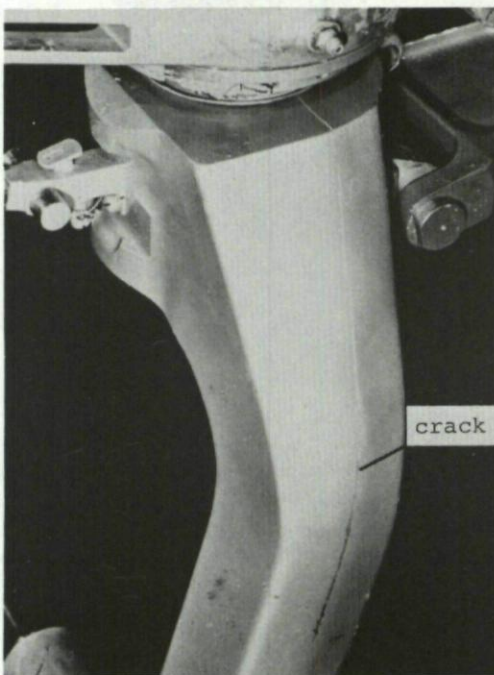
(b)

The crack was found to extend through the thickness of the fork, as indicated in Figures 13-32(b) and 13-32(c), and when the crack was opened up it was found to extend over about three quarters of the longitudinal cross section of the fork, as indicated in Figure 13-33. Figure 13-34(a) shows the fracture surface and reveals a dull fibrous fracture typical of stress corrosion cracking, where the crack appears to have started in the upper bore for the nose-landing gear leg attachment and the adjacent bore hole, which was introduced as a weight saving measure. However while the bores may have been effective in respect to weight savings, they provided natural traps for moisture. Figure 13-34(a) also reveals a narrow ribbon of material along both external surfaces which appear to have a lighter appearance than the area affected by SCC, and this suggests that the stress corrosion crack may have propagated over a substantial distance through the NLG-fork before breaking through to the external surfaces. Thus the crack may have been hidden for a substantial period of time prior to visual detection. Figure 13-34(b) shows a metallographic section through the crack tip and demonstrates quite clearly that the crack had propagated along grain boundaries, as expected for SCC in this type of alloy. The intergranular fracture mode was confirmed by scanning electron microscopy.

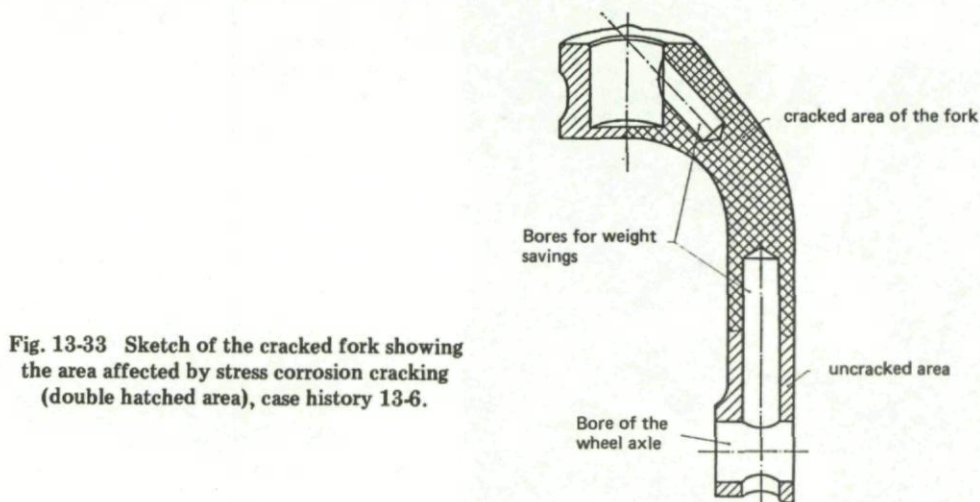
Fig. 13-33 Sketch of the cracked fork showing the area affected by stress corrosion cracking (double hatched area), case history 13-6.

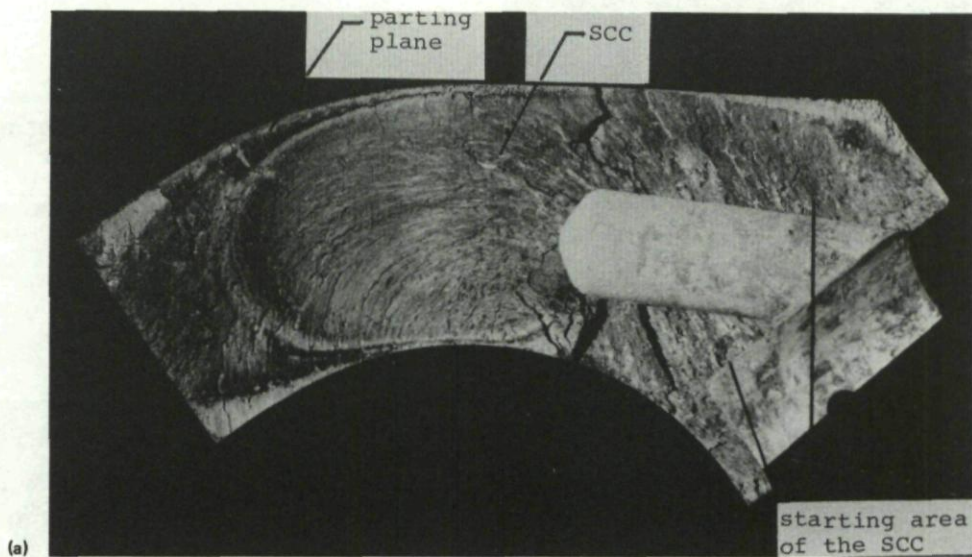
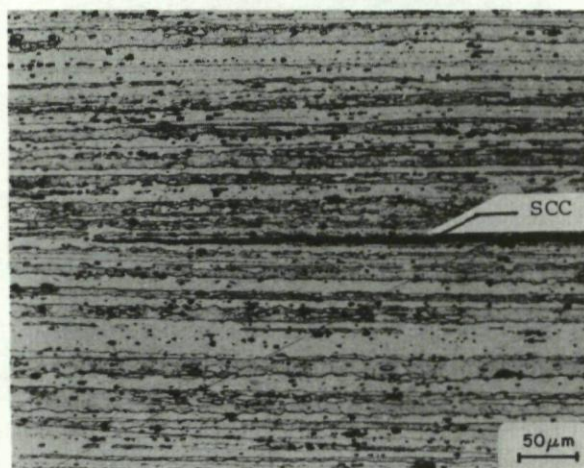
Fig. 13-34 Stress corrosion cracking in a 7075-T6 NLG fork, case history 13-6.

- (a) Macroscopic view of the SC crack in the fork.
- (b) Section through the tip of the crack showing the intergranular crack path.

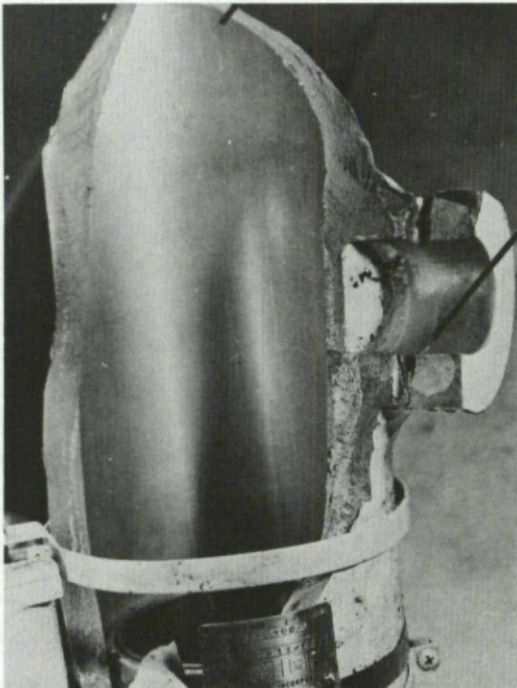
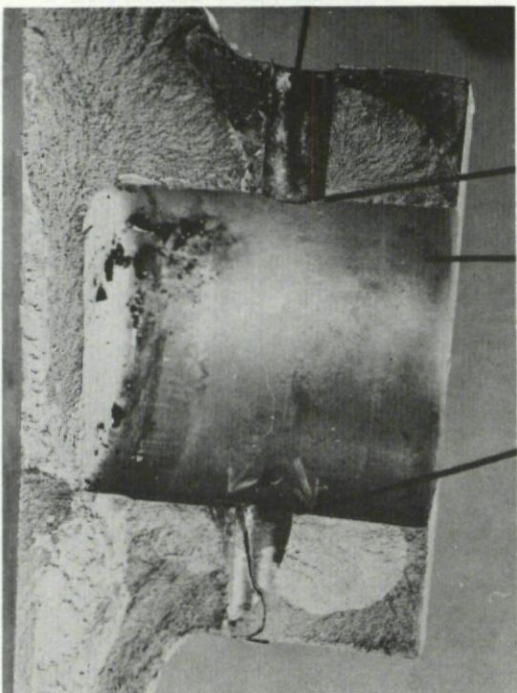
The nose landing gear strut of a fighter aircraft failed during a normal landing procedure after only 30 hours of flight had been accumulated. The failed part is shown in Figure 13-35, and closer examination of the fracture surfaces evident in the failed part revealed that pre-existing cracks had been present prior to the final failure. The fracture surfaces due to these pre-existing cracks are shown in Figure 13-36, and it can be seen that these had initiated at the corners of the bore holes used to locate the clamping attachment bolts for the retraction cylinder.

Fig. 13-35 Stress corrosion cracking in a 7075-T6 nose landing gear strut, case history 13-7.

CRACK ORIGIN

CRACKED BORE

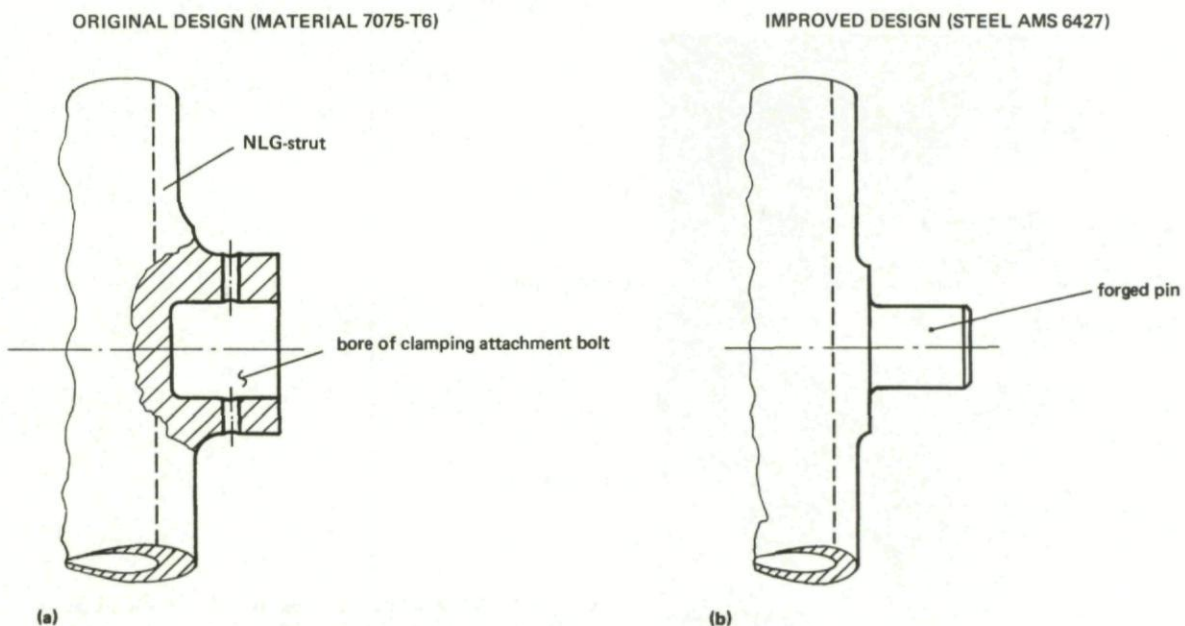
Fig. 13-38 Design details of the nose landing gear strut, case history 13-7.

- (a) Original design.
- (b) Modified design.

A number of alternative designs were considered to resolve this problem including the use of one of the newer high strength, stress corrosion resistant forging alloys such as 7050-T73. However, it was decided to change to a high strength low alloy steel, AMS-6427 (0.3% C, 0.9% Cr, 0.2% Cu, 0.9% Mn, 0.42% Mo, 1.9% Ni) which provides higher strength together with good stress corrosion resistance. The design was also changed, replacing the clamping attachment bore with a forged steel pin, as indicated in Figure 13-38. The steel forging was protected by a vacuum deposited layer of cadmium plating followed by a layer of epoxy primer and a single coat of polyurethane paint.

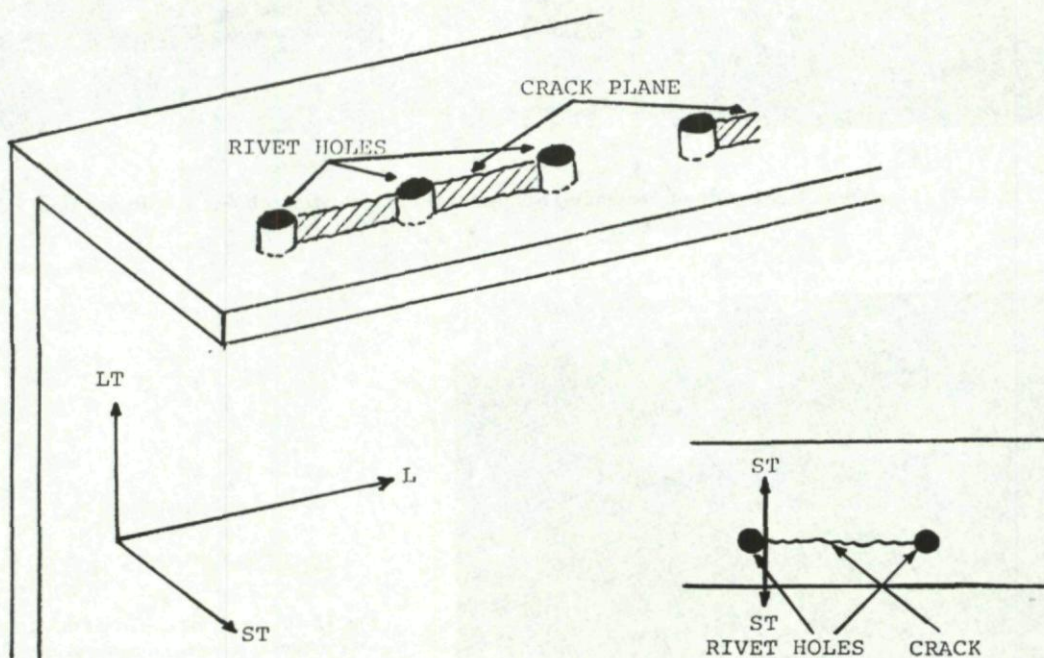
A spectrographic analysis showed the alloy contained 3% Mg, 5.1% Zn, 1.8% Cu, 0.18% Cr and lesser amounts of Fe, Si and Mn. The alloy concentrations were consistent with specifications for 7075 and the alloy hardness indicated the material was in a T6 strength condition. A microstructural evaluation of the grain structure showed a heavily wrought structure of pancake shaped grains, where the crack plane was coincident with the plane containing the longitudinal-long transverse directions, and the short transverse direction was normal to the crack plane as indicated in Figure 13-40.

Fig. 13-40 Orientation of the crack plane with respect to the principal directions in the fuselage frame, case history 13-8.

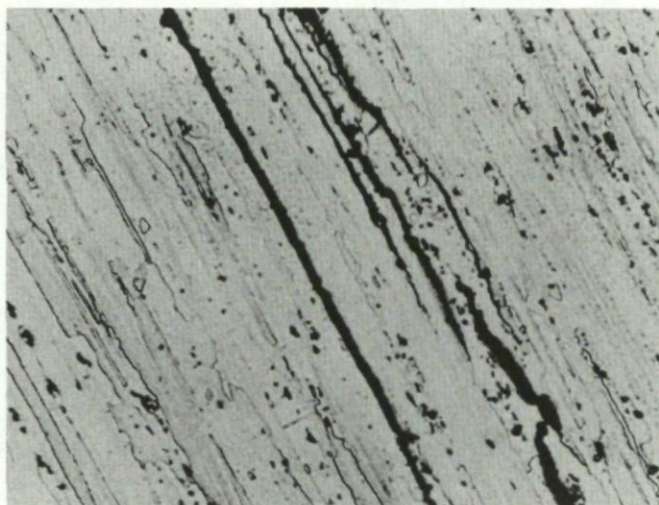
Figure 13-41 shows a metallographic section normal to the LT direction and cracks can be seen running in the longitudinal direction along grain boundaries. The fracture surfaces were corroded, and in most cases they showed no recognizable feature other than flat grain boundary surface facets, as shown in Figures 13-42(a) and 13-42(b), and secondary cracking (Fig. 13-43). In a few cases striation like markings were present immediately adjacent to the fastener holes and in most cases the surfaces of the fastener holes contained corrosion pits. The failure analysis report made no mention of sealants or other forms of corrosion protection in the fastener holes and no information was given on the fastener materials used. However it was concluded that cracking was due to stress corrosion, initiating at corrosion pits in the bore of the fastener holes. The stresses were believed to be due to assembly and operating loads and a stress analysis showed that stresses in the ST direction in the region of the fastener holes were in excess of the threshold values for stress corrosion cracking given in Reference 13-1, Table 13-1.

Fig. 13-41 Metallographic section indicating the intergranular crack path in the fuselage frame, case history 13-8.

It was recommended to replace these fuselage frames with 7075-T73 to prevent SCC. However, since there was evidence of fatigue in some areas and since threshold stress intensities for fatigue in 7075-T73 are slightly lower than for 7075-T6 it might be preferable to replace this alloy completely with a higher strength stress corrosion resistant alloy such as 7050-T73. Wet assembly of fasteners should also assist by excluding moisture from the fastener holes.

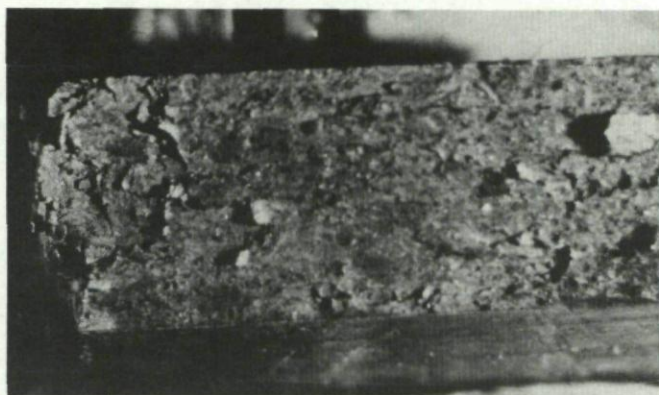
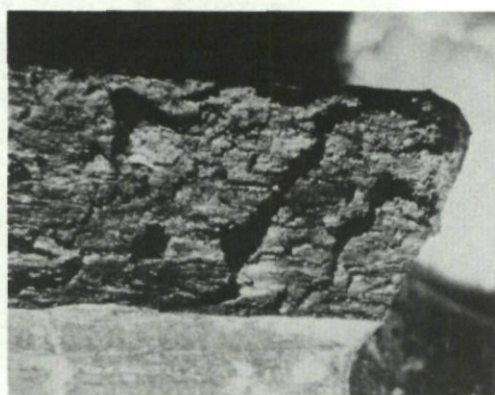
Fig. 13-42 Fracture surface topography extending between two adjacent fastener holes, case history 13-8.

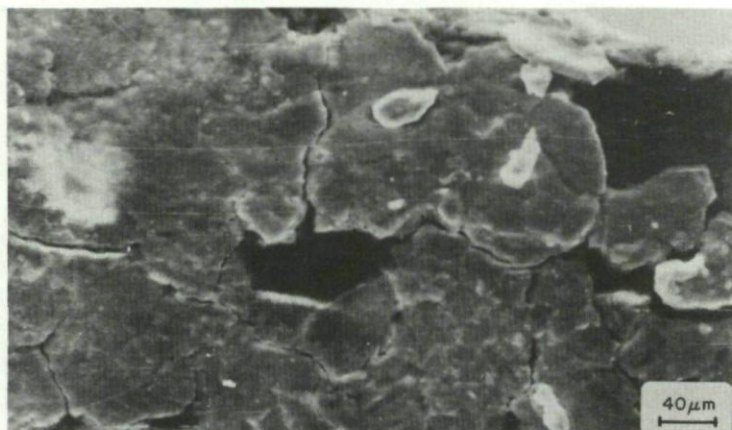
Fig. 13-43 Scanning electron micrograph of a fracture surface from case history 13-8, showing secondary intergranular cracking.

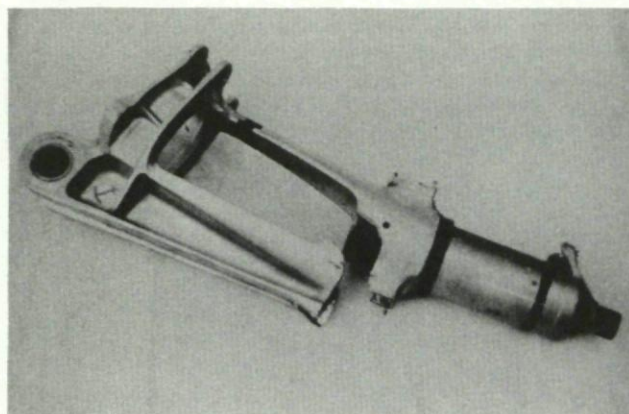
(a)

A landing gear forging of an aircraft, Figures 13-45(a) and 13-45(b) failed during ground operations. The crack initiated on an interior surface at the junction of an axial bore and a radial bore, Figures 13-45(c) and 13-45(d). The fracture surface to the right of the radial bore, see Figure 13-45(c), contained a dark corroded area, which had propagated to a considerable length as indicated by the open arrows. This was surrounded by a light, non-corroded, overload region which formed a narrow band between the dark corroded region and the outer surface of the part. This indicates that the growing crack had not broken through to the outside until the final overload failure had occurred, and therefore the pre-crack had remained hidden until this final failure. The presence of the narrow band of overload fracture suggests that growth of the pre-crack had been suppressed by compressive residual stresses in the surface layers, which presumably did not exist, or had been removed by machining on the interior surfaces. Figures 13-45(c) and 13-45(d) show that severe corrosion and pitting occurred on the interior surface of the radial bore, and deep corrosion pits were present in the crack initiation regions.

Fig. 13-45 Failure of an Al-Cu main landing gear part, case history 13-10.

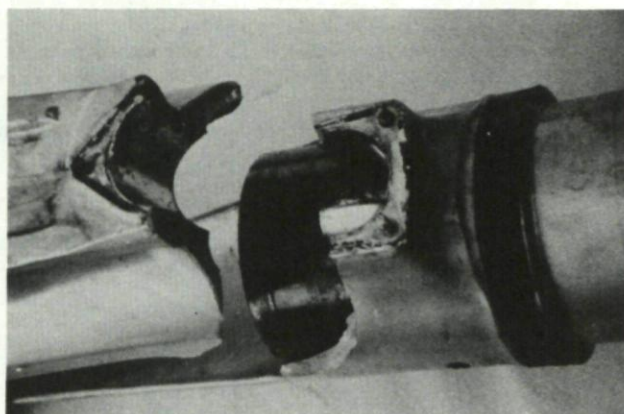
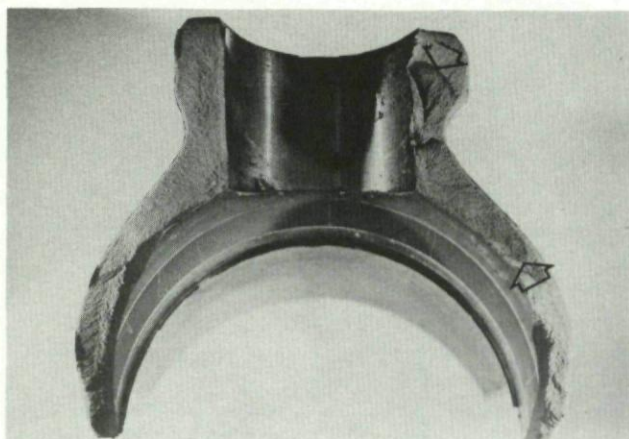
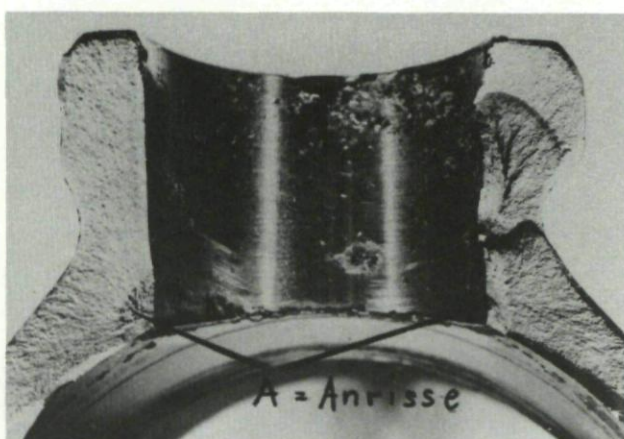
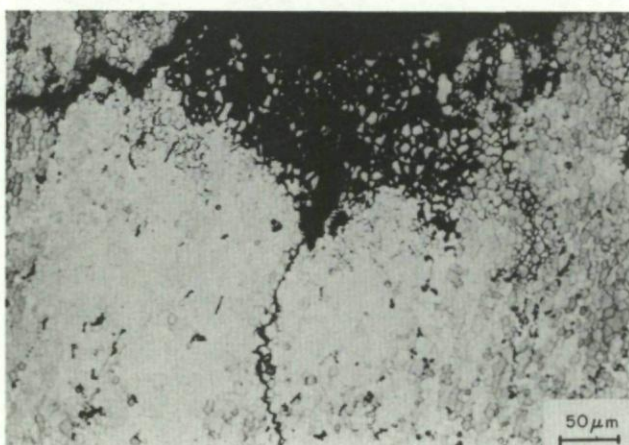
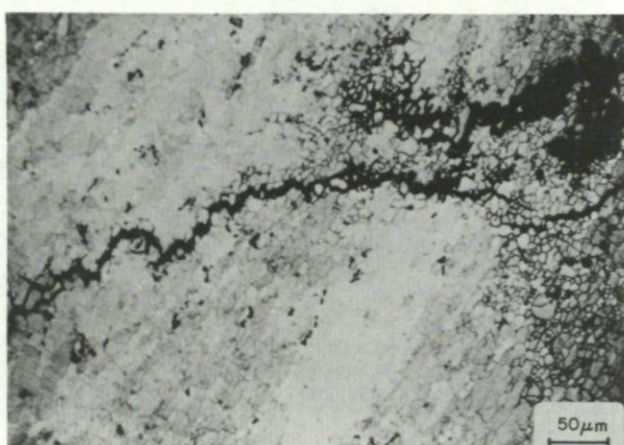
- (a) Fracture component.
- (b) Close-up of the fracture area.
- (c) Arrows indicate the extent of corrosion induced cracking.
- (d) Crack initiation sites at the junction of the axial and radial bores.
- (e) Sub-surface intergranular cracking adjacent to the radial bore.
- (f) Sub-surface intergranular cracking adjacent to the axial bore.

The component was made from an AlCuSiMn alloy, conforming to the German specification WLB 3.1254. This alloy contains about 4.3% Cu, and is similar to 2017 aluminium. Metallographic examination showed that the material had a very fine recrystallized grain structure, with a grain size of about 10-20 μm . Cross sections prepared through the component adjacent to the radial and axial bores showed severe intergranular corrosion immediately adjacent to the machined internal surfaces as shown in Figures 13-45(e) and 13-45(f) respectively. In both figures long cracks can be seen growing out of the regions of intergranular cracking to penetrate deeply into the wall thickness. These cracks resemble stress corrosion cracks, propagating intergranularly and exhibiting signs of crack branching.

It was concluded that the failure occurred by stress corrosion cracking and this produced the dark pre-crack shown in Figures 13-45(c) and 13-45(d). Although the strength of the alloy was not given in this failure report, it is known that alloys of this type are sensitive to intergranular corrosion and stress corrosion cracking, particularly when heat treatment leads to the formation of solute-depleted regions adjacent to grain boundaries which are anodic with respect to the grain boundaries and grain interiors. Little specific data appears to be available on 2017 aluminium, but Reference 13-45 indicates that stress corrosion service failures can be expected in 2017-T4 or 2017-T451 when sustained tensile stress acts in the short transverse direction relative to the grain structure. In this particular component there was very little directionality in grain structure, but as indicated in Section 13-5 equiaxed structures of the type observed might represent a worst-case condition with respect to SCC.

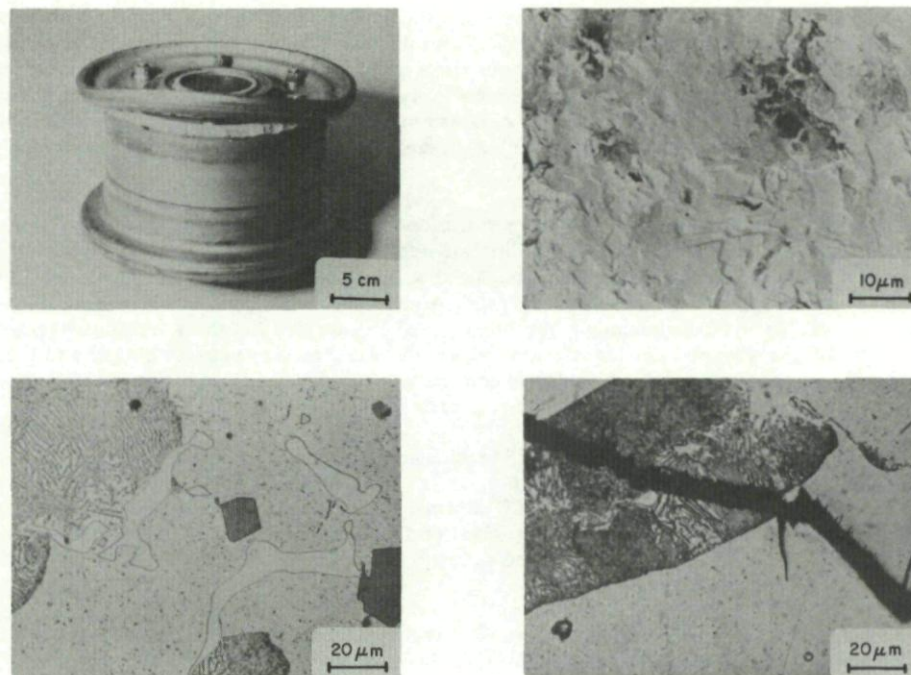
Fig. 13-47 Stress corrosion cracking of a magnesium alloy nose wheel, case history 13-12.

A magnesium alloy nose-wheel of a fighter aircraft failed and caused a tire blow-out. The wheel was produced as a casting using the MgAlZn alloy, AZ-91C, and this failed through the formation of a major crack in the fillet between the flange and the rim. This crack had caused the flange to be partly torn from the wheel body, as shown in Figure 13-47(a). Visual inspection revealed corrosion pits and small cracks in the fillet between the flange and the rim at the surface of contact with the tire-bead. The fractographic investigation failed to reveal any indications of fatigue or intergranular failure. The fracture surfaces were dirty and severely damaged, and the only recognizable features were lamellar components of the microstructure protruding from the fracture surface at various angles, as indicated in Figure 13-47(b).

- (a) Fractured wheel.
- (b) Fracture surface topography.
- (c) Microstructural constituents.
- (d) Section through a crack showing transgranular propagation.

A microstructural examination of the alloy revealed a magnesium alloy matrix containing various precipitated phases. These included: (a) pools of eutectic containing lamellar particles of the compound Mg_3Al_2 , (b) coarse white particles containing zinc which may have been $Mg_3Al_2Zn_3$ or $MgZn_2$, and (c) grey angular particles of a manganese bearing compound $MgMnAl$ or Al_4Mn . These constituents can be seen in Figure 13-47(c). Figure 13-47(d) shows a crack cutting through a patch of lamellar eutectic and propagating transgranularly through the magnesium solid solution matrix. Some secondary cracking can be seen propagating out of the main crack, and this appears to be following specific crystallographic planes.

The fact the corrosion pits were clearly visible in the region of crack initiation suggested that corrosion may have played an important role both in the initiation and crack propagation processes, and since propagation was largely transgranular and sensitive to grain orientation it was felt that stress corrosion cracking was a possible cause of fracture.

Magnesium alloys are known to exhibit both intergranular and transgranular stress corrosion cracking, and intergranular cracking is often associated with heavy grain boundary precipitation. Transgranular cracking is the more usual form of SCC in magnesium alloys, and this is believed to be influenced by the precipitation of iron and aluminium compounds on the basal planes of the hexagonal grain structure. It is also known that the corrosion resistance of magnesium alloys is extremely sensitive to the presence of impurities such as iron, nickel and copper, and that their effect becomes marked above a critical concentration known as the tolerance limit (Ref. 13-52). For iron the tolerance limit is about 0.017%, while for copper and nickel the tolerance limits are about 0.1% and 0.0005% respectively. A chemical analysis of this particular magnesium alloy indicated iron and copper contents each of 0.02%. The iron content was therefore above the tolerance limit and this might be expected to cause the alloy to be susceptible to general corrosion and to transgranular stress corrosion cracking.

No information was given in this report on the corrosion protection system employed, however as noted in Chapter 6, it is most important to isolate magnesium alloys from the environment by providing a fully protective envelope. It is also important to use primers with a very high chromate content and appropriate leaching characteristics to maintain a high concentration of inhibitor at any exposed metal surface.

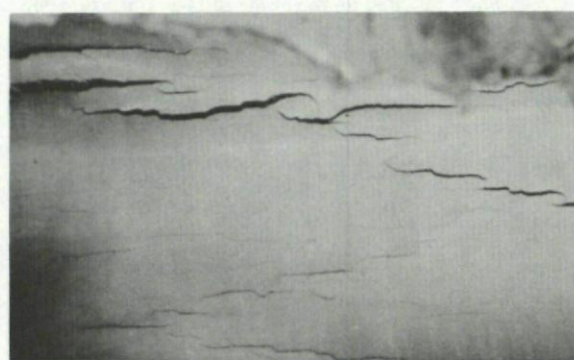
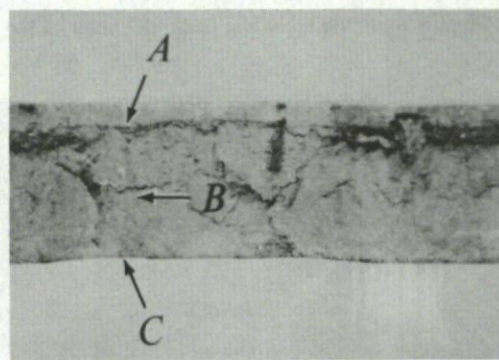
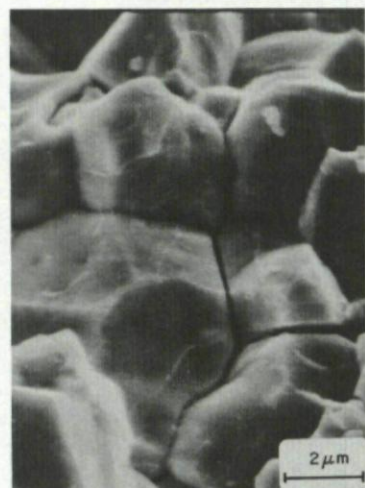
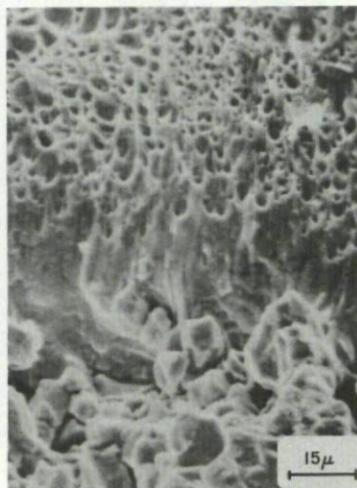
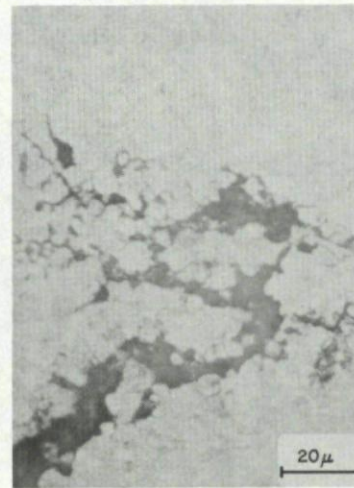
Fig. 13-50 Failure of a 18-Ni maraging steel pressure vessel, case history 13-15.

Visual examination of the cylinder inner wall showed numerous cracks running along the length of the cylinder, and there was no evidence of deformation associated with the crack sites, as indicated in Figure 13-50(a). Further examination of the open fracture faces showed that crack initiation had occurred on the inner surface of the cylinder, and indicated that before final overload fracture occurred the crack fronts were establishing a stable, slow crack growth configuration. The cracks had propagated through about 80% of the wall thickness before final overload rupture occurred, as indicated in Figure 13-50(b). In this figure, the symbols 'A', 'B' and 'C' indicate the overload fracture region, the region of slow crack growth, and the initiation region respectively.

Fractographic examination showed that the fracture mode in the initiation region and the region of slow crack growth was intergranular, and heavy corrosion products partly obscured the grain facets in the initiation region. Figure 13-50(c) shows the fracture topography in region B, while Figure 13-50(d) shows the transition zone between the region of slow crack growth (B) and the overload region A. This latter region showed ductile dimples, characteristic of overload rupture. Metallographic cross-sections through the wall of the cylinder showed extensive intergranular cracking with multiple crack paths, as indicated in Figure 13-50(e).

The presence of corrosion products and intergranular fracture in the region of slow crack growth suggested that an environmentally induced fracture mode was operating. The inner surface of the cylinder was found to be covered by a thin film of oil which was analysed and found to be an established hydraulic fluid. Because of the small amount of oil available for analysis it was not possible to determine whether any contaminants were present that might cause corrosion. However, as noted in Section 13-6, it is known that many light oils and hydraulic fluids contain small amounts of water which are sufficient to cause stress corrosion cracking in some susceptible alloys. No other source of corrosion was identified, and in the absence of alternative explanations the failure was attributed to stress corrosion cracking.

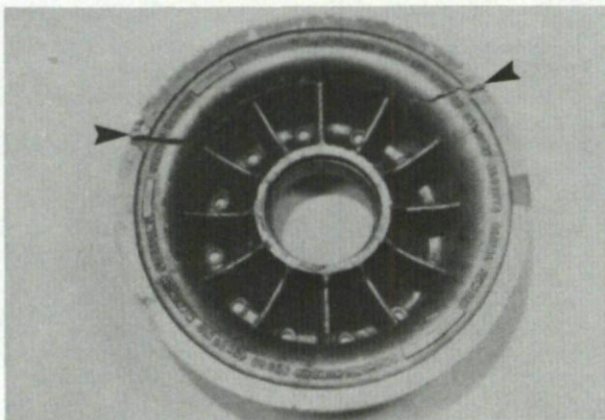
(a)

A large rim section was found broken from the rim of a STOL transport aircraft main wheel after landing (Fig. 14-8(a)). The cause of fracture was found to be corrosion fatigue cracking which had grown completely through the rim section. Cracking initiated from the tyre bead seat radius, and the corrosion products were typical of a marine environment.

Fig. 14-8 Corrosion fatigue of a magnesium alloy (AZ-91C) main landing gear wheel

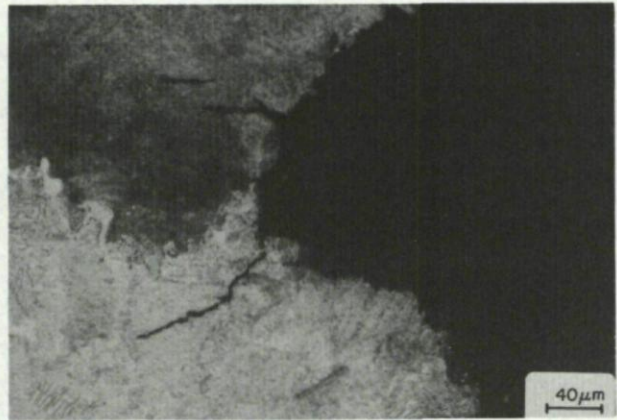
(b)

These experimental low pressure tyre wheels allowed salt moisture to penetrate the tyre bead seat area between tyre and rim, aided by frequent tyre changes. The wheel was a magnesium alloy casting (AZ-91C) and fatigue crack initiation occurred at the base of deep corrosion pits. Figure 14-8(b) shows a typical pit with multiple crack origins.

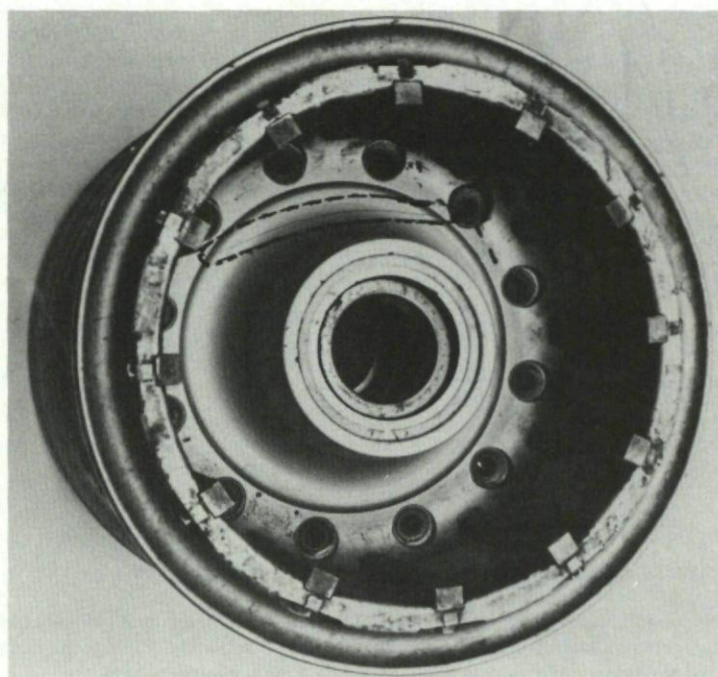
(a)

Long cracks were found during visual inspection of a fighter aircraft main landing gear wheel. The cracks were approximately 125 mm long and were found to run between the rim of the wheel and a bolt hole, as shown in Figure 14-9(a). The crack initiation site is indicated by the arrow in Figure 14-9(b).

Fig. 14-9 Corrosion fatigue of a magnesium alloy (QE-22A) main landing gear wheel

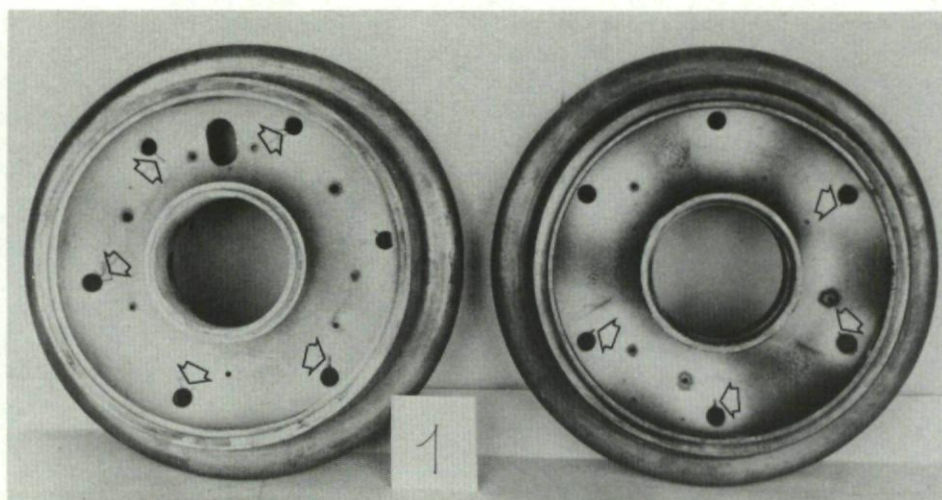
(a)

Multiple cracks were found propagating out of bolt housings during a visual and liquid penetrant inspection of the nose wheels of a fleet of fighter aircraft. Many wheels were found to be affected, and typical cracks are indicated by the arrows shown in Figure 14-10(a).

Fig. 14-10 Corrosion fatigue of a magnesium alloy (AZ-91C) nose wheel
