AGARD Corrosion Handbook Volume 1 Aircraft Corrosion: Causes and Case Histories

AIRCRAFT CORROSION: CAUSES AND CASE HISTORIES

W.Wallace
Head, Structures and Materials Laboratory
National Aeronautical Establishment
National Research Council Canada
Ottawa, Ontario, Canada

D.W.Hoeppner
Cockburn Professor of Engineering Design
Department of Mechanical Engineering
University of Toronto
Toronto, Ontario, Canada

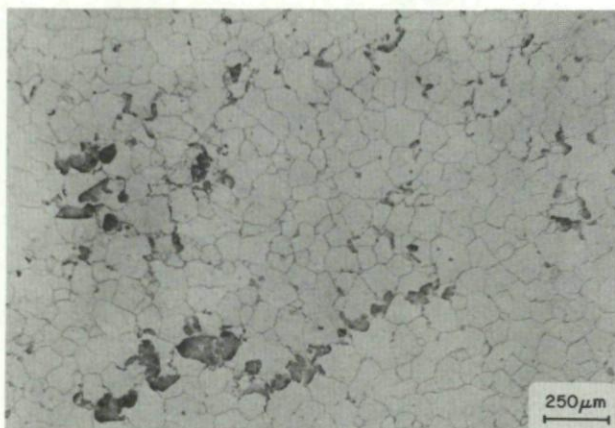
(b)

Metallurgical analysis showed that the wheels were made of a magnesium alloy casting, AZ-91C, with a nominal composition Mg-9% Al-0.7% Zn. The microstructure (Fig. 14-10(b)) consisted of equiaxed grains with fine precipitates of an intermetallic compound along grain boundaries. Brinell hardness determined with a 500 kg load and a 10 mm diameter ball indenter was found to be BHN-51 to 59, which is typical of materials in the T4 heat treatment condition.

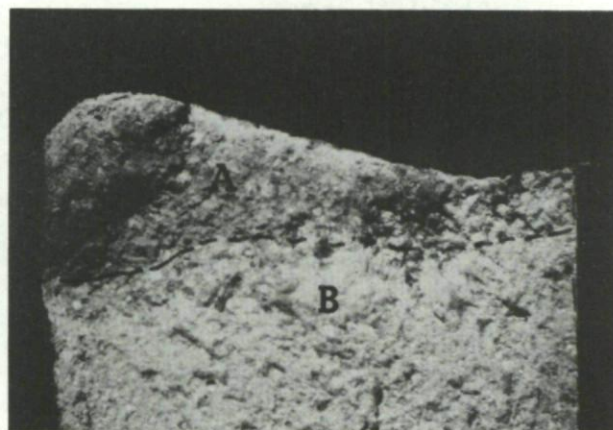
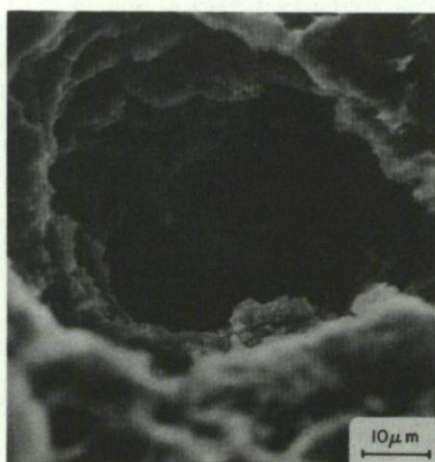
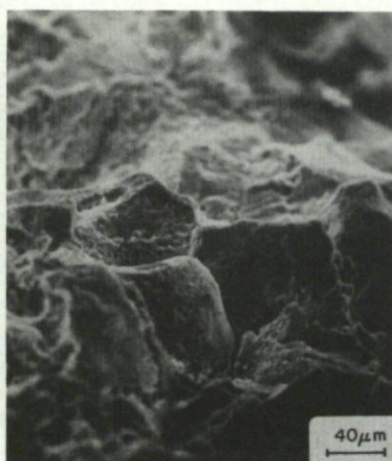
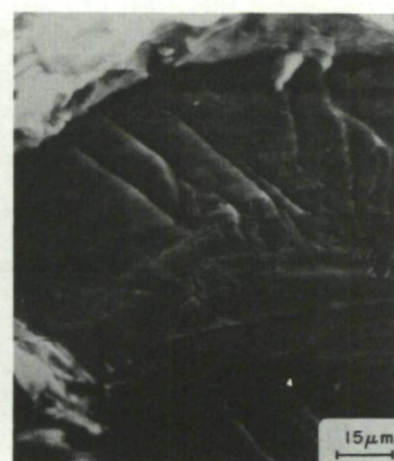
Several cracks were opened in the laboratory, and these showed a dark zone, covered by corrosion products, which extended up to the bright overload zone produced during opening (Fig. 14-10(c)). The inner surfaces of the bolt holes were also examined. These were found to contain deep corrosion pits of the type shown in Figure 14-10(d). Examination of the fracture surfaces using a scanning electron microscope showed that intergranular cracking had occurred in the initiation regions (Fig. 14-10(e)), while transgranular fracture had occurred at longer crack lengths (Fig. 14-10(f)). Both the intergranular and transgranular zones were badly corroded, but fatigue striations were clearly visible in the transgranular areas (Fig. 14-10(f)).

Pitting attack in the bolt holes may have been influenced by galvanic effects, or by crevice conditions existing between the wheel and the steel bolts. However, the presence of heavy corrosion across the fracture faces and the clear evidence of striations suggests that corrosion fatigue was responsible for at least the later stages of crack propagation. This aircraft had operated in the Mediterranean region which is also a significant factor. This, and the two preceding case histories, suggest that magnesium alloy castings are not good choices for aircraft wheels.

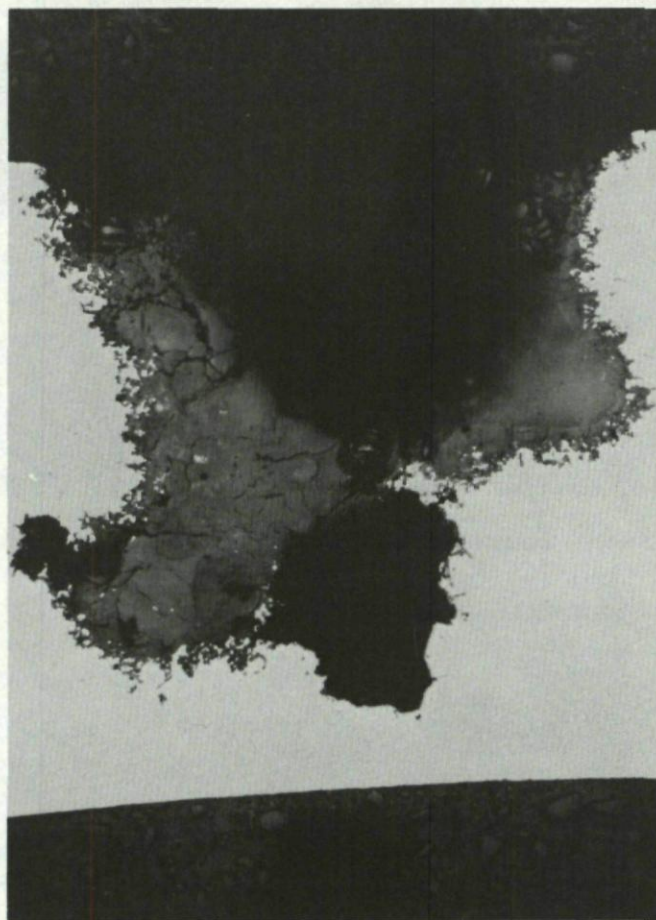
Fig. 15-7 Typical microbiological corrosion.
Alloy 5052 (Al-Mg)

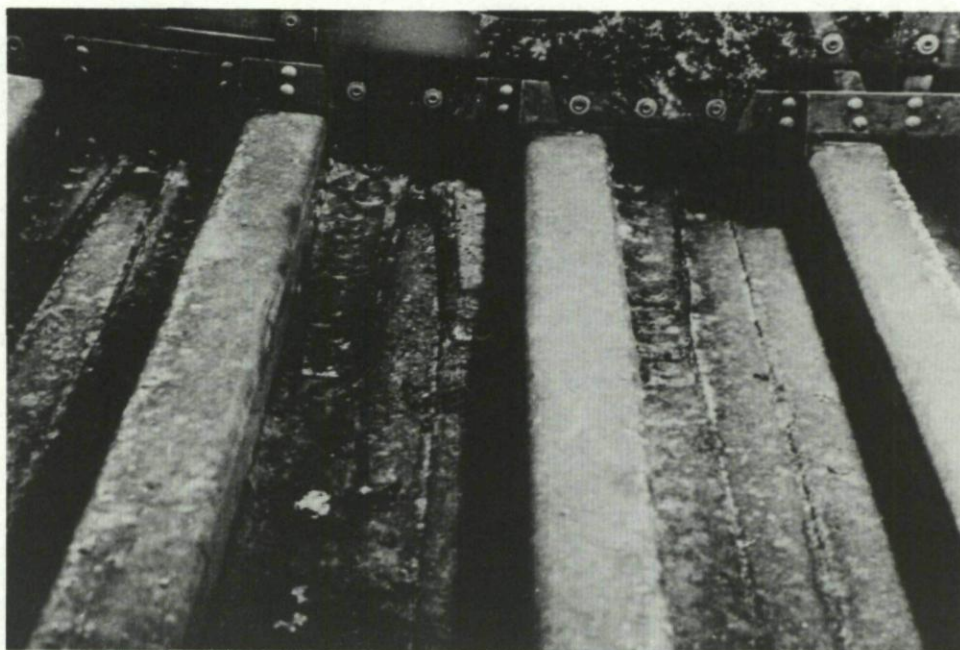
Fig. 15-8(b) Typical view of integral fuel tanks with microbiological corrosion
