MIL-HDBK-790

MILITARY HANDBOOK

FRACTOGRAPHY AND CHARACTERIZATION OF FRACTURE ORIGINS IN ADVANCED STRUCTURAL CERAMICS

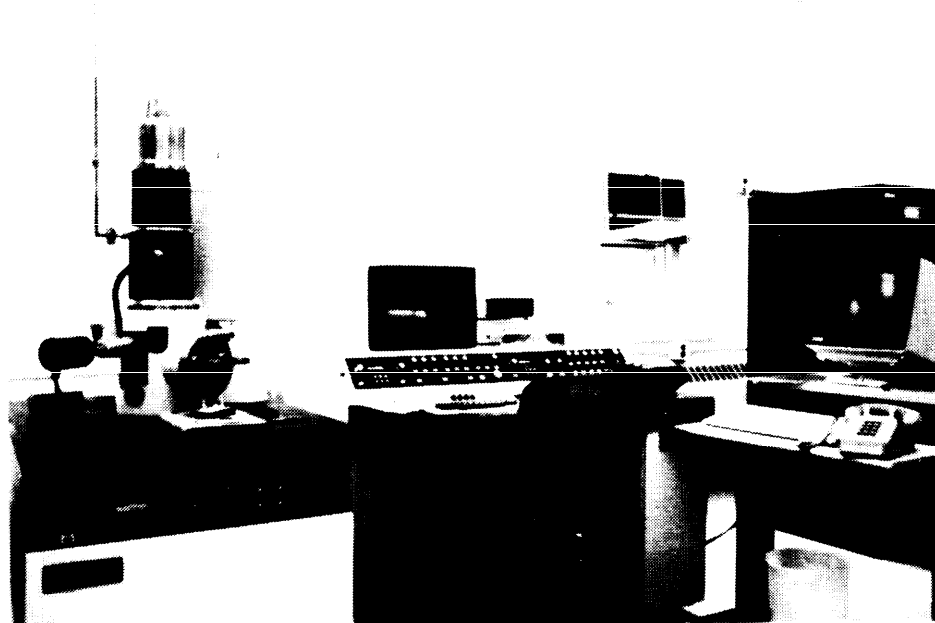
FIGURE 3. Scanning electron microscope with energy dispersive spectroscopic capabilities, low-energy operation and magnification between 20x and 20,000x.

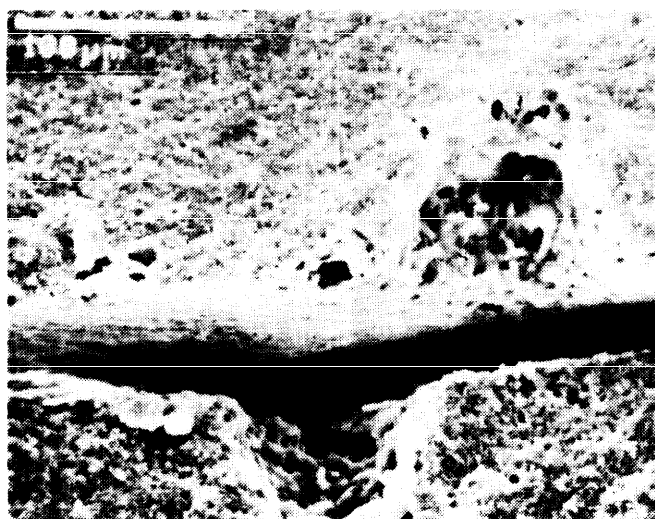
MATERIAL: Injection Molded & Sintered Silicon Nitride with Yttria & Alumina additions, as-fired

TEST CONDITION: Fast fracture in 4-point flexure at room temperature

COMMENTS: $\sigma = 472$ MPa;
-Photo shows both halves of the fracture surface
