AGARD REPORT No. 716

# Composite Structure Repair

AGARD Report No.716  
COMPOSITE STRUCTURE REPAIR

Larry G.Kelly  
AFWAL/FIBC  
Wright Patterson AFB  
OH 45433  
USA

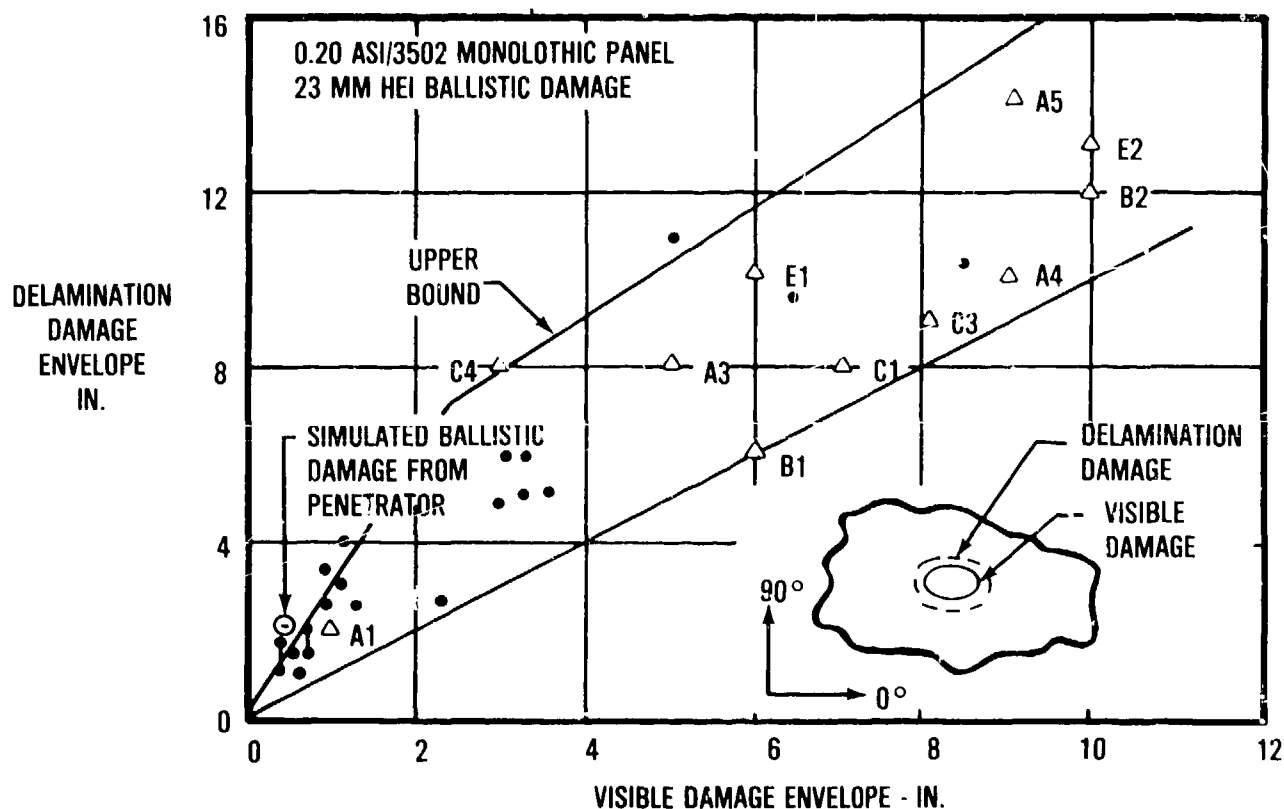
Figure 3. Ballistic Damage to Carbon Epoxy Panels

Ultrasonic equipment is the most widely used and is generally employed with a set of standards for set up and defect comparison. Figure 3 compares size of visible damage to area of internal delaminations as determined by ultrasonics. This data is from Reference 1 and is for a wide range of carbon panel types; some with buffer strips and stitching to contain delayed and superquick fused 23 mm high explosive projectile damage. The original data is from McDonnell Aircraft but I have included data from Boeing, Northrop and Air Force reports (dots and bars). This data includes impacts of fragments (1/4, 3/8, 1/2 inch) and projectiles (12.7, 14.5, 23 mm) with angles of obliquity up to 60 degrees.

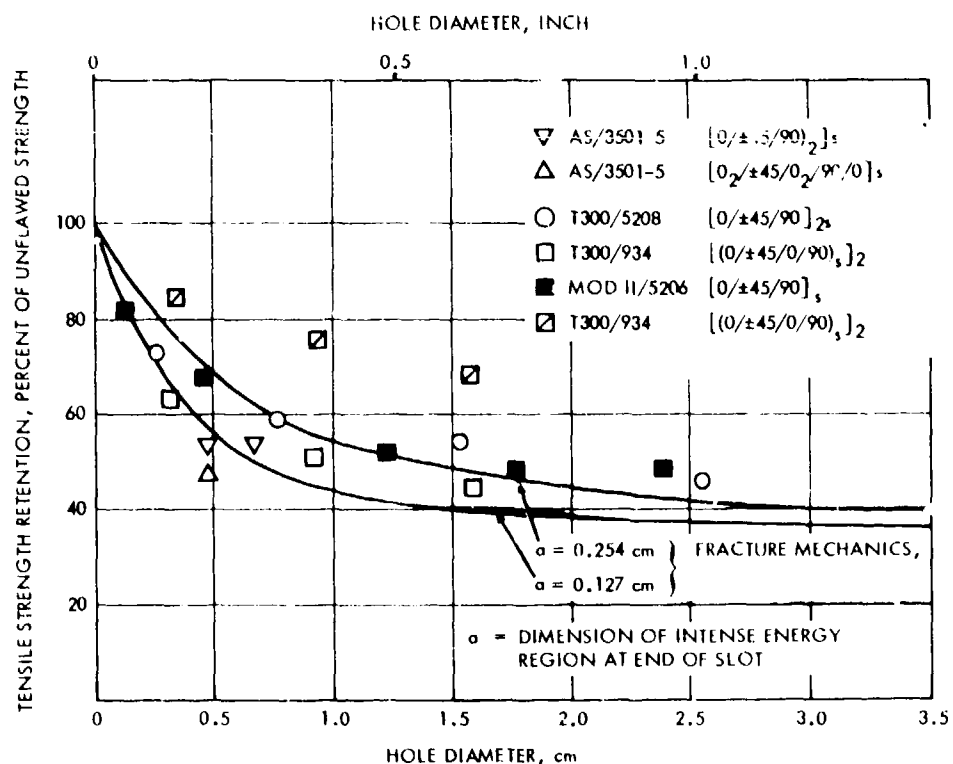
Figure 5. Tensile Strength Retention of Laminates with a Hole

Figure 5, from Reference 3, shows that there is substantial strength loss in carbon composites with relatively small holes.

Current design practice in the U.S. is to limit ultimate strain allowables in carbon composite structures to approximately 3500-4500 $\mu$  in/in. This allows for stress concentrations due to bolt holes or notches and provides for some accommodation of strain concentrations due to defects or damage. The figure 5 data does, however, point out the need for good quality repairs with substantial load carrying capability especially for structures designed with higher strain allowables.

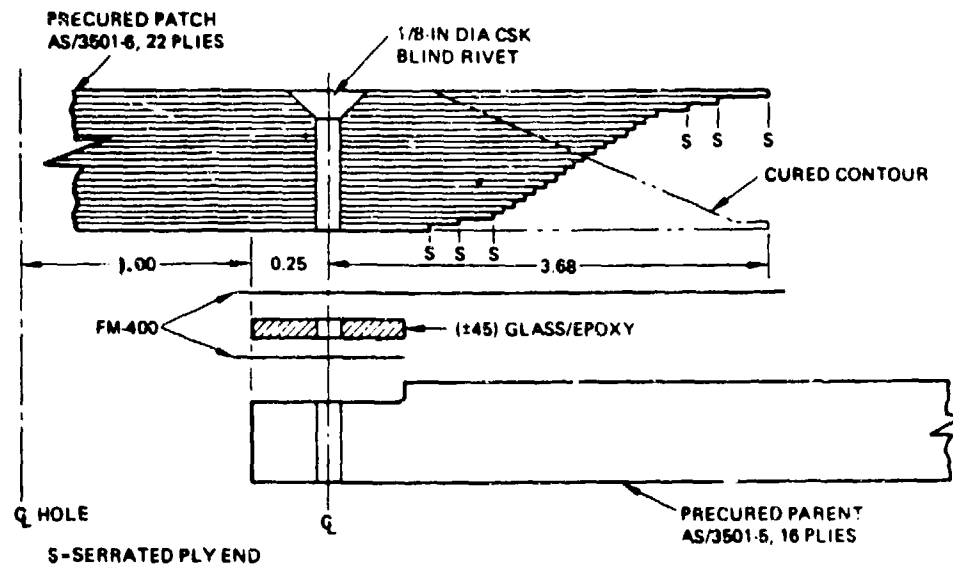
Figure 9. External Patch Repair

Applying this concept to 2" diameter holes in four-point-load sandwich beams obtained the results shown in Table 1. Figure 9 shows the details of the 22 ply patch design. Comparing the resulting failure loads with the parent allowables quite satisfactory results were obtained for low to intermediate load levels (6-7,000 lb/inch).

Having established the capability of composite scarfed joints to satisfactorily transfer the required loads, the application of this repair concept (Figure 11) and that of the precured external patch (Figure 9) was applied to the repair of 4 inch diameter holes in 12 inch by 48 inch panels (Figure 12).

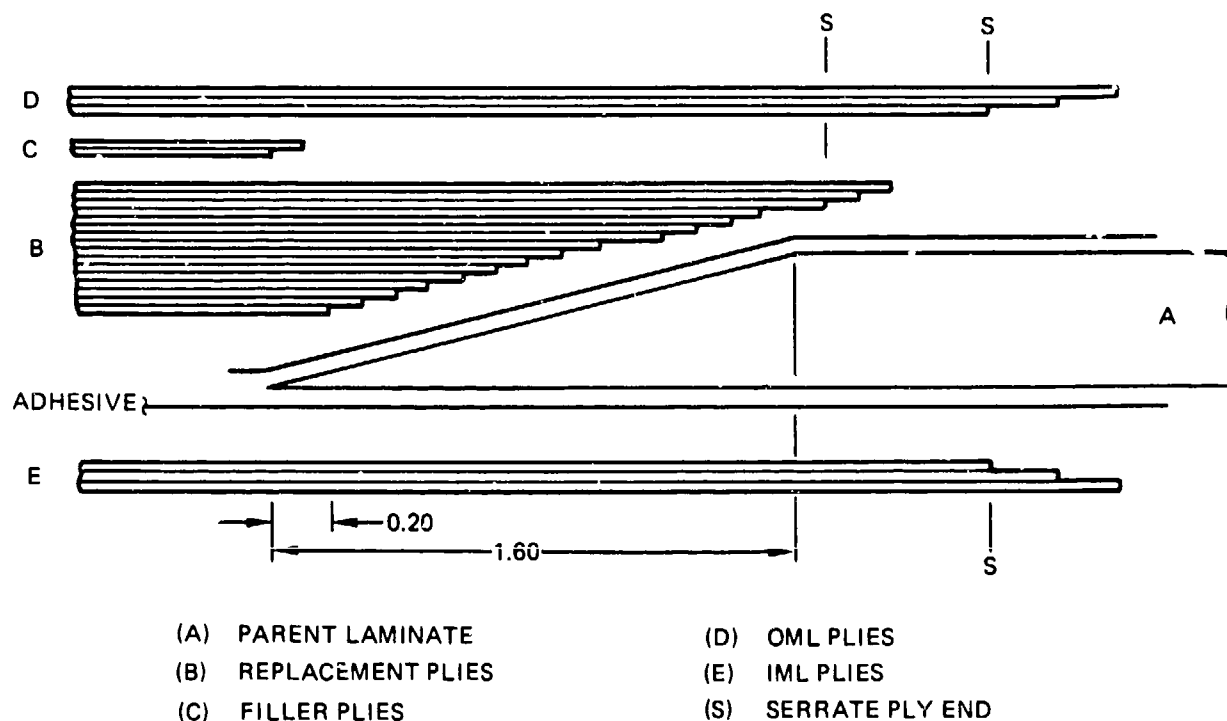
Figure 10. Basic Cured 16-Ply Scarf Joint

Precured bonded composite doublers, discussed previously, metal sheets and plates and metal foils of 8, 12 and 16 mil thickness have all been utilized satisfactorily as patch materials for low load levels and relatively flat surfaces. For curved or irregular surfaces and intermediate to high load levels the most versatile repair concept is the cured in place flush scarf repair. Accomplishing the scarf may appear difficult at first but was found to be relatively easy with simple portable tools. As a general rule when making a large area repair a flush scarfed repair is preferred since a significantly higher percent of the strength of the parent laminate can be restored. This is especially true for compressive loading where eccentricity of the patch can increase bending forces. Practical size limitations will probably restrict this repair approach to laminate thicknesses less than 1/2 inch because of the amount of material that has to be removed to achieve the required taper for proper scarf angle ( $L = 18$  to 40 times the thickness). Figure 10 illustrates a typical scarf joint using a 16 ply laminate to be repaired.

This basic scarf joint employs an 18:1 taper ratio since a .10 inch step is 18 times the nominal ply thickness of (.0055 inch). The scarfing is accomplished quite readily with the use of a portable router to cut .10 inch concentric steps, each successively larger, followed by a portable power driven sander to provide a finished scarf. A good scarf patch design practice is to extend the outermost plies over the ends of all the other plies and to serrate these plies to minimize ply end peeling. This can easily be done to the edge normal to the fiber direction with a pair of standard 1/8 inch V-notch pinking shears. It is also good practice to avoid placing unidirectional material as the outer most ply. An outside cover of woven material or for balanced

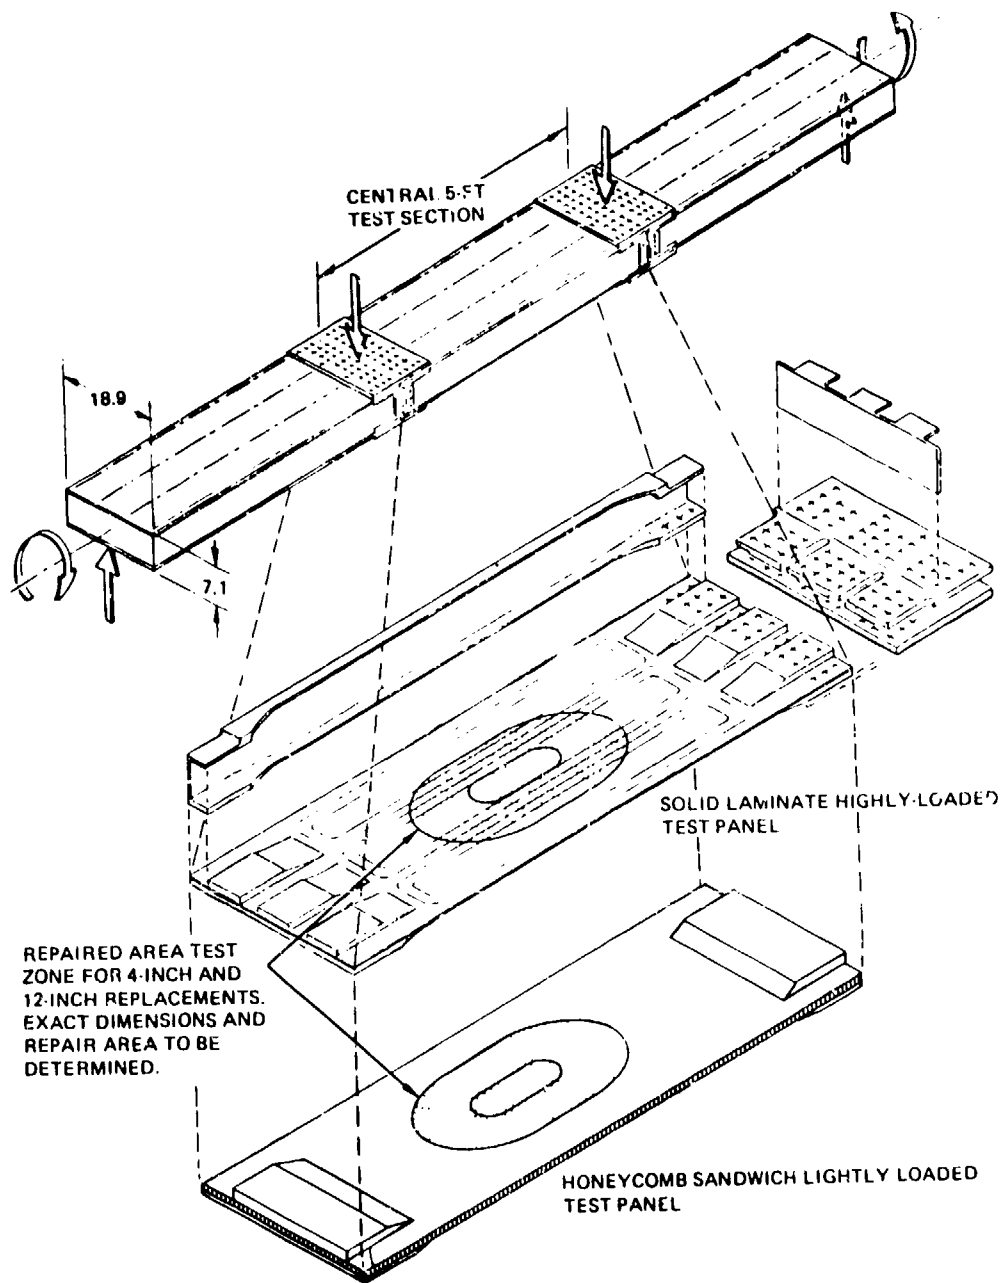
Figure 13. Large Scale Demonstration Panel Box Beam Test Fixture

The final demonstration of the repair concept developed was accomplished through the use of a 17 foot long, 19 inch wide, 7 inch deep box beam to which four point bending and torsion loads can be applied to the tension cover of a five foot test section, Figure 13. The five test panels and repair techniques utilized are outlined below:

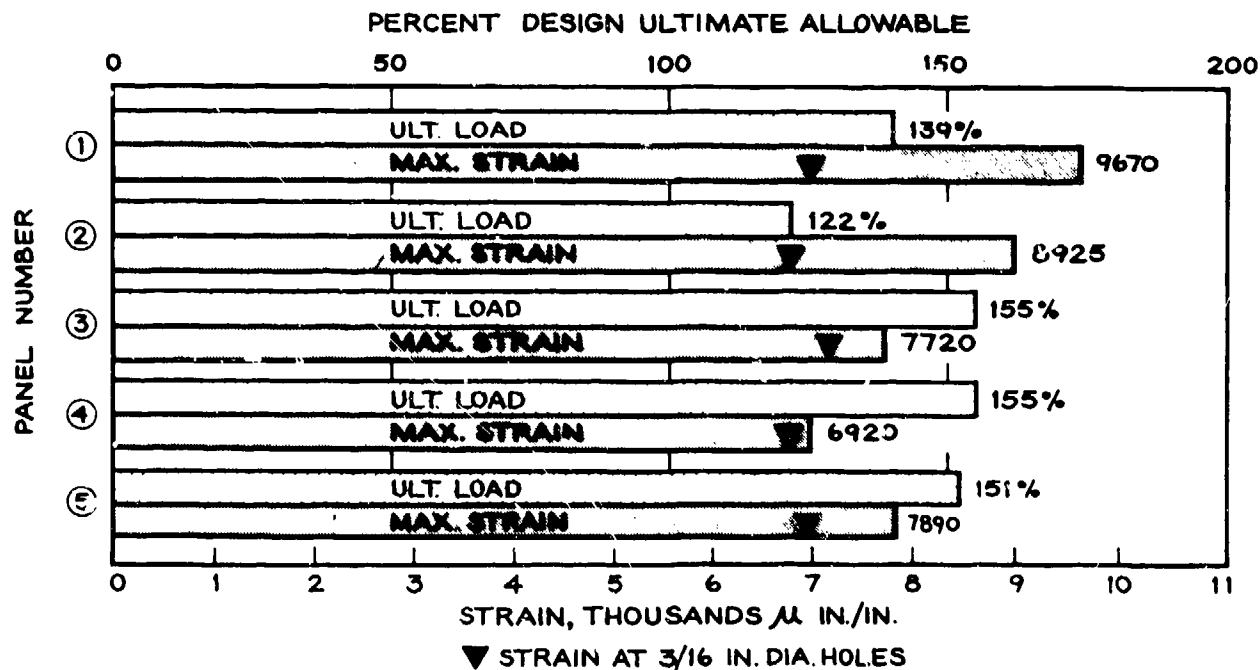
Figure 14. Demonstration Panel Results

Test results for these five panels are shown in Figure 14 and summarized below. More details on these test results can be found in Reference 6.

- Panel 1. Failure was remote from the patch area at 139% of the parent ultimate tension allowable at a failure load of 2390 lbs/inch
- Panel 2. Failure was through the repaired area at 122% of the parent ultimate tension allowable at a failure load of 2095 lbs/inch
- Panel 3. Failure was remote from the patch area at 155% of the parent ultimate tension allowable at a failure load of 14,200 lbs/inch
- Panel 4. Failure was through the repaired area at 155% of the parent ultimate tension allowable at a failure load of 14,200 lbs/inch
- Panel 5. Failure was remote from the repaired area at 151% of the parent ultimate tension allowable at a failure load of 19,300 lbs/inch
