# Composite Structure Repair

AGARD Report No.716  
COMPOSITE STRUCTURE REPAIR

Larry G. Kelly  
AFWAL/FIBC  
Wright Patterson AFB  
OH 45433  
USA

Paper presented at the 57th Meeting of the Structures and Materials Panel in  
Vimeiro, Portugal on 9-14 October 1983.

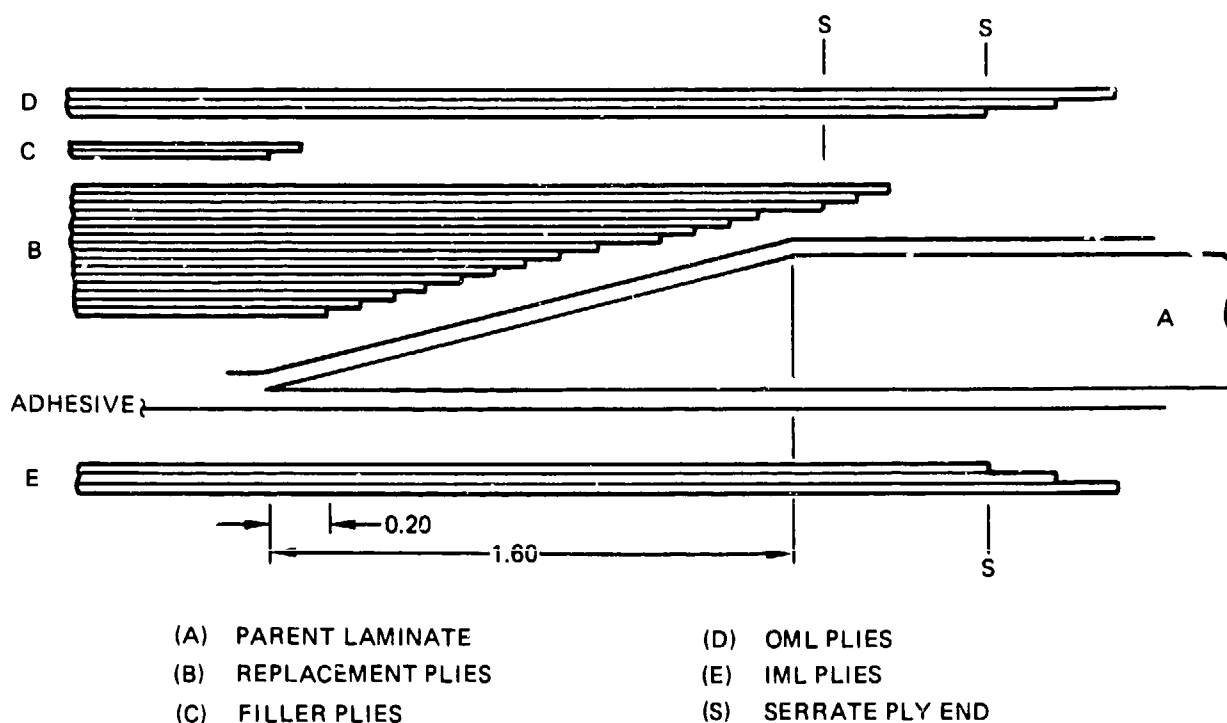
Figure 10. Basic Cured 16-Ply Scarf Joint

This basic scarf joint employs an 18:1 taper ratio since a .10 inch step is 18 times the nominal ply thickness of (.0055 inch). The scarfing is accomplished quite readily with the use of a portable router to cut .10 inch concentric steps, each successively larger, followed by a portable power driven sander to provide a finished scarf. A good scarf patch design practice is to extend the outermost plies over the ends of all the other plies and to serrate these plies to minimize ply end peeling. This can easily be done to the edge normal to the fiber direction with a pair of standard 1/8 inch V-notch pinking shears. It is also good practice to avoid placing unidirectional material as the outer most ply. An outside cover of woven material or for balanced

Precured bonded composite doublers, discussed previously, metal sheets and plates and metal foils of 8, 12 and 16 mil thickness have all been utilized satisfactorily as patch materials for low load levels and relatively flat surfaces. For curved or irregular surfaces and intermediate to high load levels the most versatile repair concept is the cured in place flush scarf repair. Accomplishing the scarf may appear difficult at first but was found to be relatively easy with simple portable tools. As a general rule when making a large area repair a flush scarfed repair is preferred since a significantly higher percent of the strength of the parent laminate can be restored. This is especially true for compressive loading where eccentricity of the patch can increase bending forces. Practical size limitations will probably restrict this repair approach to laminate thicknesses less than 1/2 inch because of the amount of material that has to be removed to achieve the required taper for proper scarf angle ( $L = 18$  to 40 times the thickness). Figure 10 illustrates a typical scarf joint using a 16 ply laminate to be repaired.
