**(NAVY) NAVAIR 17-15-50.3
(ARMY) TM 38-301-3
(AIR FORCE) T.O. 33-1-37-3
(COAST GUARD) CGTO 33-1-37-3**

**JOINT OIL ANALYSIS
PROGRAM MANUAL**

**LABORATORY ANALYTICAL METHODOLOGY
AND EQUIPMENT CRITERIA
(AERONAUTICAL)**

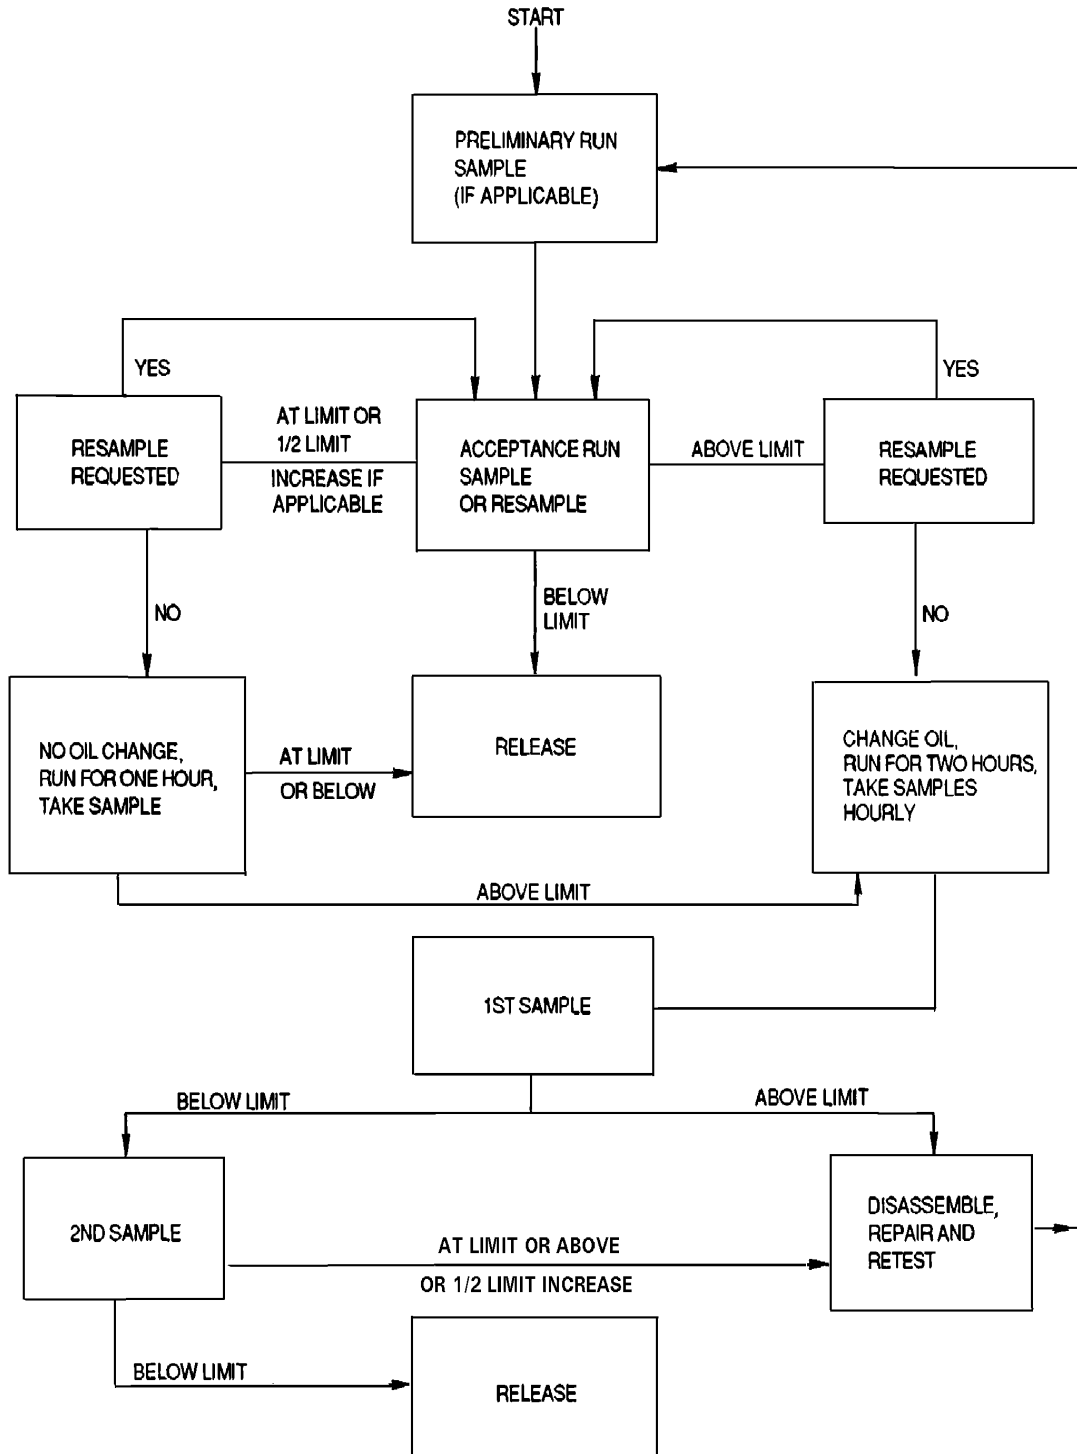
TABLE 2-4. AIR FORCE ALC DEPOT DECISION LOGIC

*DO NOT CHANGE OIL FOR T56 OR G56 AT ALC UNLESS REQUIRED

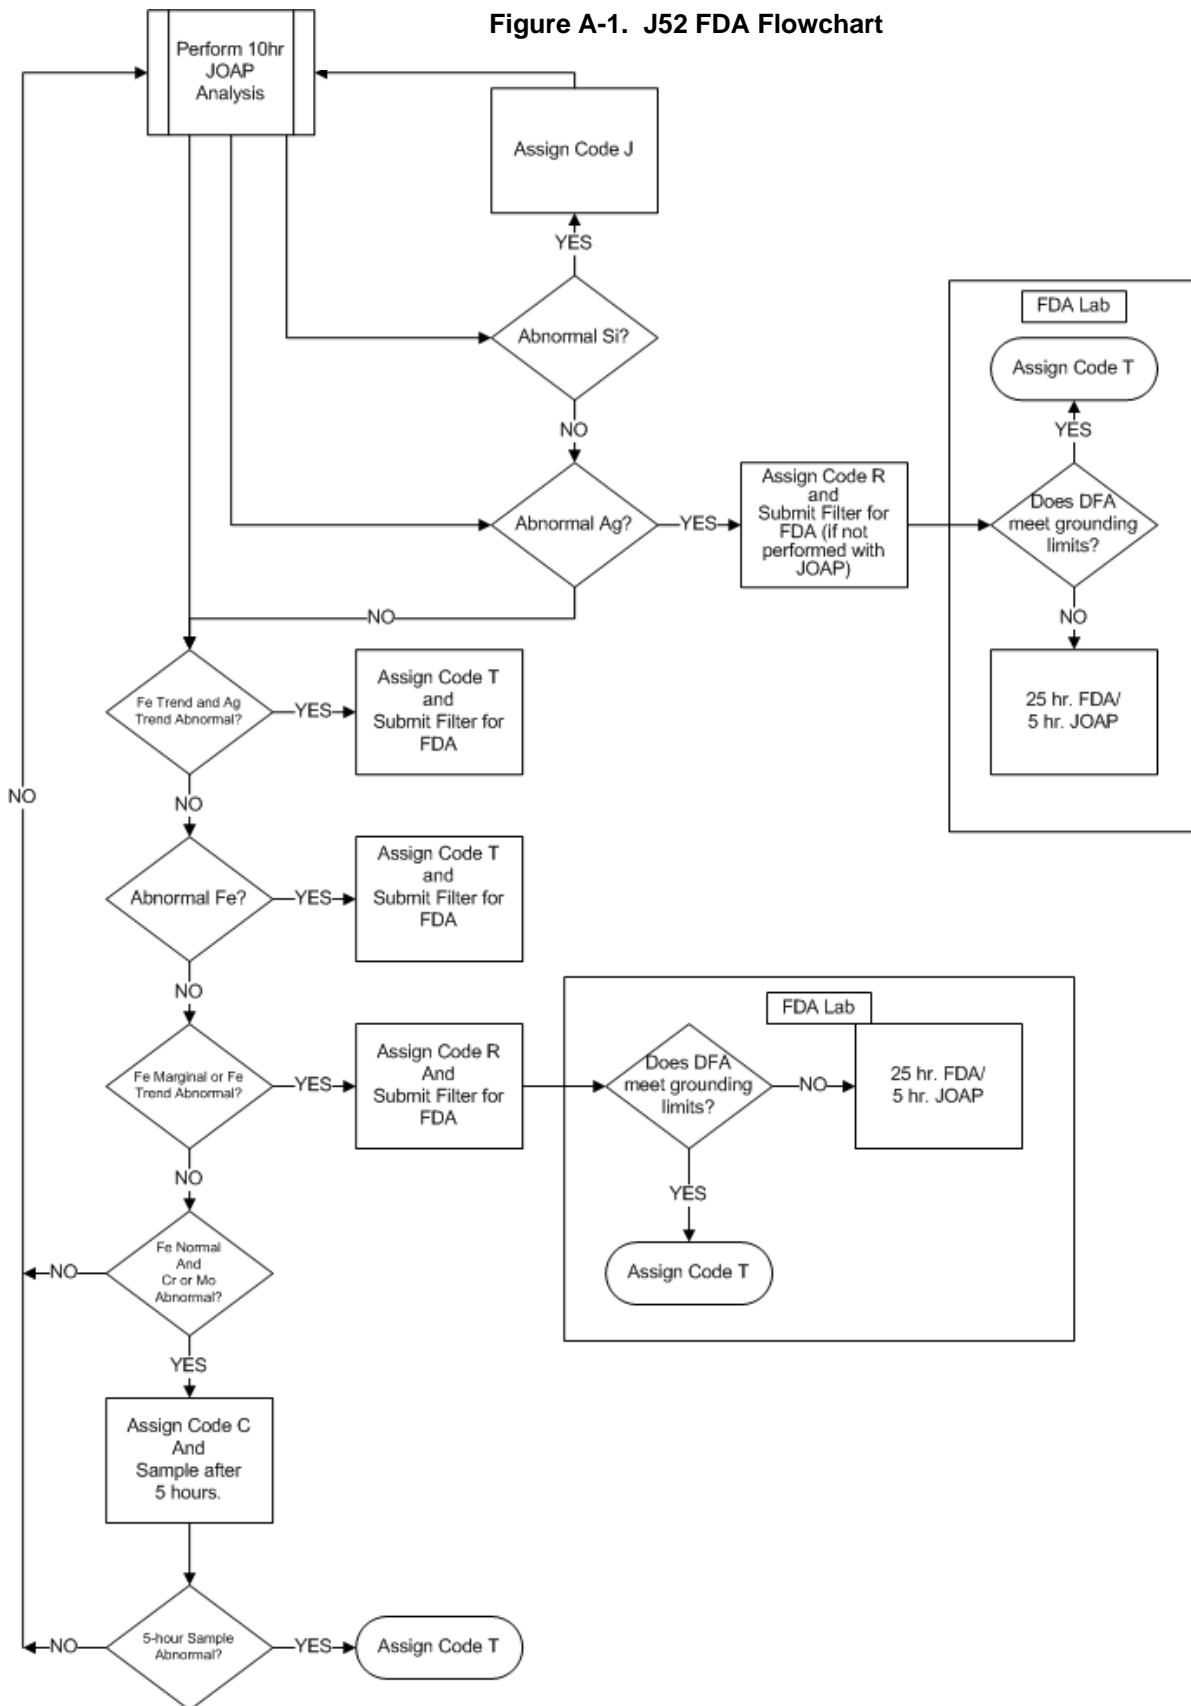
Figure A-1. J52 FDA Flowchart

1. If the FE is at or exceeds the abnormal limit, issue advice code T, do not fly or operate, recommend engine removal.
2. If the Fe trend and the Ag trend is at or exceeds the abnormal trend limit, issue advice code T, do not fly or operate, recommend engine removal.

3. If the Fe is in the high range or the trend for Fe meets or exceeds the table limit, recommendation shall be code R, do not fly or operate, inspect filter using FDA. If the FDA inspection meets grounding criteria, assign code T, do not fly or operate, recommend engine removal. If the FDA inspection does not meet grounding criteria, place filter on a 25 hour cycle, place JOAP oil sampling on a 5 hour interval until results return to normal.

4. If Cr and/or Mo are abnormal and the Fe is in the normal range, recommend code C, resample after 5 hours, do not change oil. If the resample is abnormal, assign code T, do not fly or operate, recommend engine removal.

5. If Ag is abnormal, recommend code R, do not fly or operate, inspect filter using FDA. If the FDA inspection meets grounding criteria, assign code T, do not fly or operate, recommend engine removal. If the FDA inspection does not meet grounding criteria, place filter on a 25 hour cycle, place JOAP oil sampling on a 5 hour interval until results return to normal.

6. IF Si is abnormal, recommend code J, contamination confirmed, change oil, resample with normal sampling schedule.

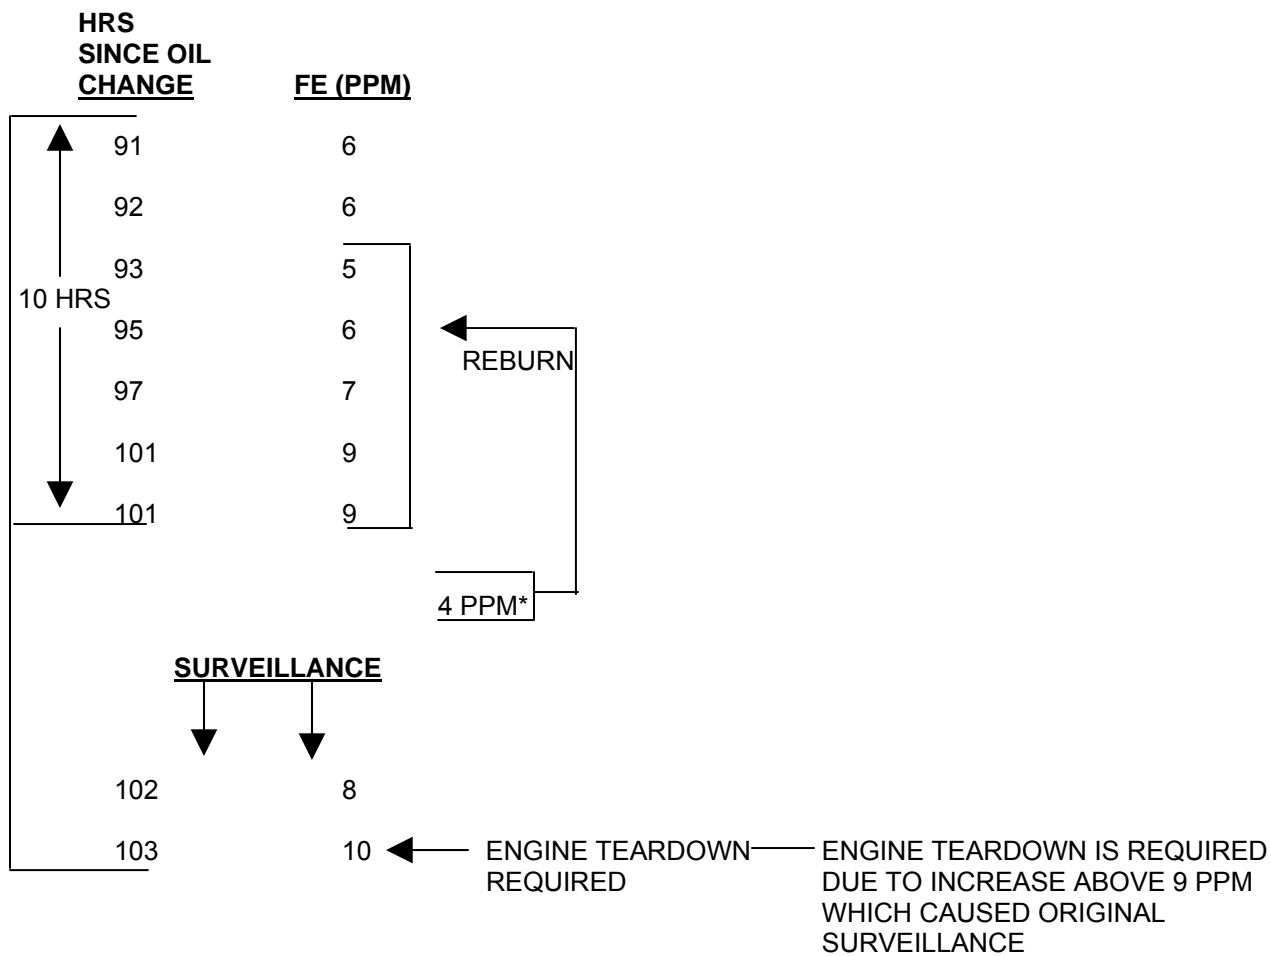
EXAMPLE: PRIOR TO SURVEILLANCE
 (FOR FE INCREASE IN 10 ENGINE HOURS)

JOAP RECORD ACTION REQUIRED REASON

* 4 PPM or greater using JOAP Atomic Emission.

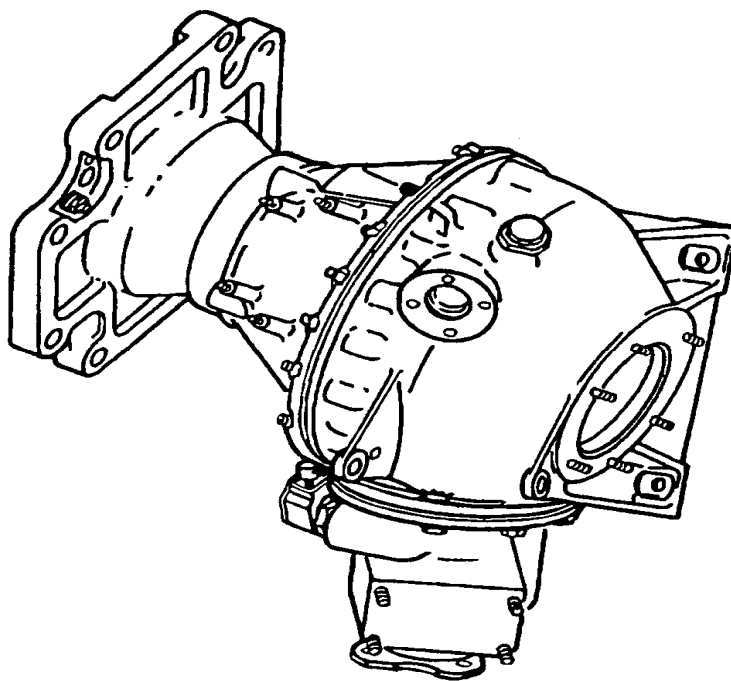
Figure A-2. Tail Rotor Gearbox

UH-60A, UH-60L, UH-60M, EH-60A, (Cont.)
EH-60L, HH-60A, HH-60L, MH-60K,
MH-60L, MH-60M, BLACK HAWK (ARMY)
TAIL ROTOR GEARBOX

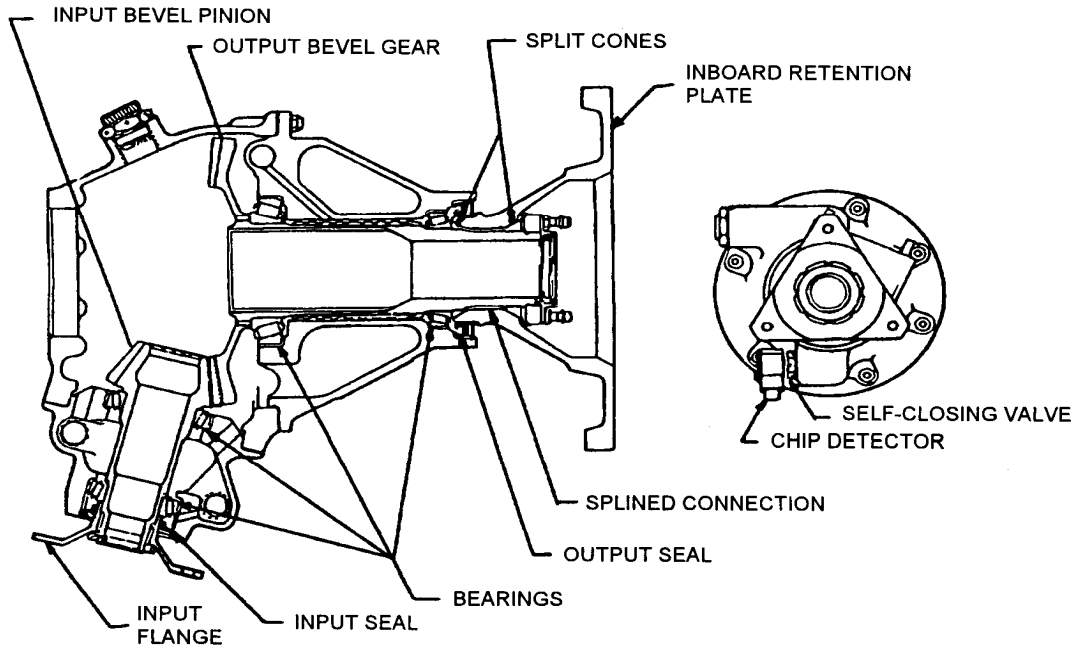
Figure A-3. Tail Rotor Gearbox Nomenclature

UH-60A, UH-60L, UH-60M, EH-60A, (Cont.)
 EH-60L, HH-60A, HH-60L, MH-60K,
 MH-60L, MH-60M, BLACK HAWK (ARMY)
 TAIL ROTOR GEARBOX

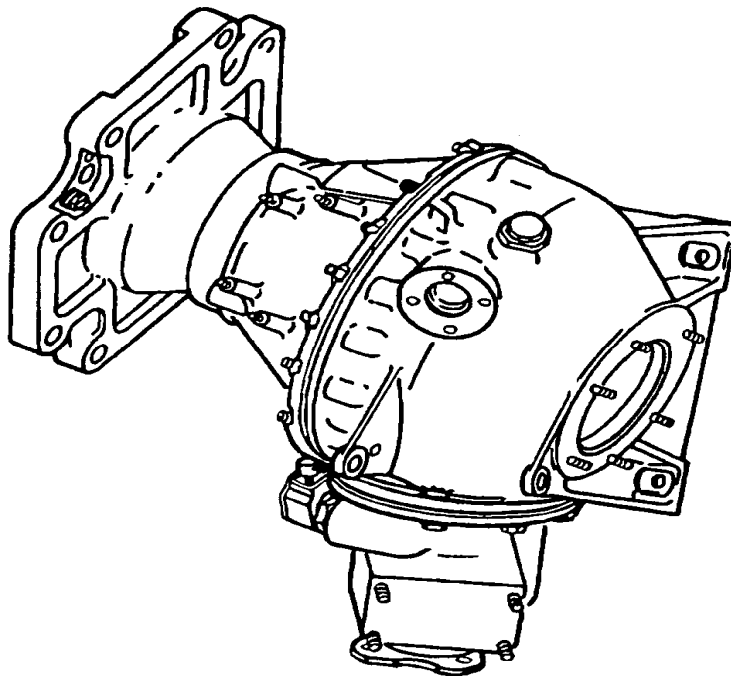
Figure A-5. Tail Rotor Gearbox

VH-60N (Cont.)
TAIL GEARBOX

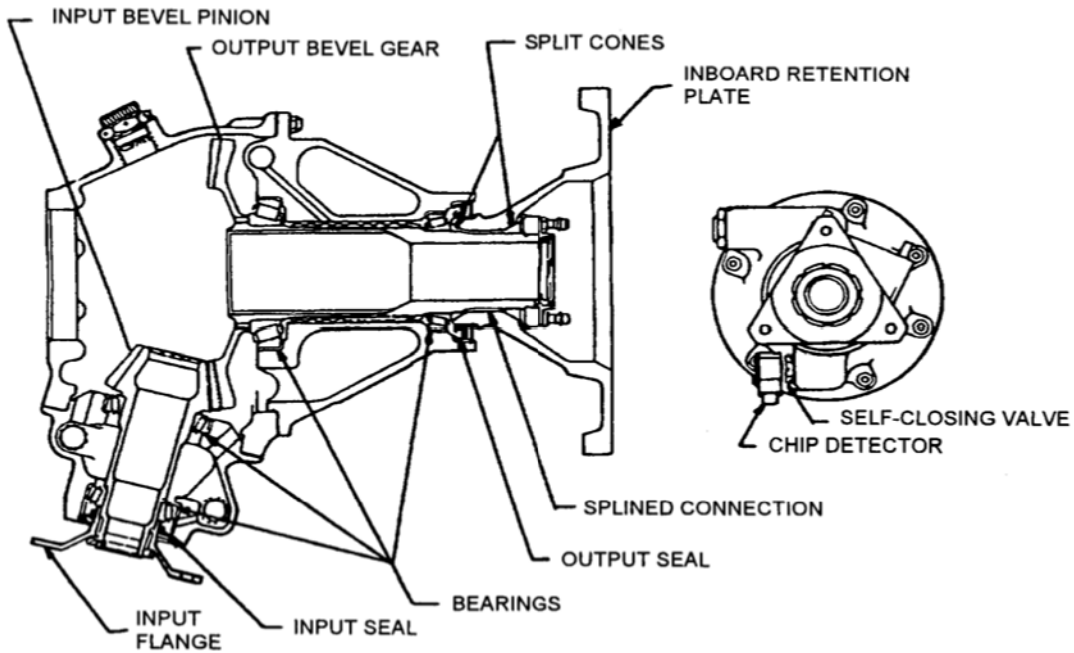
Figure A-6. Tail Rotor Gearbox Nomenclature

VH-60N (Cont.)
TAIL GEARBOX
