JOINT OIL ANALYSIS PROGRAM MANUAL

VOLUME III

LABORATORY ANALYTICAL METHODOLOGY AND EQUIPMENT CRITERIA (AERONAUTICAL)

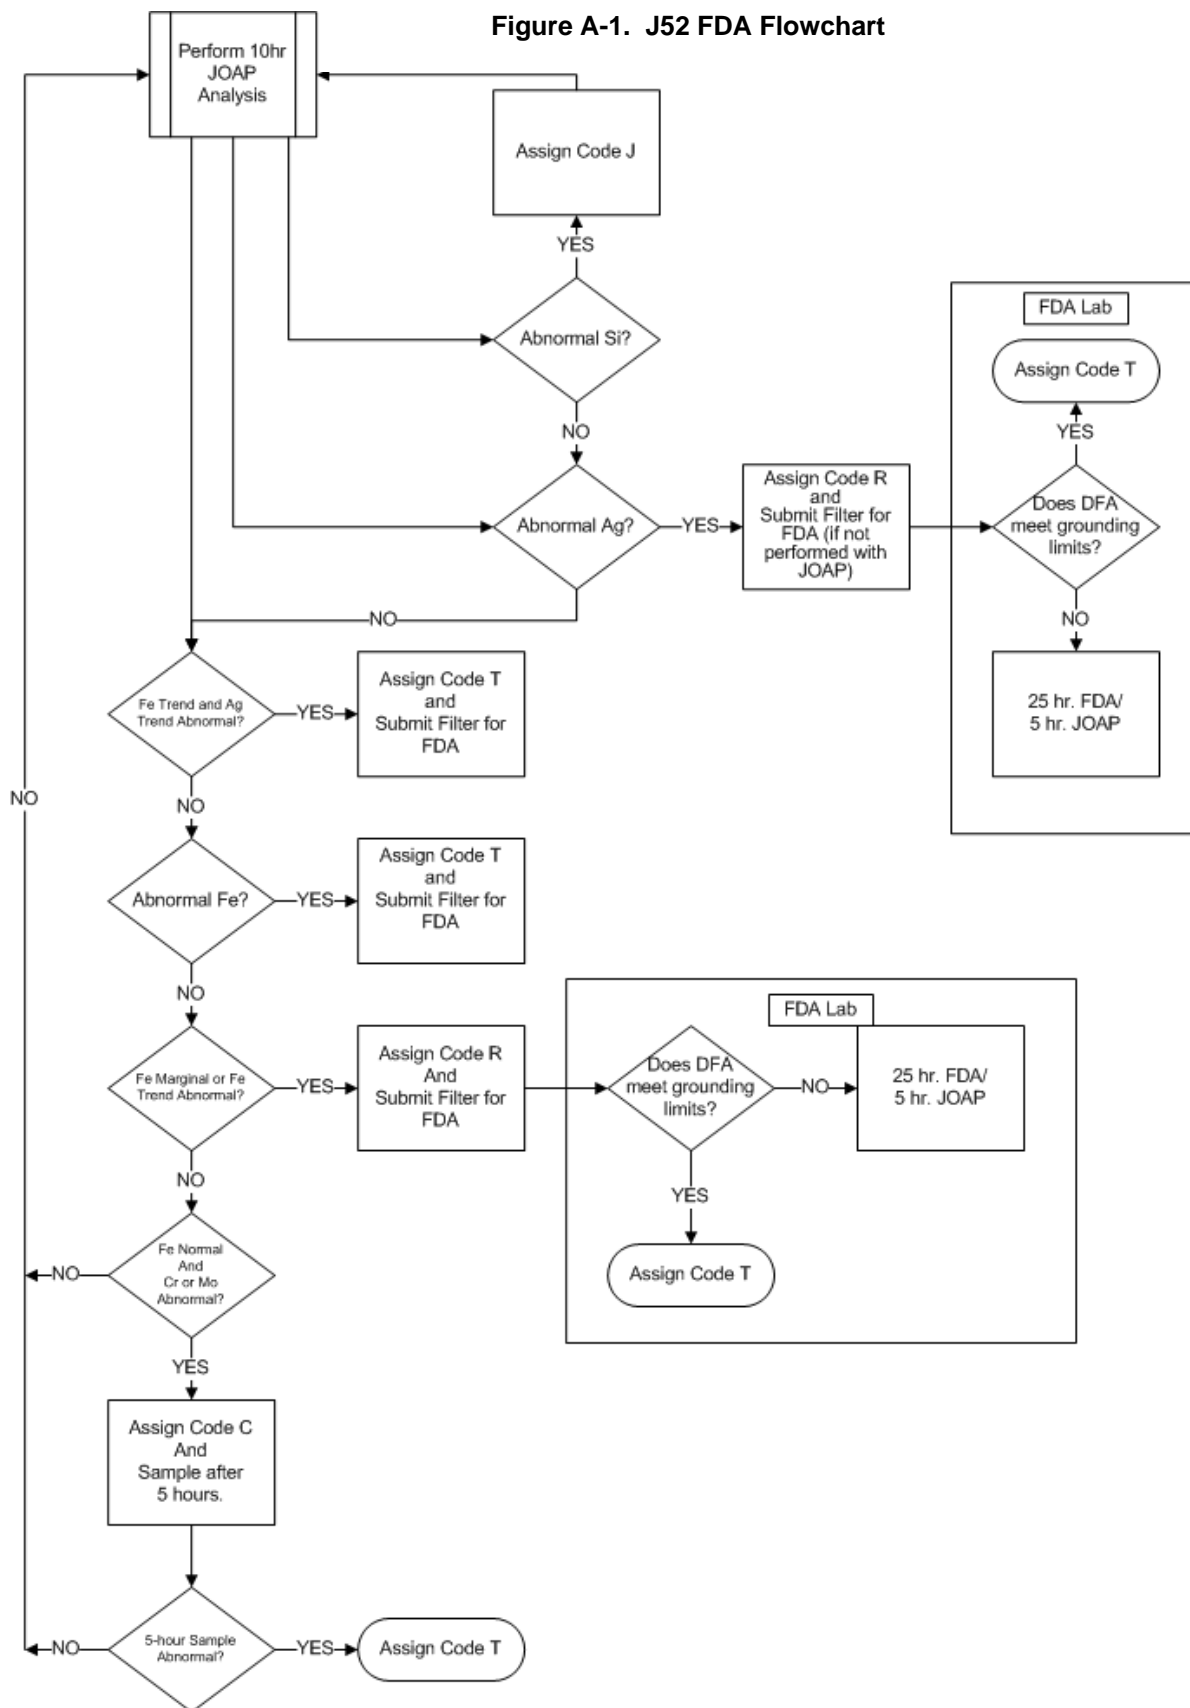
Figure A-1. J52 FDA Flowchart

1. If the FE is at or exceeds the abnormal limit, issue advice code T, do not fly or operate, recommend engine removal.
2. If the Fe trend and the Ag trend is at or exceeds the abnormal trend limit, issue advice code T, do not fly or operate, recommend engine removal.

3. If the Fe is in the high range or the trend for Fe meets or exceeds the table limit, recommendation shall be code R, do not fly or operate, inspect filter using FDA. If the FDA inspection meets grounding criteria, assign code T, do not fly or operate, recommend engine removal. If the FDA inspection does not meet grounding criteria, place filter on a 25 hour cycle, place JOAP oil sampling on a 5 hour interval until results return to normal.

4. If Cr and/or Mo are abnormal and the Fe is in the normal range, recommend code C, resample after 5 hours, do not change oil. If the resample is abnormal, assign code T, do not fly or operate, recommend engine removal.

5. If Ag is abnormal, recommend code R, do not fly or operate, inspect filter using FDA. If the FDA inspection meets grounding criteria, assign code T, do not fly or operate, recommend engine removal. If the FDA inspection does not meet grounding criteria, place filter on a 25 hour cycle, place JOAP oil sampling on a 5 hour interval until results return to normal.

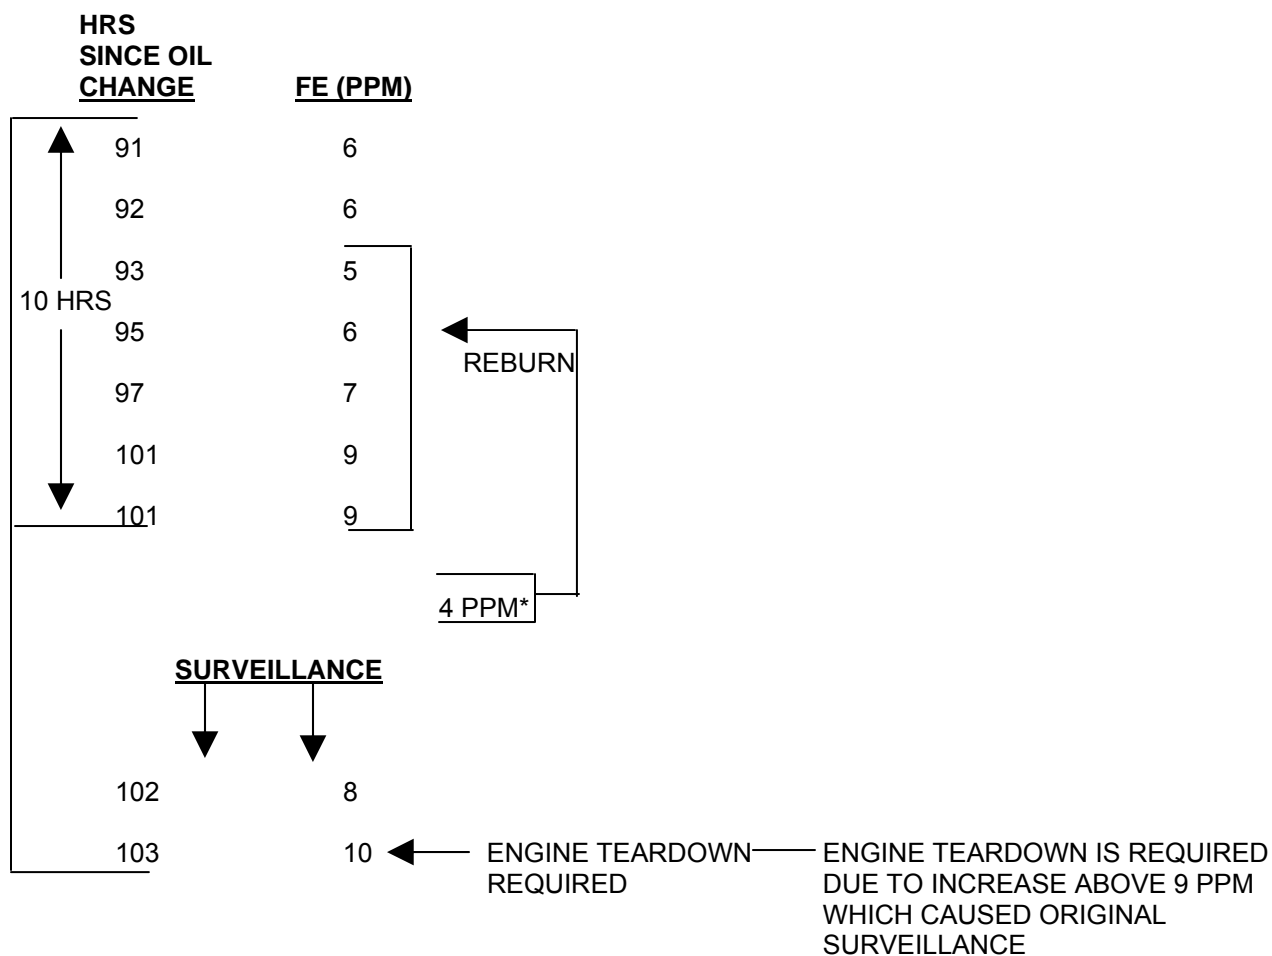
EXAMPLE: PRIOR TO SURVEILLANCE
 (FOR FE INCREASE IN 10 ENGINE HOURS)

JOAP RECORD ACTION REQUIRED REASON

* 4 PPM or greater using JOAP Atomic Emission.

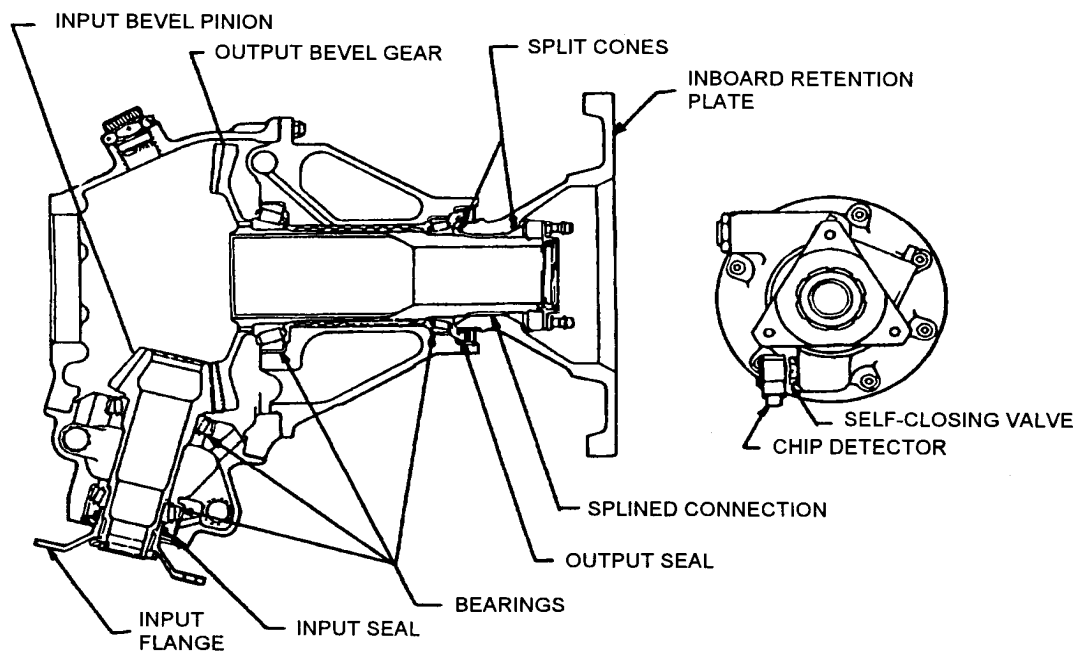
Figure A-3. Tail Rotor Gearbox Nomenclature

UH-60A, UH-60L, UH-60M, EH-60A, (Cont.)
 EH-60L, HH-60A, HH-60L, MH-60K,
 MH-60L, MH-60M, BLACK HAWK (ARMY)
 TAIL ROTOR GEARBOX

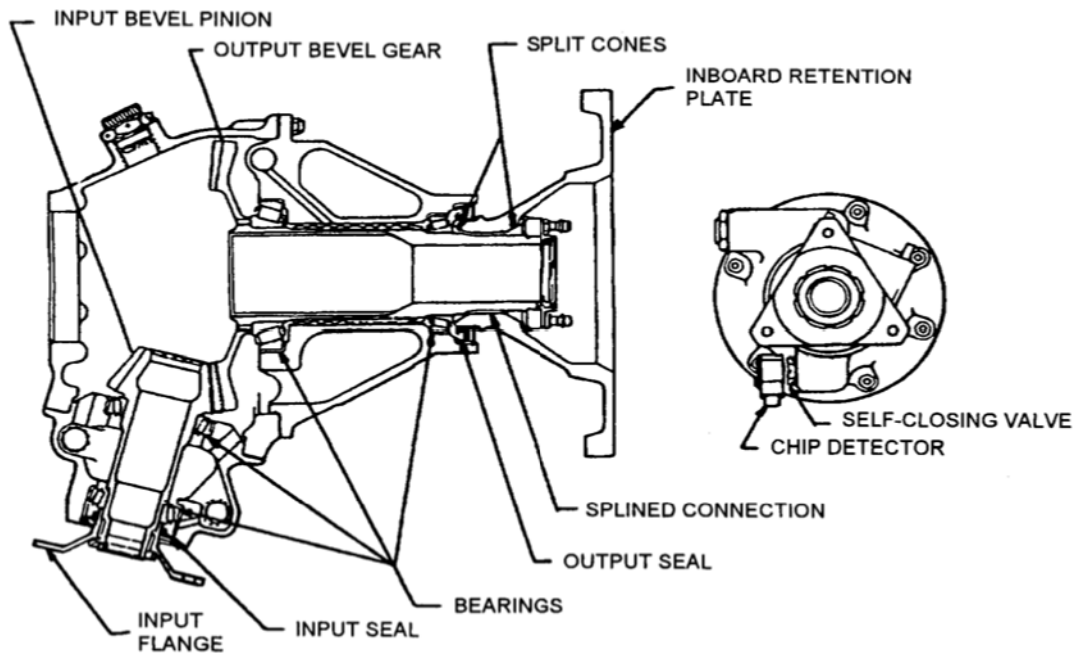
Figure A-6. Tail Rotor Gearbox Nomenclature

VH-60N (Cont.)
TAIL GEARBOX
