JOINT OIL ANALYSIS PROGRAM MANUAL

VOLUME III

LABORATORY ANALYTICAL METHODOLOGY AND EQUIPMENT CRITERIA (AERONAUTICAL)

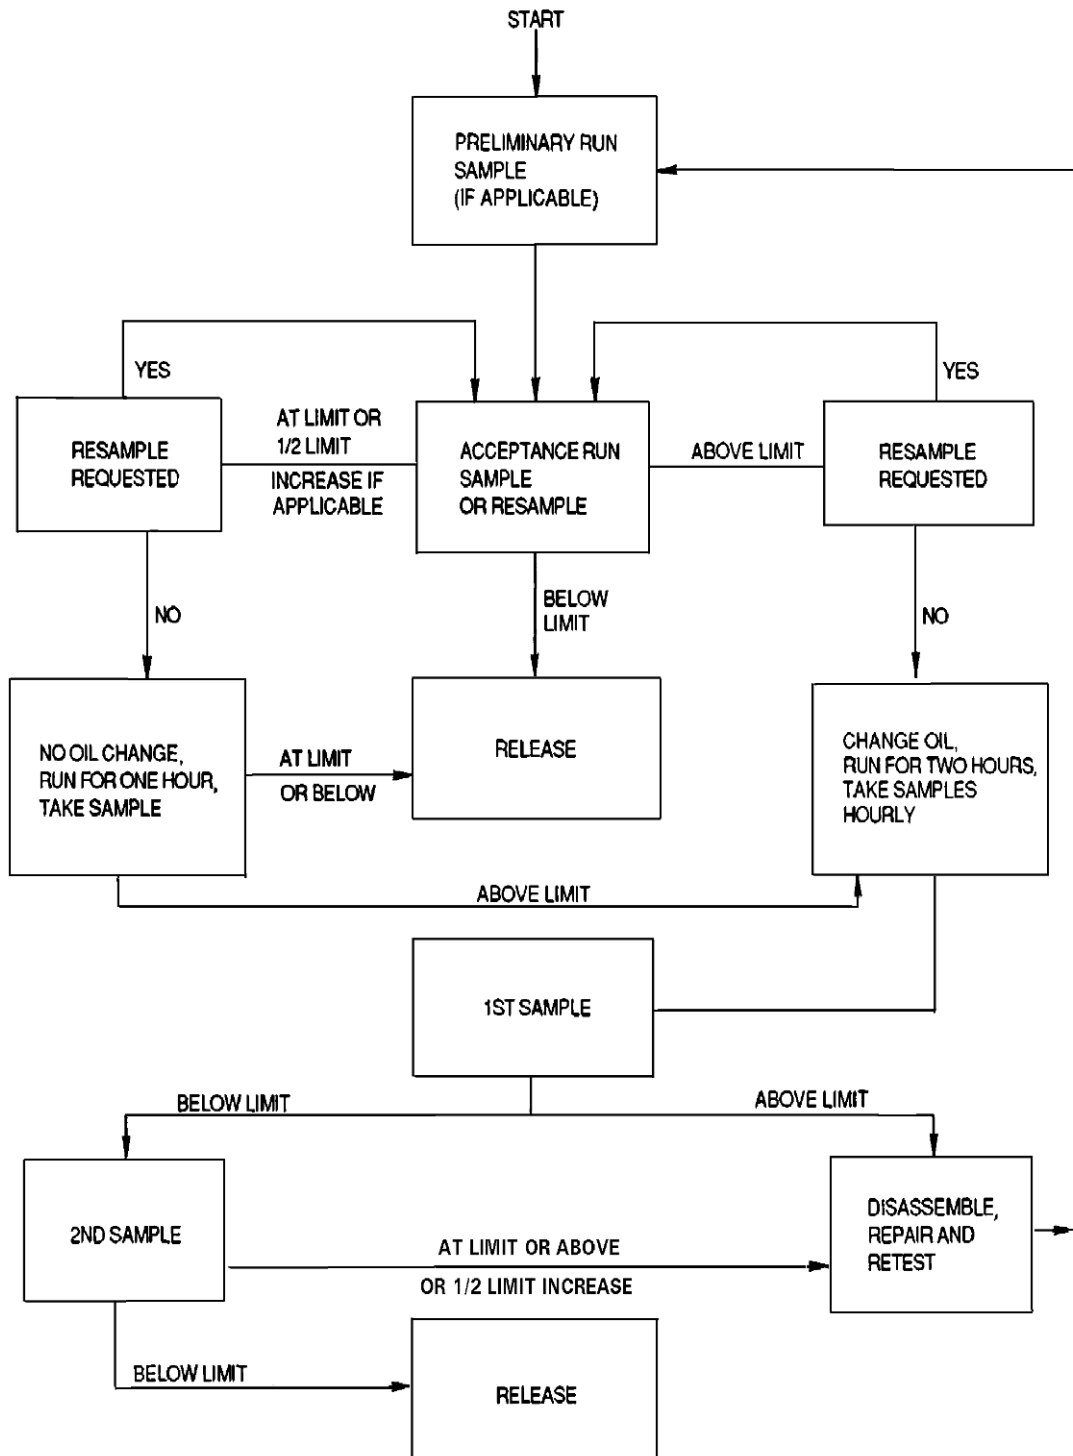
TABLE 2-4. AIR FORCE ALC DEPOT DECISION LOGIC

*DO NOT CHANGE OIL FOR T56 OR G56 AT ALC UNLESS REQUIRED

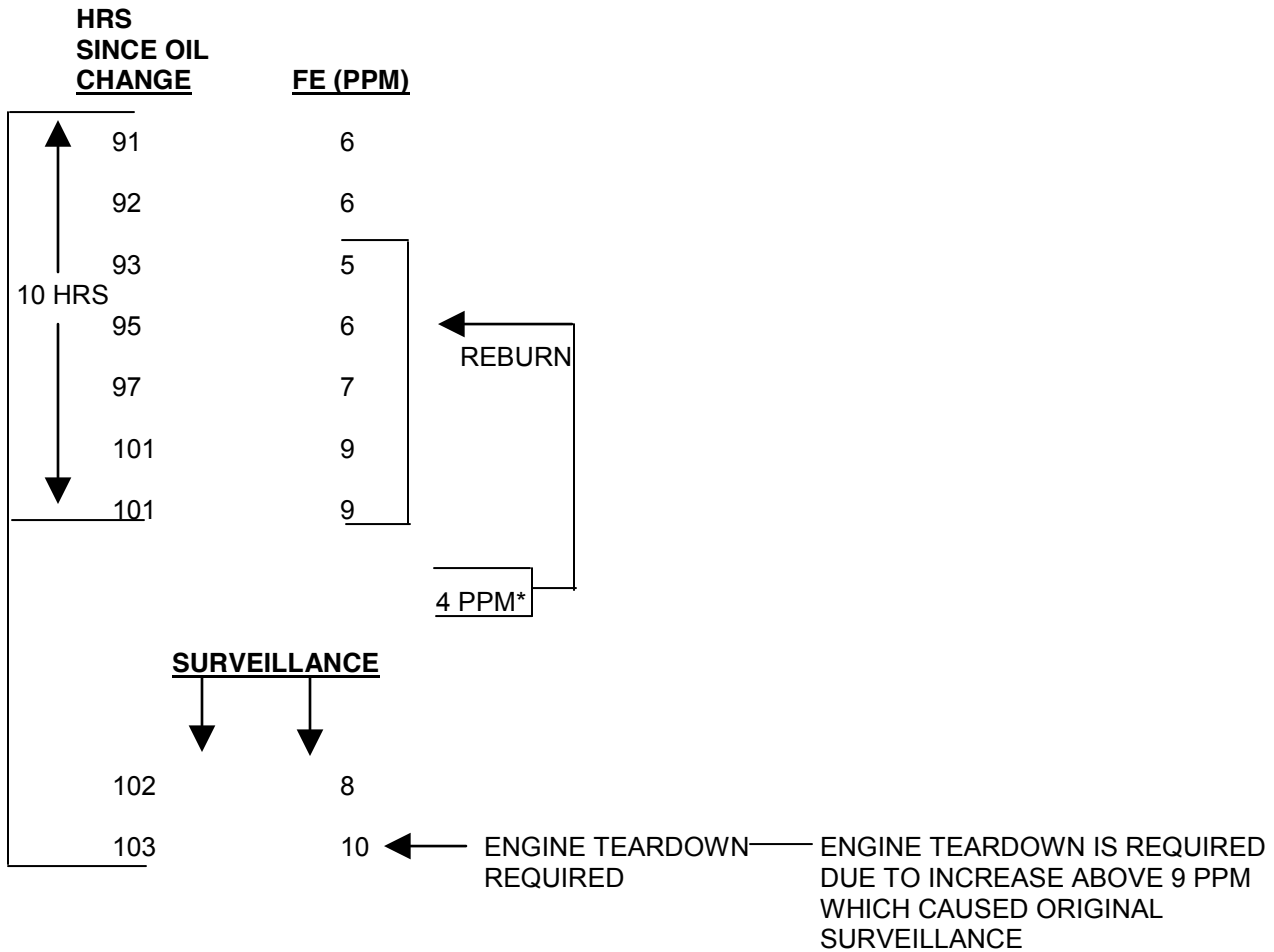
EXAMPLE: PRIOR TO SURVEILLANCE
 (FOR FE INCREASE IN 10 ENGINE HOURS)

JOAP RECORD ACTION REQUIRED REASON

* 4 PPM or greater using JOAP Atomic Emission.

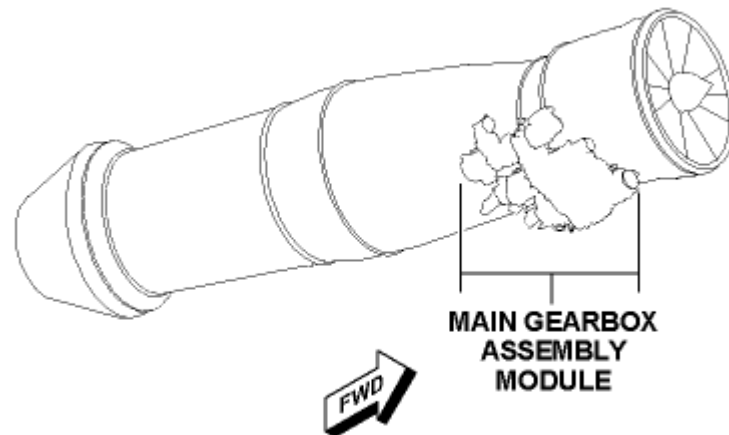
G-P7310180000-P002-001-1

Figure 1. Main Gearbox Assembly Module General Locator

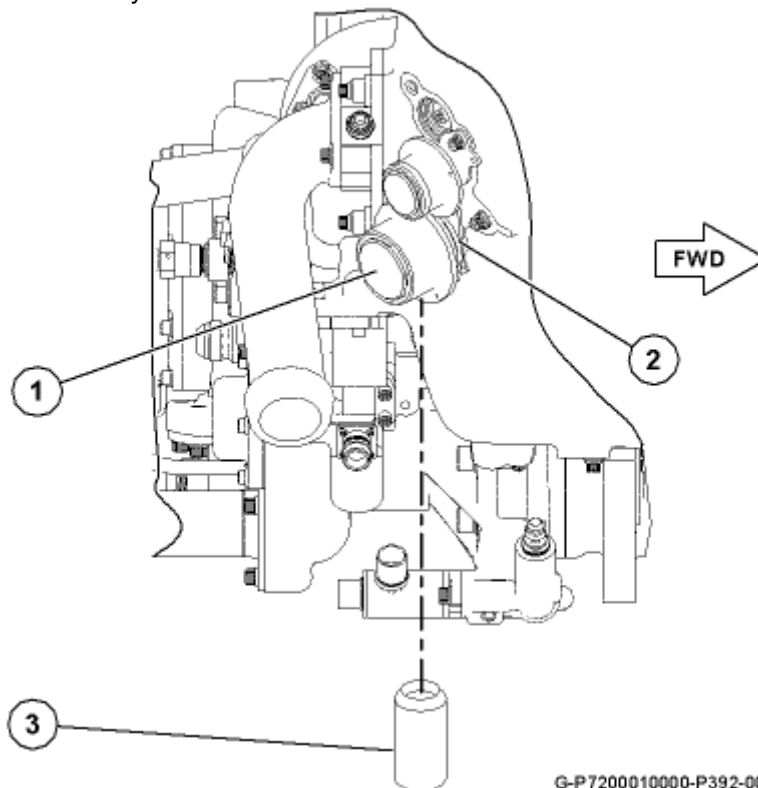
G-P7200010000-P392-001-1

Figure 2. Oil Overflow / Sample Port.

1. Remove quick disconnect cap (1, Figure 2) from overflow/oil sample port (2).

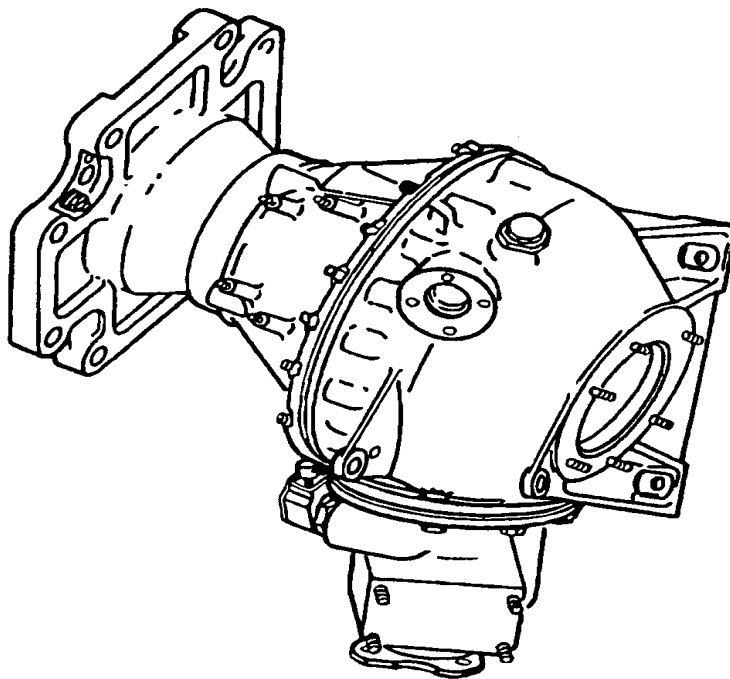
Figure A-4. Tail Rotor Gearbox

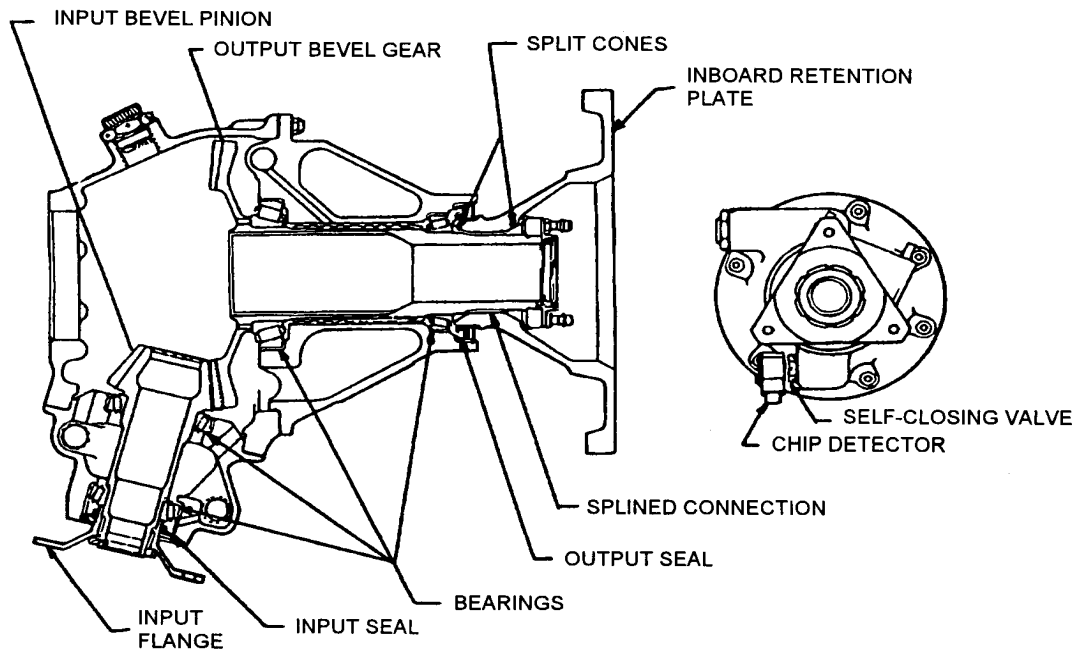
Figure A-5. Tail Rotor Gearbox Nomenclature

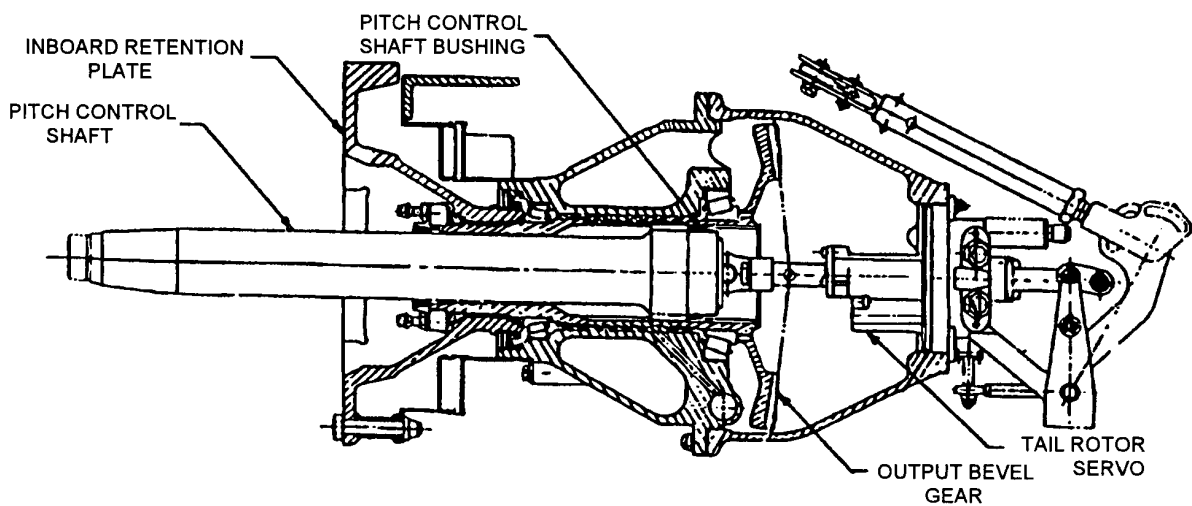
Figure A-6. Tail Rotor Gearbox, Tail Rotor Servo, & Pitch Control Shaft Assembly

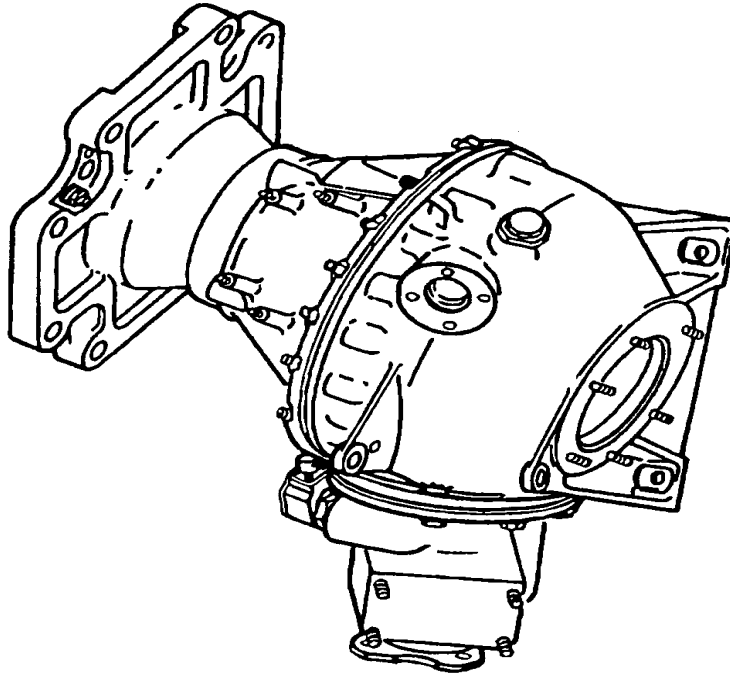
Figure A-7. Tail Rotor Gearbox

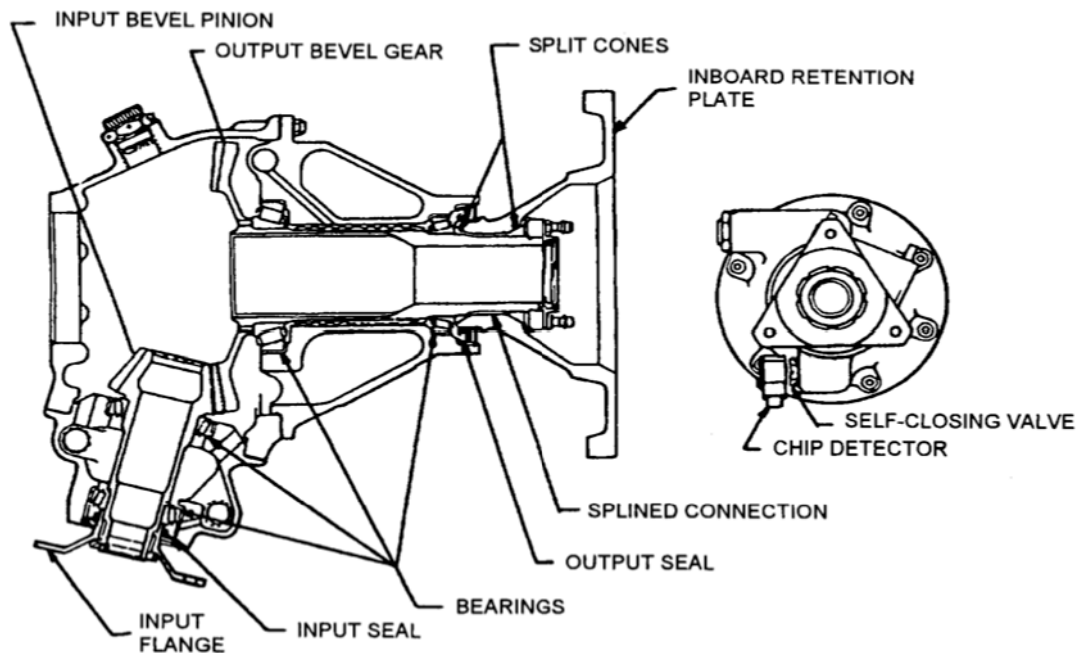
Figure A-8. Tail Rotor Gearbox Nomenclature

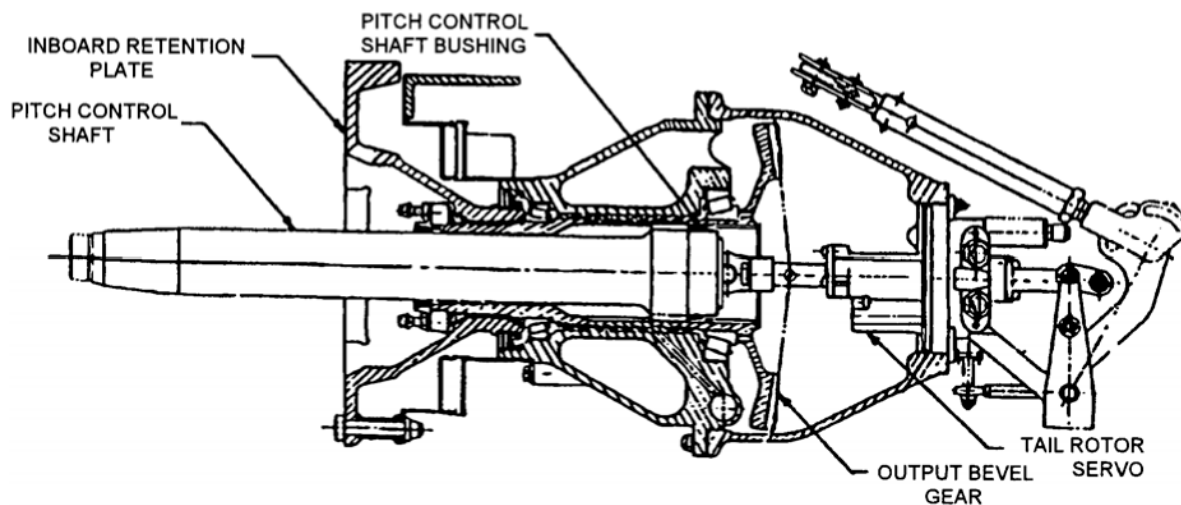
Figure A-9. Tail Rotor Gearbox, Tail Rotor Servo, & Pitch Control Shaft Assembly
