JOINT OIL ANALYSIS PROGRAM MANUAL

VOLUME III

LABORATORY ANALYTICAL METHODOLOGY AND EQUIPMENT CRITERIA (AERONAUTICAL)

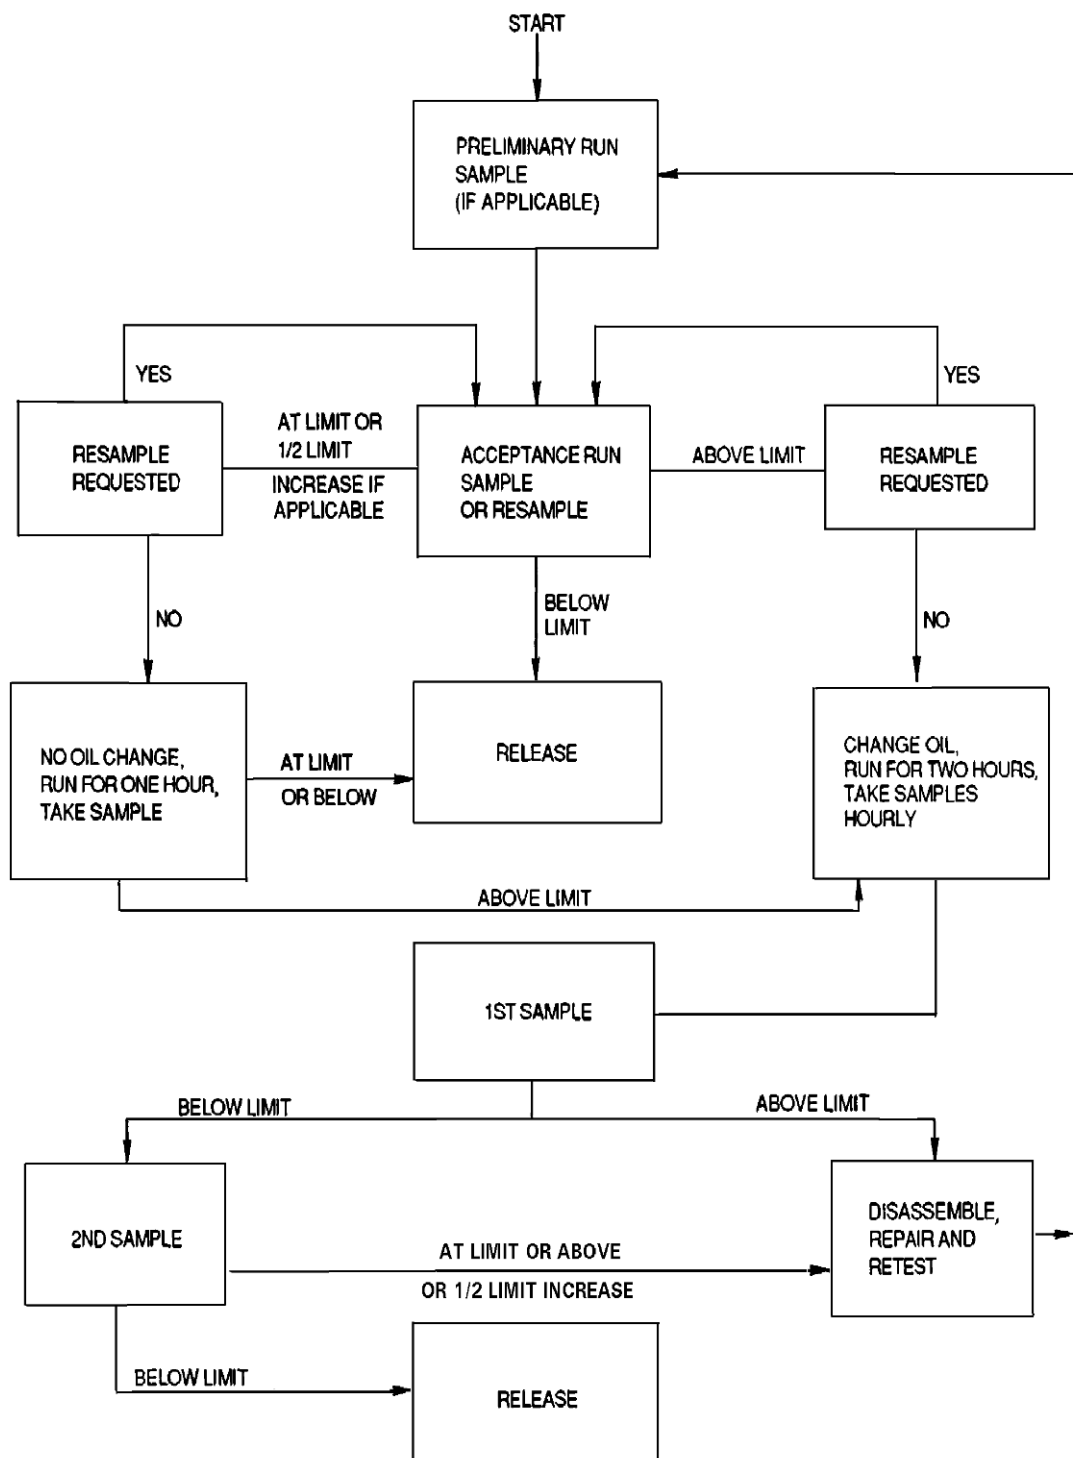
TABLE 2-4. AIR FORCE ALC DEPOT DECISION LOGIC

*DO NOT CHANGE OIL FOR T56 OR G56 AT ALC UNLESS REQUIRED

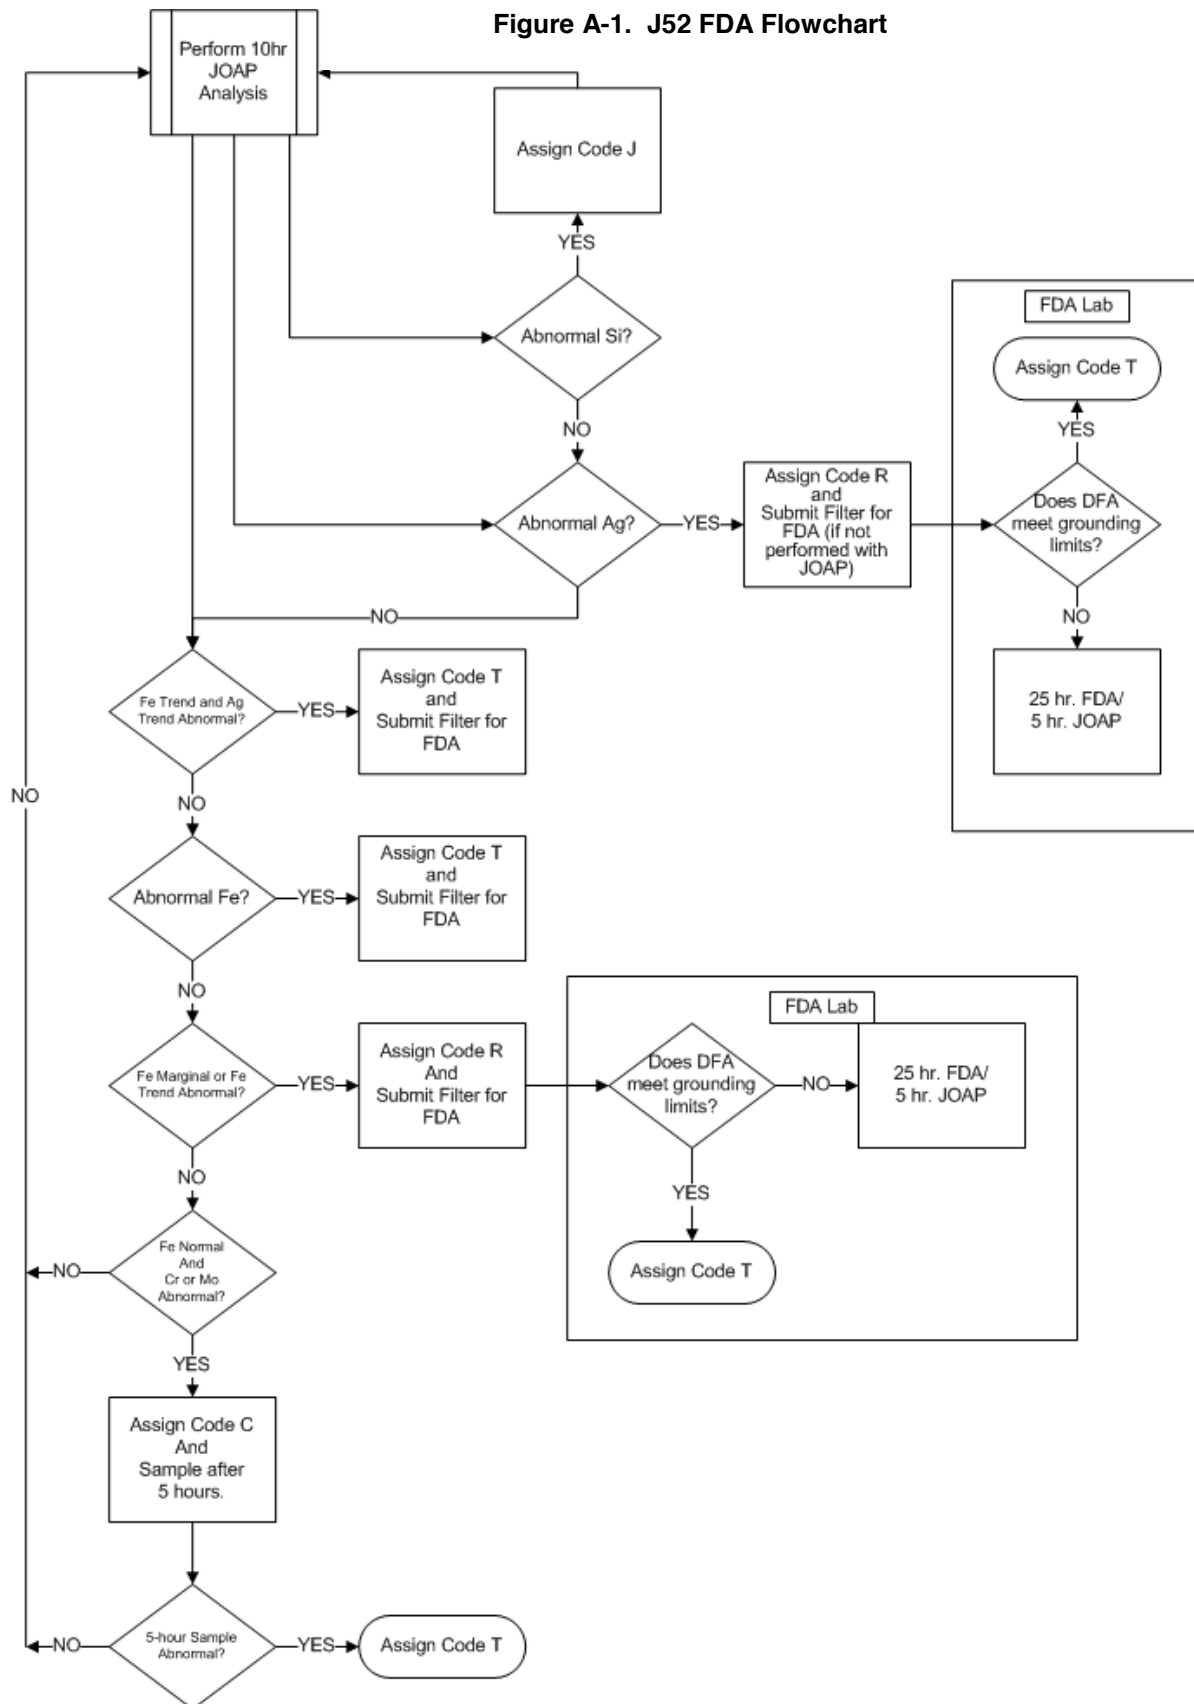
Figure A-1. J52 FDA Flowchart

1. If the Fe trend is at or exceeds the abnormal trend limit, AND if ANY ONE of the following elements: Ag, Cr or Mo is at or exceeds the abnormal trend limit issue advice code T, do not fly or operate, recommend engine removal..

2. If the Fe trend and the Ag trend is at or exceeds the abnormal trend limit, issue advice code T, do not fly or operate, recommend engine removal.
3. If the Fe is in the high range or the trend for Fe meets or exceeds the table limit, recommendation shall be code R, do not fly or operate, inspect filter using FDA. If the FDA inspection meets grounding criteria, assign code T, do not fly or operate, recommend engine removal. If the FDA inspection does not meet grounding criteria, place filter on a 25 hour cycle, place JOAP oil sampling on a 5 hour interval until results return to normal.

4. If Cr and/or Mo are abnormal and the Fe is in the normal range, recommend code C, resample after 5 hours, do not change oil. If the resample is abnormal, assign code T, do not fly or operate, recommend engine removal.

5. If Ag is abnormal, recommend code R, do not fly or operate, inspect filter using FDA. If the FDA inspection meets grounding criteria, assign code T, do not fly or operate, recommend engine removal. If the FDA inspection does not meet grounding criteria, place filter on a 25 hour cycle, place JOAP oil sampling on a 5 hour interval until results return to normal.

6. IF Si is abnormal, recommend code J, contamination confirmed, change oil, resample with normal sampling schedule.

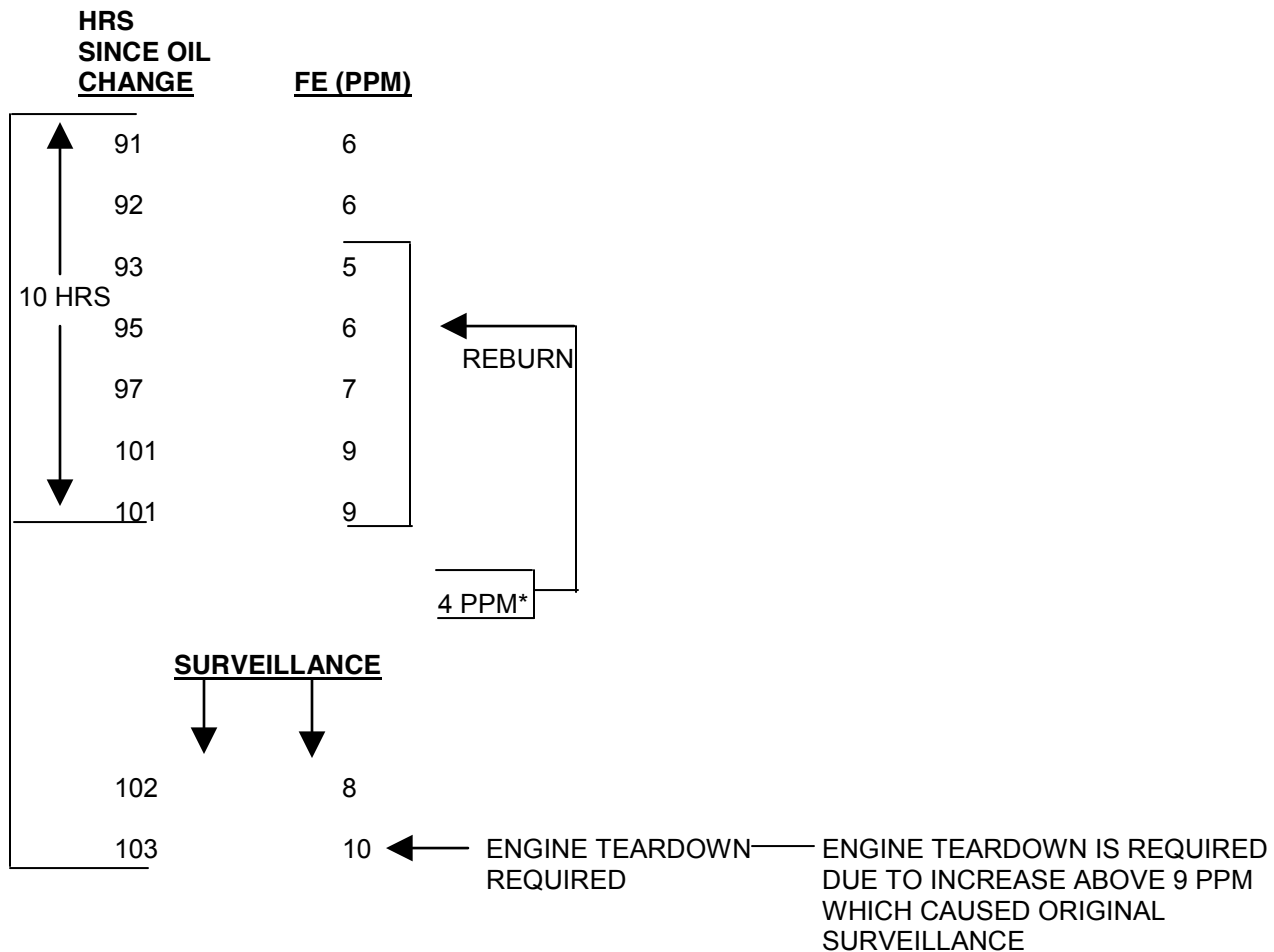
EXAMPLE: PRIOR TO SURVEILLANCE
 (FOR FE INCREASE IN 10 ENGINE HOURS)

JOAP RECORD ACTION REQUIRED REASON

* 4 PPM or greater using JOAP Atomic Emission.

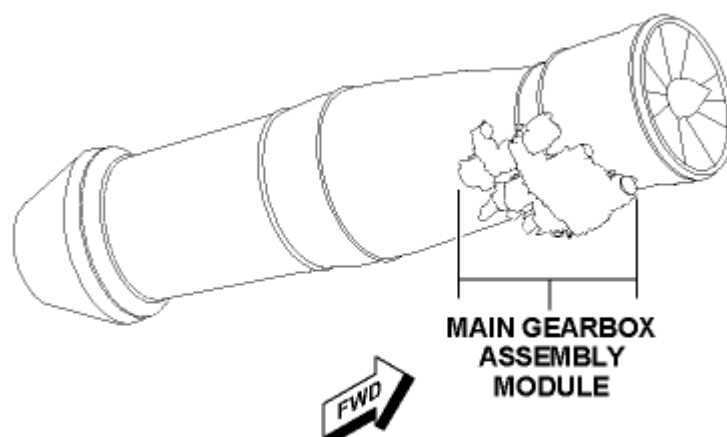
Figure 1. Main Gearbox Assembly Module General Locator

ENGINE: F135-PW-100 / 400 (Cont.)
AIRCRAFT: F-35 (F35A CTOL, F35C CV)

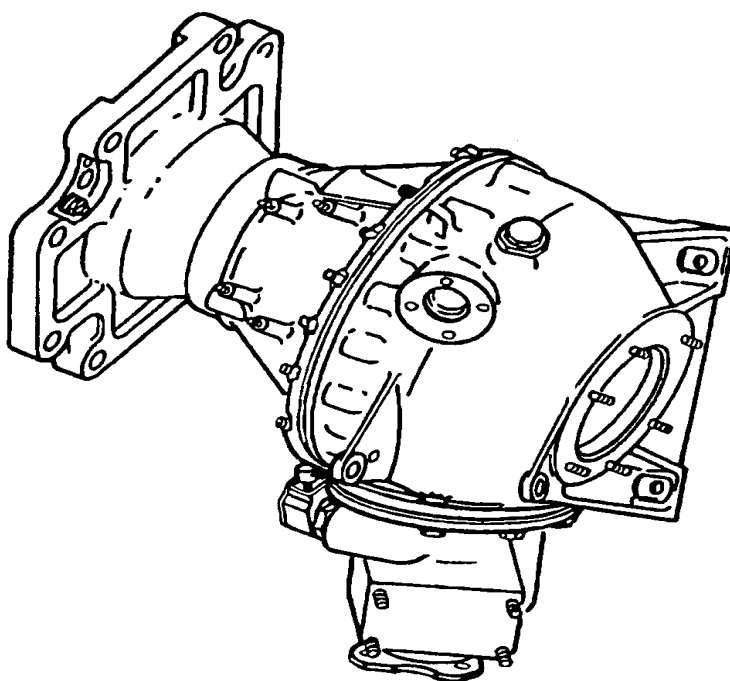
Figure A-4. Tail Rotor Gearbox

UH-60A, UH-60L, UH-60M, EH-60A, (Cont.)
EH-60L, HH-60A, HH-60L, MH-60K,
MH-60L, MH-60M, BLACK HAWK (ARMY)
TAIL ROTOR GEARBOX

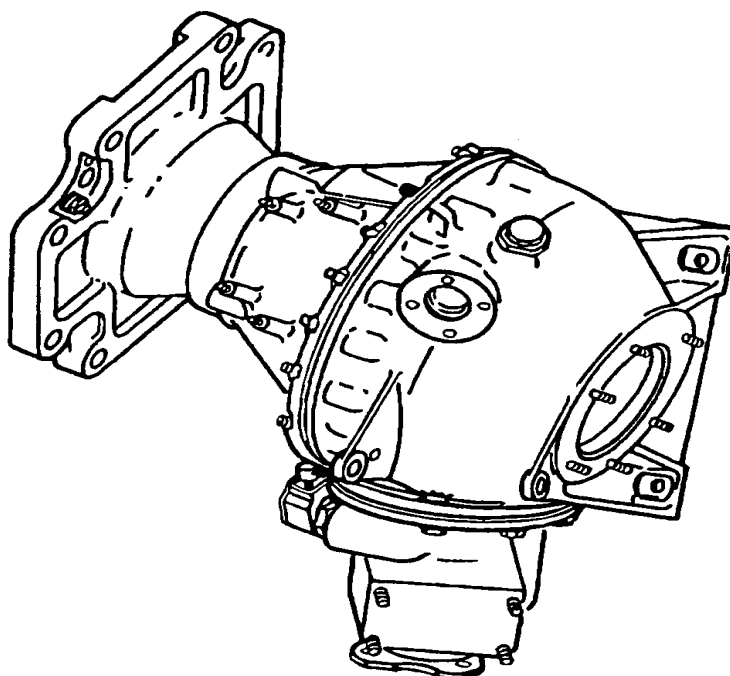
Figure A-7. Tail Rotor Gearbox

VH-60N (Cont.)
TAIL GEARBOX
