(NAVY) NAVAIR 17-15-50.3
(ARMY) TM 38-301-3
(AIR FORCE) T.O. 33-1-37-3
(COAST GUARD) TO 33-1-37-3

JOINT OIL ANALYSIS PROGRAM MANUAL

VOLUME III

LABORATORY ANALYTICAL METHODOLOGY AND EQUIPMENT CRITERIA (AERONAUTICAL)

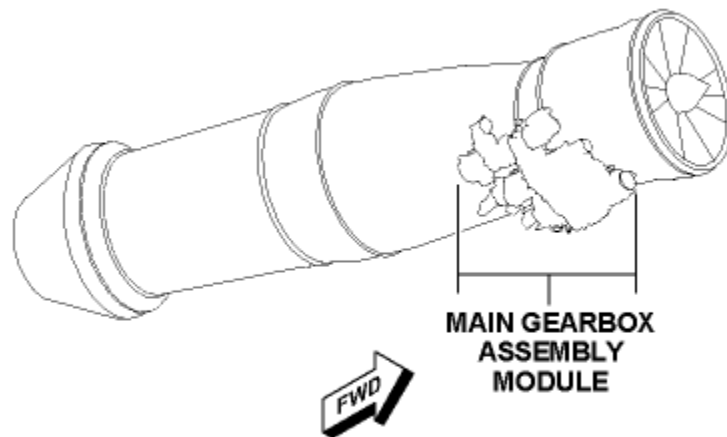
G-P7310180000-P002-001-1

Figure 1. Main Gearbox Assembly Module General Locator

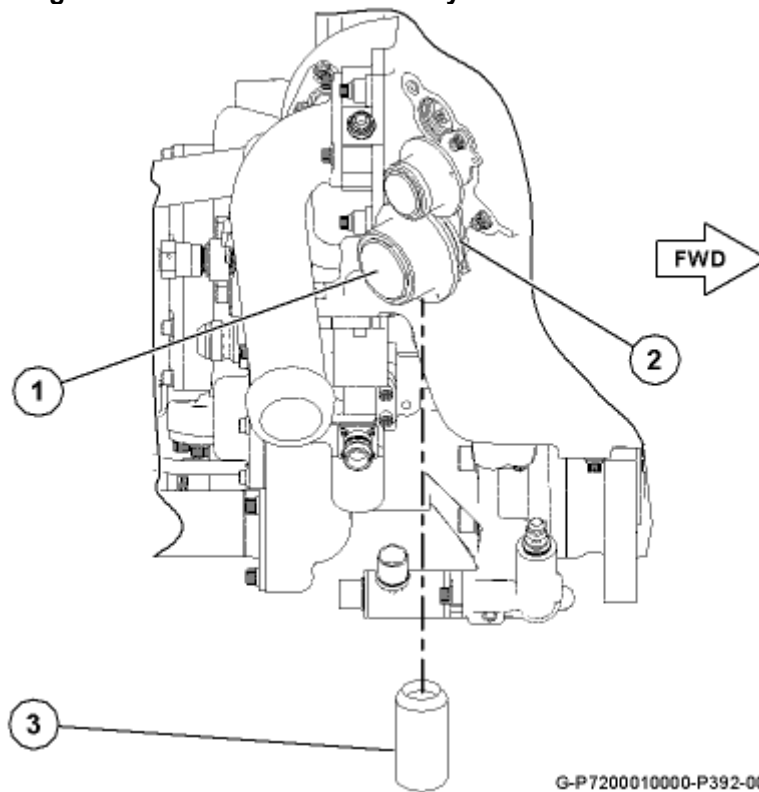
G-P7200010000-P392-001-1

Figure 2. Oil Overflow / Sample Port

1. Remove quick disconnect cap (item 1, Figure 2) from overflow/oil sample port (2).

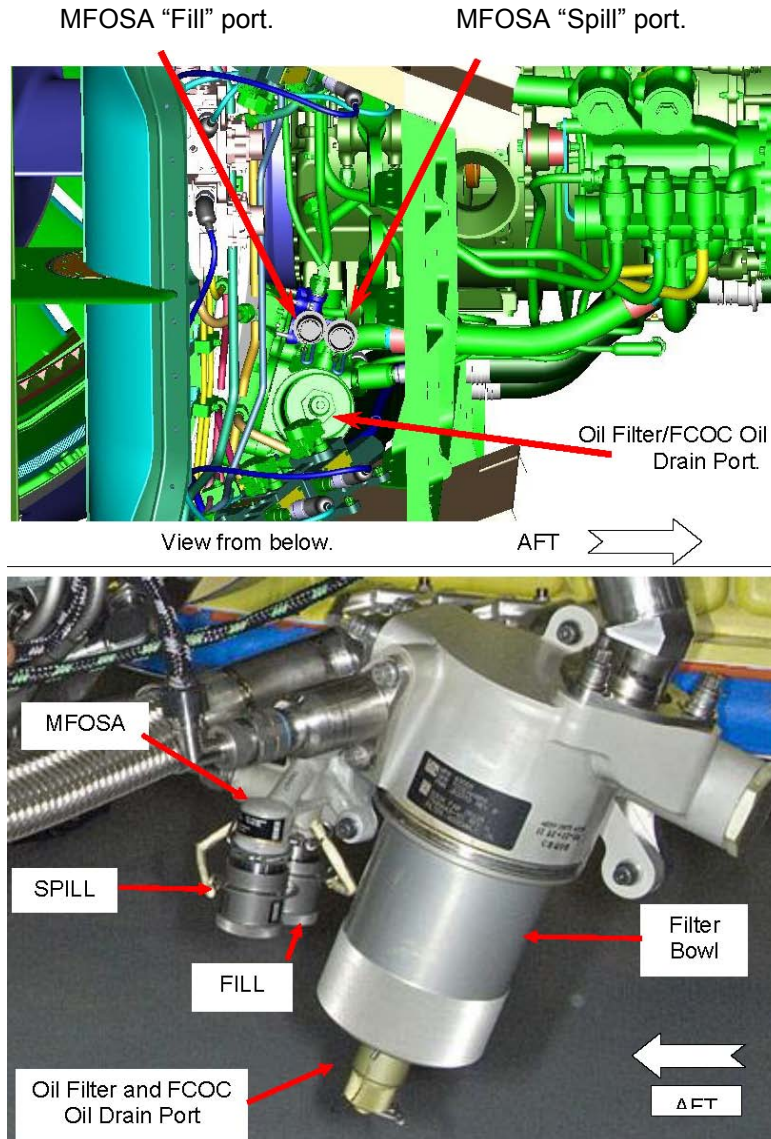
Figure 1. F-35B LiftSystem Servicing Point, General Views

- 1) Place suitable container / drip tray under work area to catch any waste oil.
- 2) Remove the Spill coupling protective cap located on the left side of the Multi Function Oil Servicing Adaptor (MFOSA). Refer to Figure 1.
- 3) Use an absorbent cloth and wipe off MFOSA and Oil Spill Drain Hose/Collector couplings, before connection, to prevent any contamination.
- 4) Remove the Fill coupling protective cap located on the right side of the MFOSA.
- 5) Use an absorbent cloth and wipe off MFOSA and Oil Sample Adaptor Bottle couplings, before connection, to prevent any contamination.

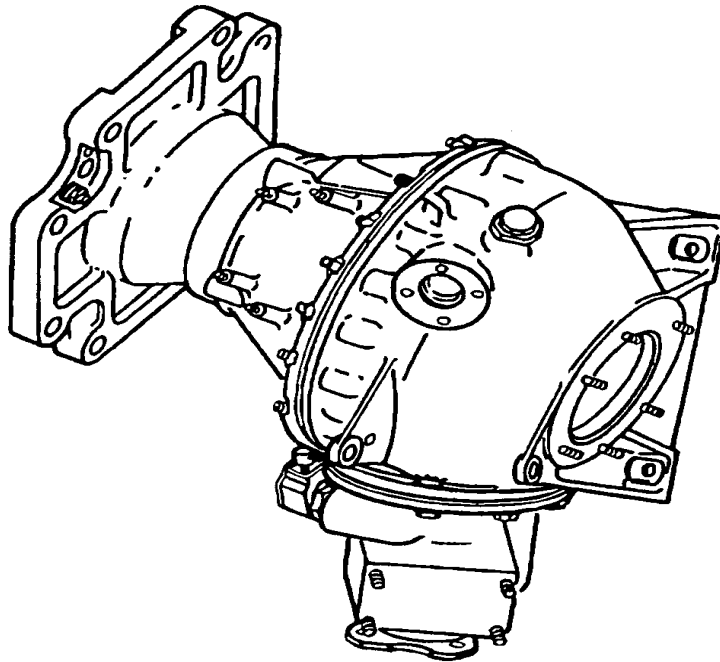
FIGURE 1. Tail Rotor Gearbox

1. The BLACK HAWK tail rotor gearbox changes the speed and angle of drive from the tail drive shaft to the tail rotor blades and pitch control mechanism. See Figure 1. The major components of the tail rotor gearbox include the housings (input, center, and output), the input bevel pinion and the output bevel gear, four (4) tapered roller bearings, an input flange, an inboard retention plate, and input and output seals. See Figure 2 for the location of the major components. The tail rotor gearbox is operated with the tail rotor servo and pitch control shaft installed into the gearbox. See Figure 3.

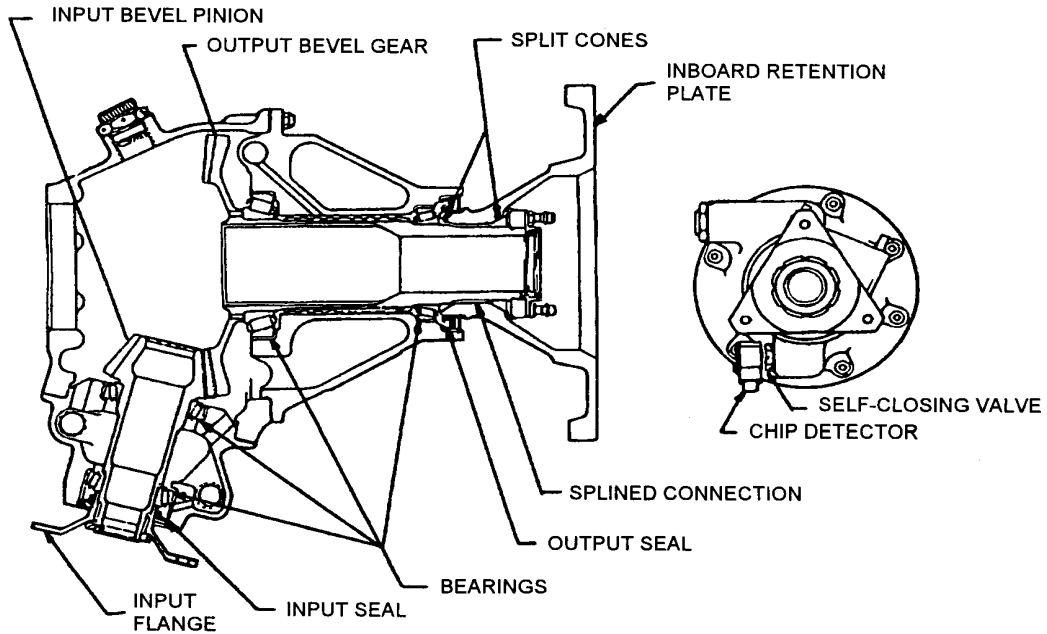
FIGURE 2. Tail Rotor Gearbox Nomenclature

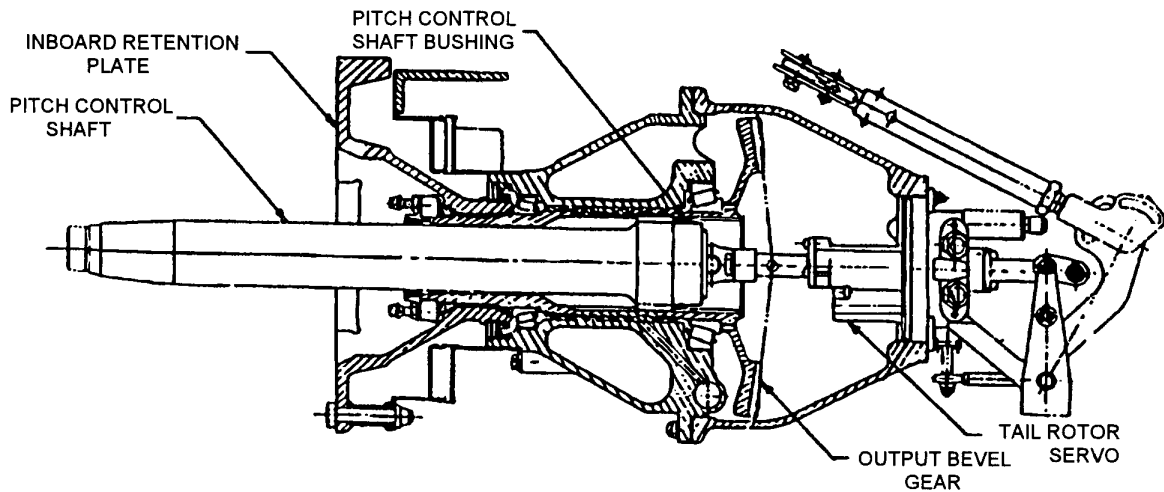
FIGURE 3. Tail Rotor Gearbox, Tail Rotor Servo, & Pitch Control Shaft Assembly

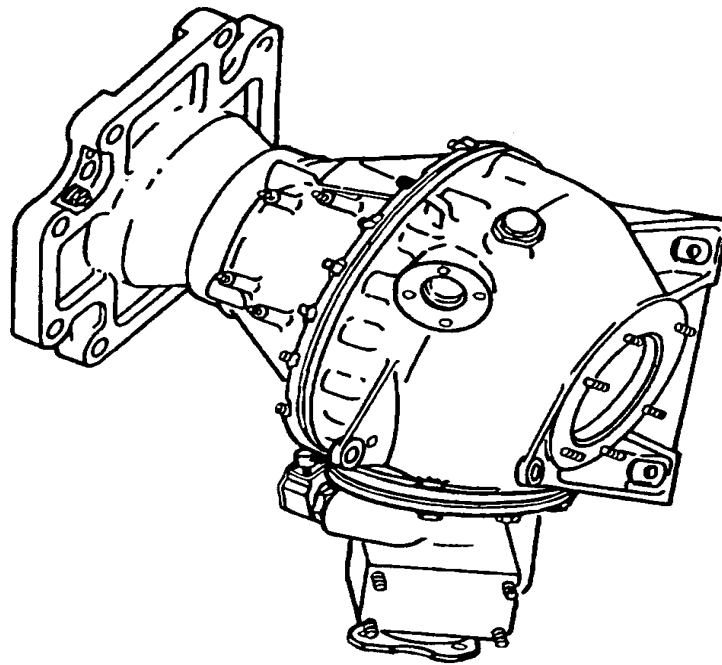
Figure 1. Tail Rotor Gearbox

1. The VH-60N tail rotor gearbox changes the speed and angle of drive from the tail drive shaft to the tail rotor blades and pitch control mechanism. See Figure 1. The major components of the tail rotor gearbox include the housings (input, center, and output), the input bevel pinion and the output bevel gear, four (4) tapered roller bearings, an input flange, an inboard retention plate, and input and output seals. See Figure 2 for the location of the major components. The tail rotor gearbox is operated with the tail rotor servo and pitch control shaft installed into the gearbox. See Figure 3.

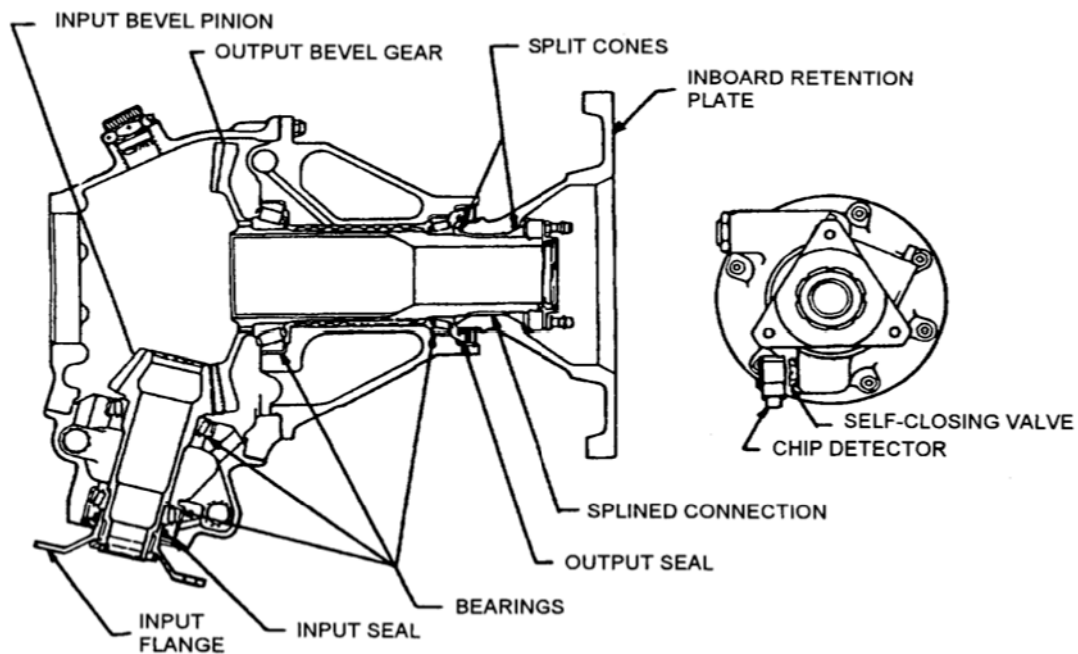
Figure 2. Tail Rotor Gearbox Nomenclature

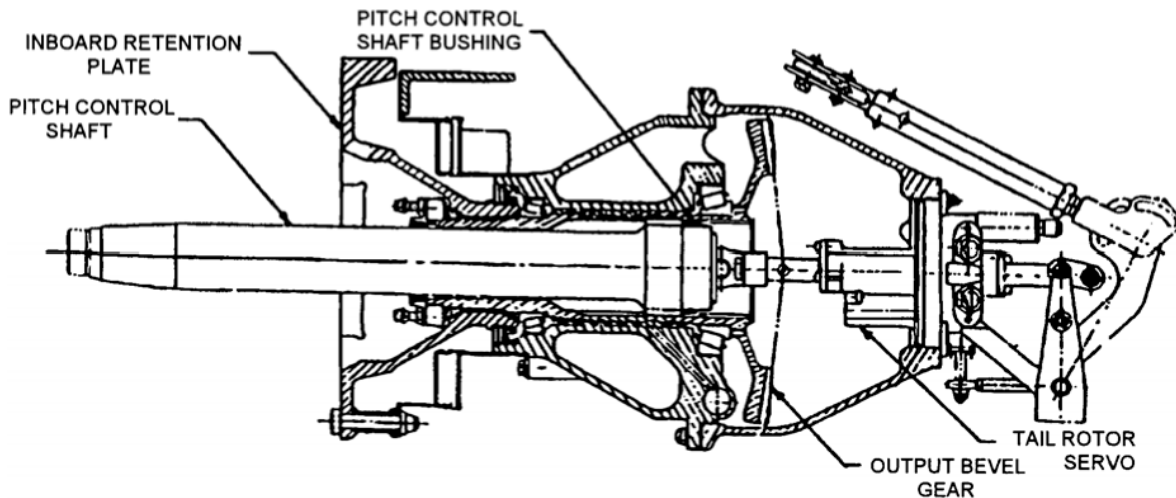
Figure 3. Tail Rotor Gearbox, Tail Rotor Servo, & Pitch Control Shaft Assembly
