T9630-AB-MMD-010

TECHNICAL MANUAL
FOR
CORROSION CONTROL ASSESSMENT
AND MAINTENANCE MANUAL
(CCAMM)

PUBLISHED BY DIRECTION OF COMMANDER, NAVAL SEA SYSTEMS COMMAND

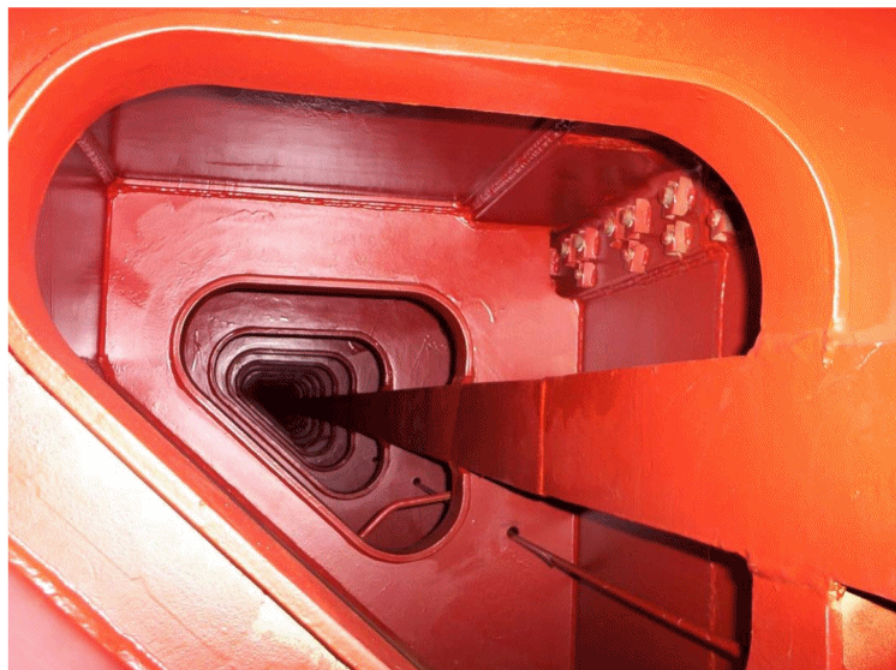
Figure 1-3 Aircraft Carrier Catapult Wing Void

1-5.3.3.4 Voids (Catapult Wing). These voids are only found on aircraft carriers. Catapult wing voids are compartments outboard of the catapult trough walls on each side of the trough. Each void consists of the knuckled down flight deck, the vertical longitudinal trough girder, and a cover plate. These voids provide access to the upper and lower support bar mounting fixtures. Triangular web frames are provided every four (4) feet between the vertical longitudinal trough girder and the inclined (knuckled) flight deck to provide structural support for the catapult trough walls. An example of an aircraft carrier catapult wing void is shown in [Figure 1-3](#).

Examples of reinforcing rings and coamings can be seen in [Figure 1-3](#) and [Figure 1-9](#).

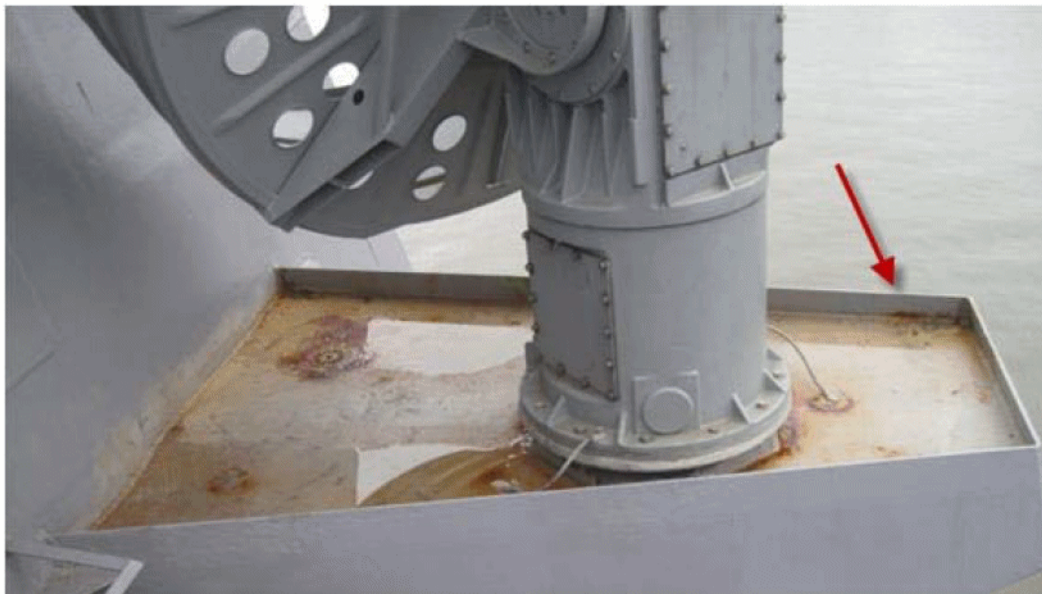
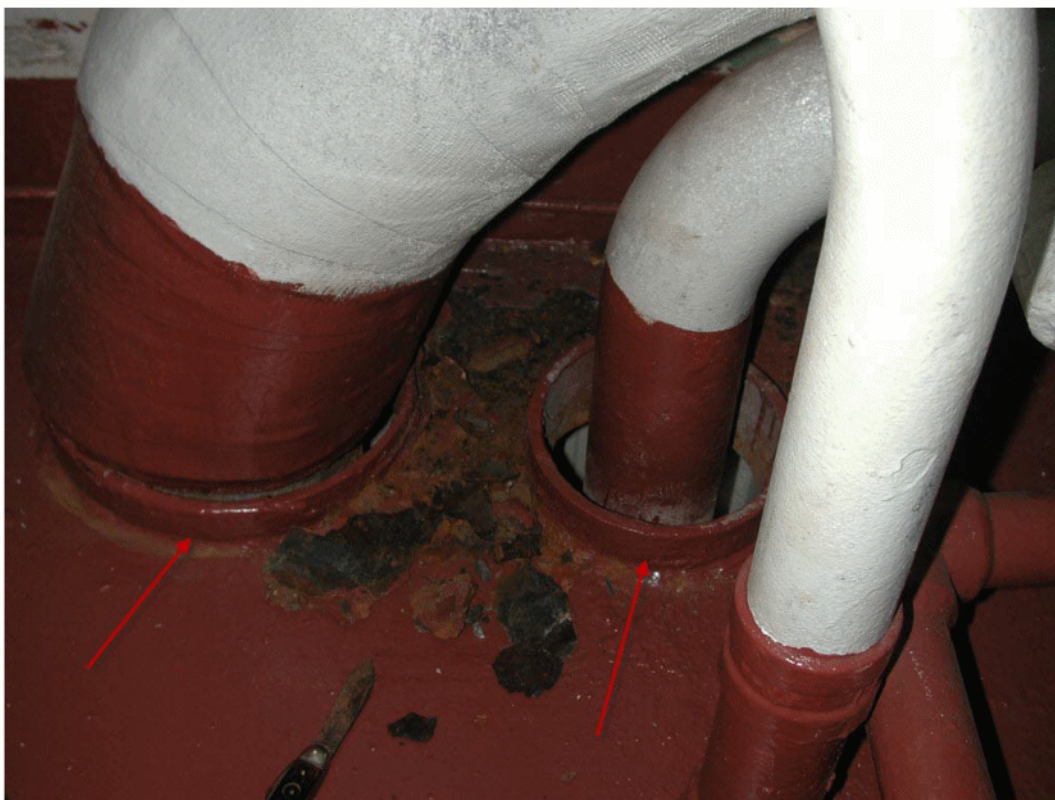
A. Coaming (Waterway Bar) Around Exterior Antenna Platform

B. Non-Tight Reinforcing Ring at Deck Piping Penetration

Figure 1-9 Examples of Reinforcing Rings and Coamings (Sheet 1 of 2)

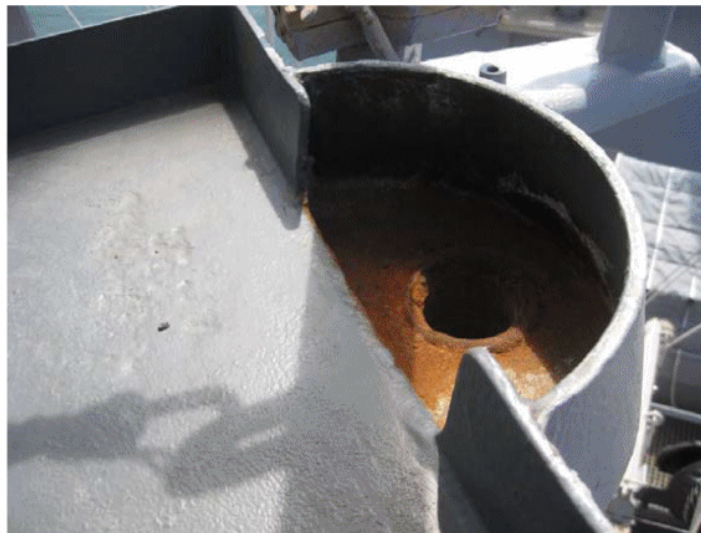
C. Coamings Around Equipment

D. Coaming (Waterway Bar) At Deck Edge

Figure 1-9 Examples of Reinforcing Rings and Coamings (Sheet 2 of 2)

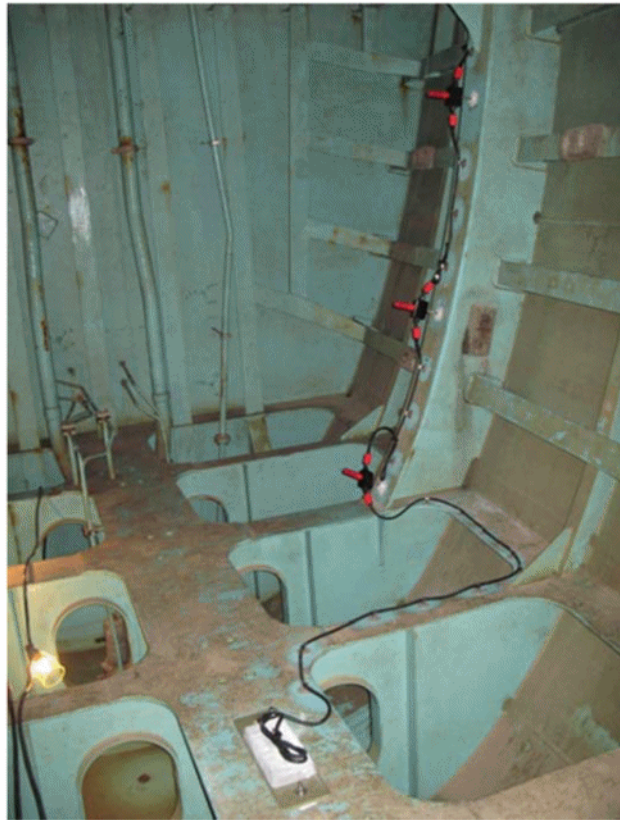
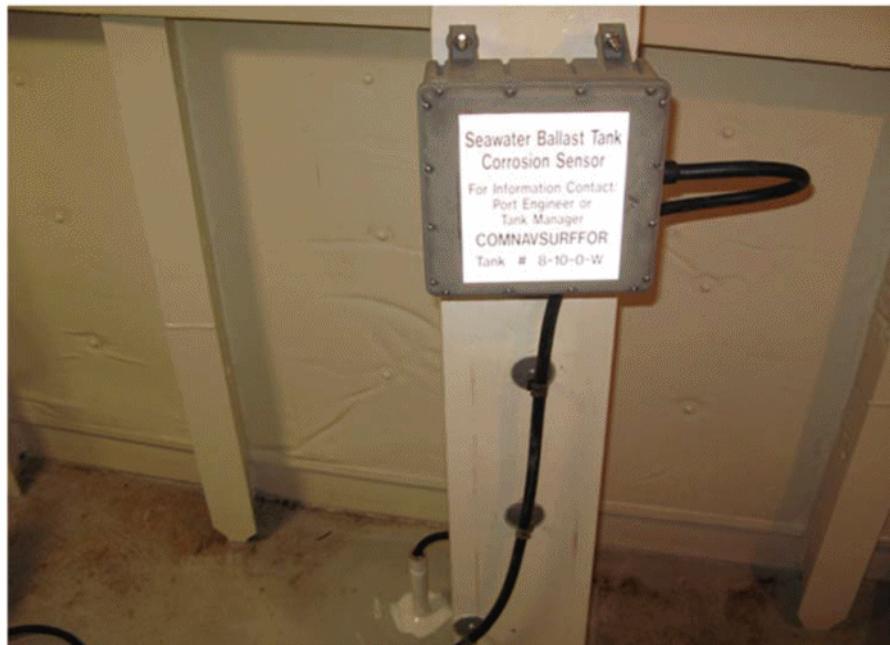
Figure 3-2 Typical TMS Installation In Tank (Top) and Data Logger (Bottom)

The hardware and software required to download and analyze the TMS data has been provided to the applicable maintenance activities for those ships that have TMS installed. The hardware required consists of a stand-alone notebook computer and a cable to interface between the computer and data logger. A TRA software user’s guide is provided to the maintenance activity in conjunction with system training. Training typically consists of one day of classroom and one day of shipboard instruction.

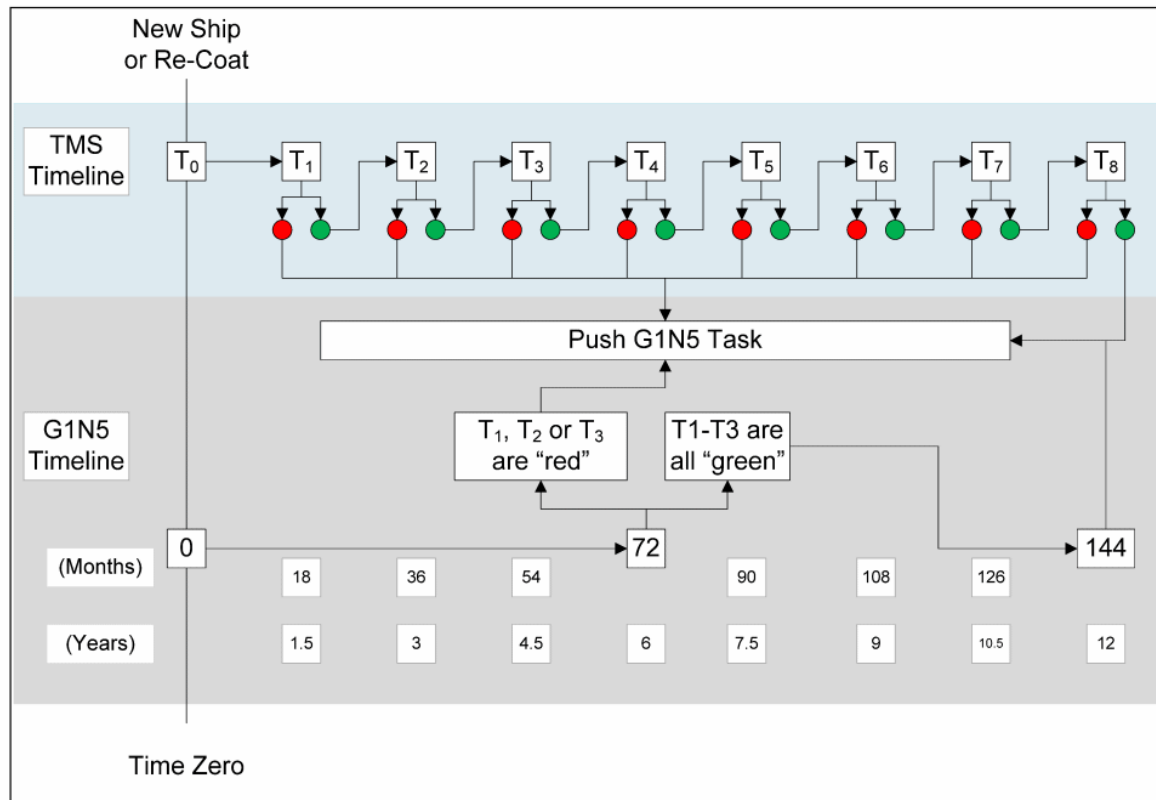
Figure 3-3 TMS Relationship to MRC G1N5 Surveys

3-6.1.1 Tank Monitoring System Usage Requirements. The RMC or other responsible and qualified maintenance activity personnel shall download and analyze data from installed seawater ballast tank TMS's using the TRA every 18 months (± 4 months). Planning Activities shall use CMP "push" tasks to schedule this. The following requirements apply based on the analysis results, as illustrated in Figure 3-3:

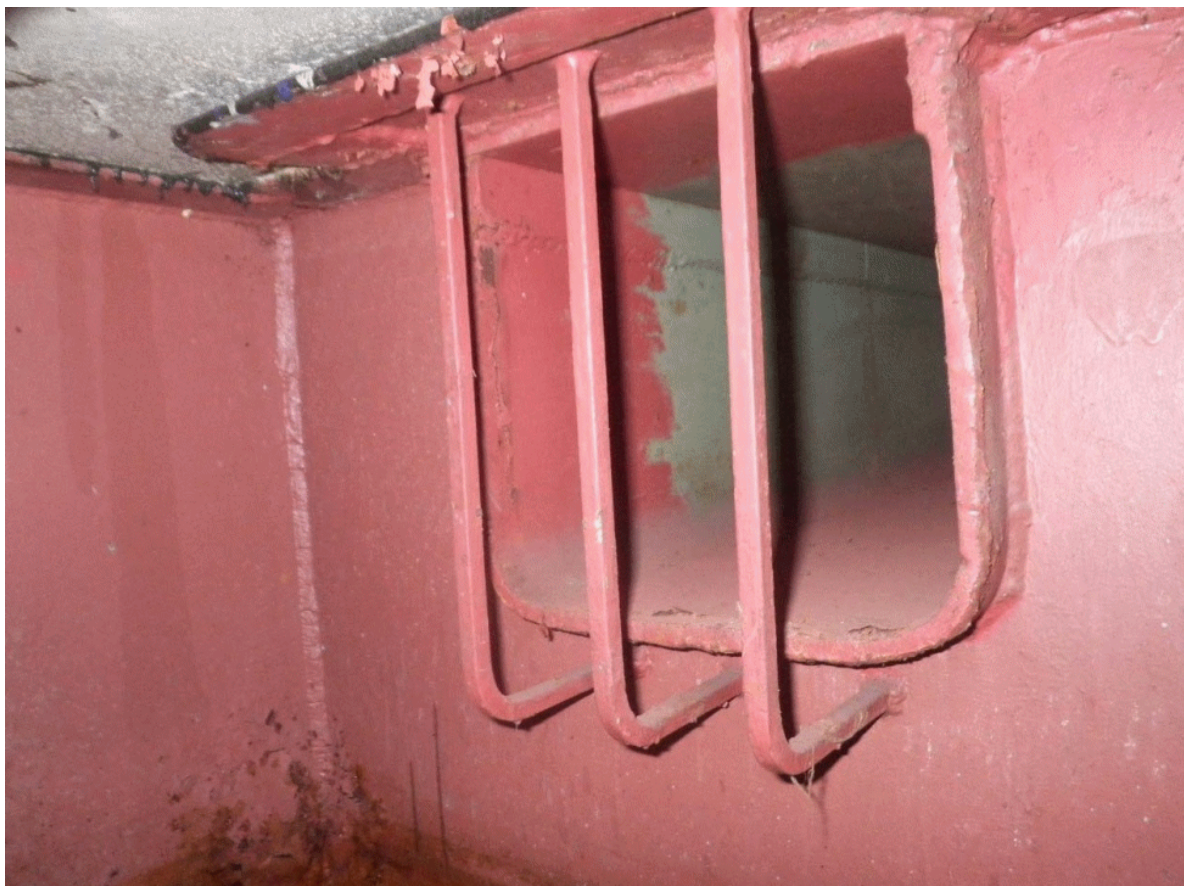
Figure 4-2 Opening to a Cross-Flooding Duct on CG-47 Class Ship

4-1.2.3 Assessment of Surface Combatant Cross-Flooding Ducts (MRC G1N6 Only). Cross-flooding ducts on surface combatants are ducts that are enclosed by ship structure that run athwartship in specific locations to provide for rapid and equalized flooding in order to maintain the stability of the ship in the event of a damage incident that involves flooding. Some of their openings are too small to permit human entry, but they can be viewed remotely from each end using strong lighting. An example is shown in [Figure 4-2](#). Where obvious structural loss or damage is visible via remote observation, but cannot be accessed by the Level 1 surveyor, the surveyor shall

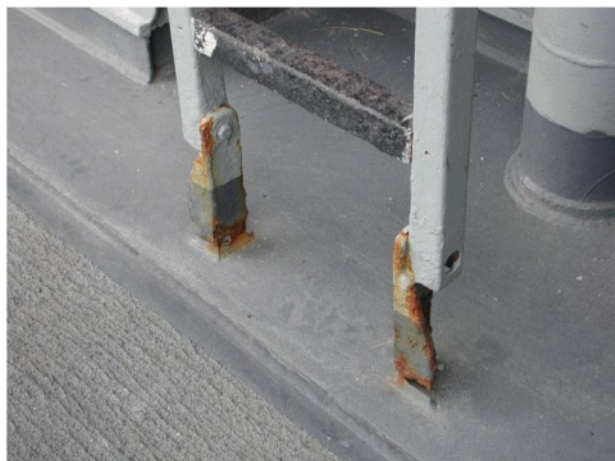
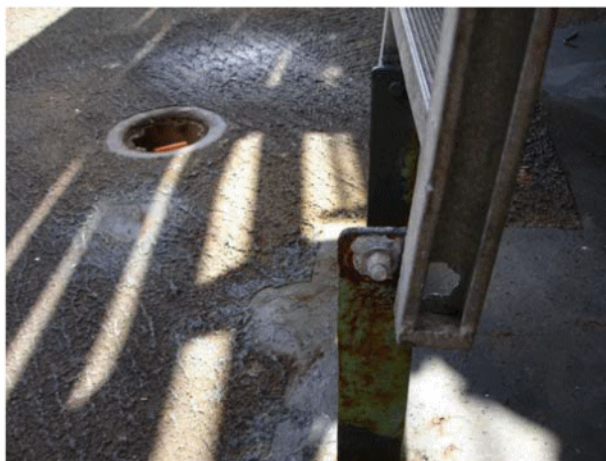
GRP Ladder and Steel Supports

Aluminum Ladder and Steel Supports

Figure 4-3 Reportable Corrosion of Vertical Ladders and Deck Supports

Examine any and all of these types of ladder features and document any recommended repairs. Inspection of ladders in tanks and voids is a mandatory part of the MRC G1N5 Level 1 survey as reflected in the form. Examples of reportable corrosion on ladder structural supports are shown in [Figures 4-3](#) and [4-4](#).

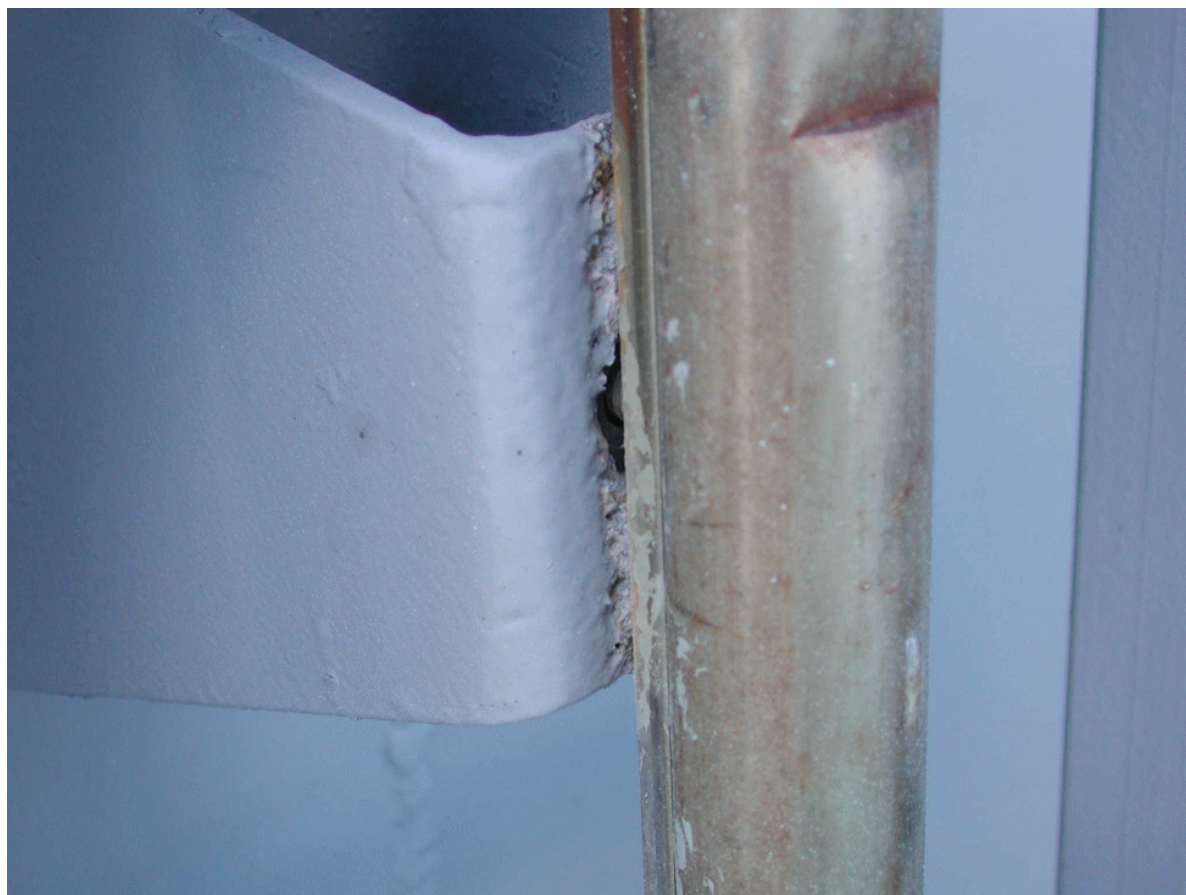
Figure 4-4 Corrosion of Aluminum Support for Stainless Steel Climber Safety Rail

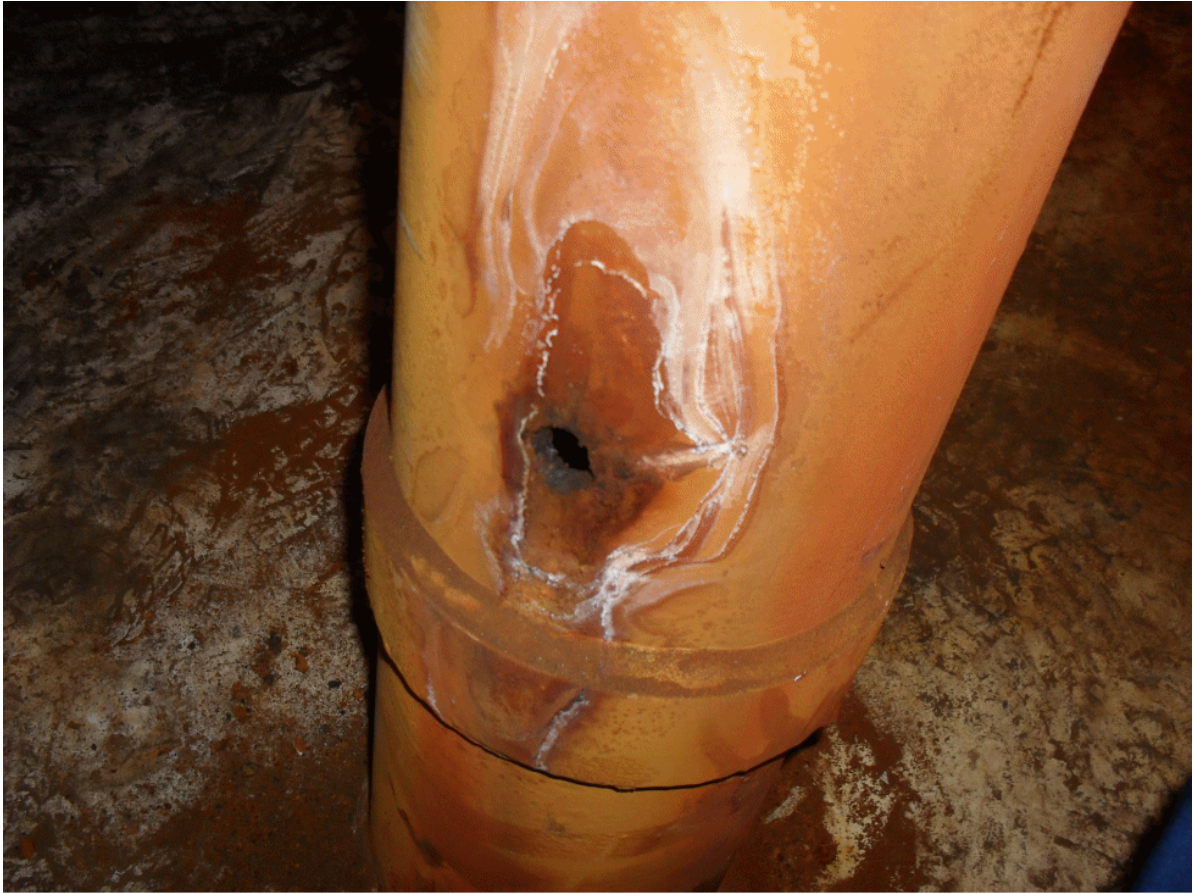
Figure 4-8 Corroded And Holed Degaussing System Conduit In A Tank

examine any installed distributed system and its supports for visually obvious damage, and shall document any damage on a GR2K 2-KILO maintenance action form. Note that degaussing system cable conduit can be confused with fluid system piping, as shown in [Figure 4-8](#). In order to report work items accurately, the surveyor shall determine the correct system of any piping or conduit, or note that they were unable to determine the system. The surveyor should examine any simple flappers on vent or overflow check valves to determine if they swing freely or are damaged; otherwise, the surveyor shall not attempt to operate any valves. Piping or valves that are noted to be leaking or having any other visually obvious damage are to be considered RBC items, and shall be brought to the immediate attention of the local engineering authority for disposition or action before the tank or void is closed.

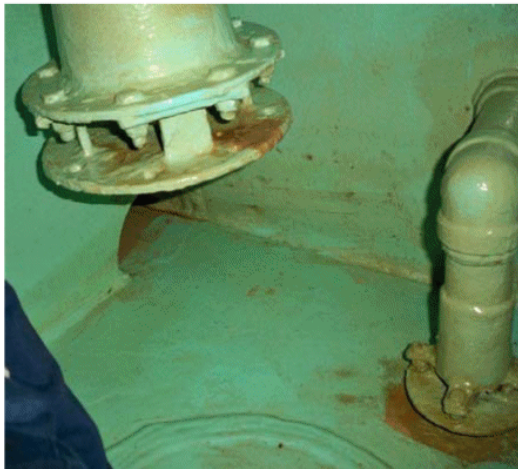
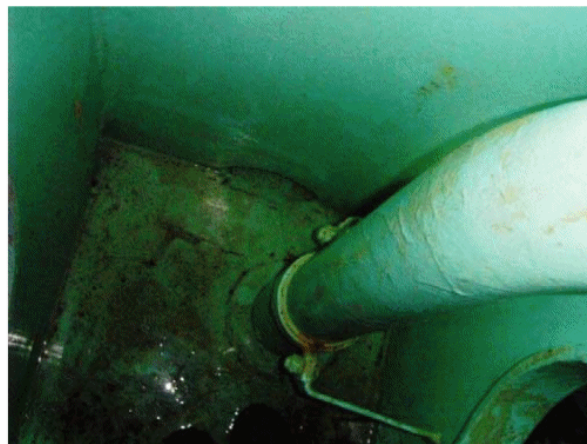
A. Waster Installed On Pipe

B. Waster (Doubler) Installed on Structure

Figure 4-9 Waster Plates Installed Under Fill or Suction Piping Tailpipes

Piping that either discharges into (i.e. fills) or takes suction from a tank may have an associated waster plate, or fluid deflector plate installed below the bellmouth fitting on the end of the piping. In some cases, the waster plate is installed directly to the tank structure below the pipe opening. Piping disciplines and documents may also refer to these terminating sections of the piping as “tailpipes”, and to the waster plates as “doubler plates”. Examples of these two styles of waster plates are shown in [Figure 4-9](#). This waster plate serves to prevent erosion and accelerated corrosion on the tank structure due to swirling and turbulent fluids at these points. This function is similar to that of the striker plate under a sounding tube. These waster plates are designed to be replaced as they wear out. If a waster plate has lost more than 25% of its original thickness through wear or pitting at the time of survey, a GR2K repair 2-KILO shall be written to have it replaced in the next maintenance availability. If the waster plate is estimated to have lost more than 50% of its original thickness, it shall be documented and brought to the attention of the local engineering authority for immediate action, and shall be repaired before closing (RBC) the tank.

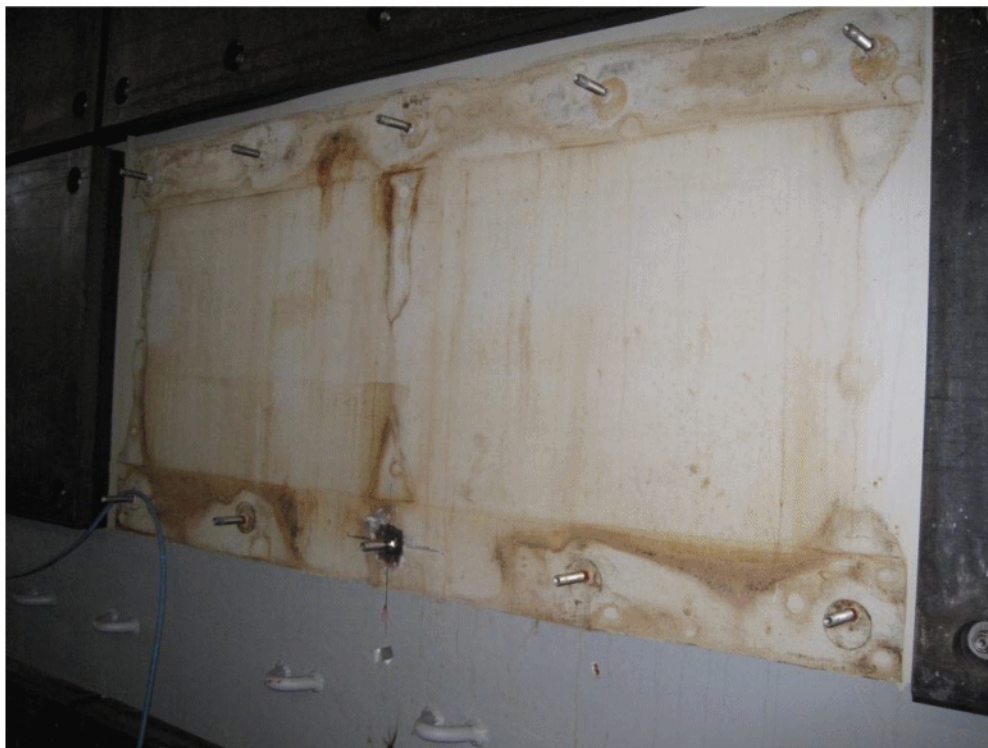
B. Wing Wall Under Batter Board

Figure 4-11 Well Deck Wing Wall And Deck Surface Areas In Way Of Planking

- b. Wing Walls and Decks Under Planking: Wood or composite material planking is installed on amphibious ship well deck wing walls and decks to protect the underlying structure from impact damage that can be caused by vehicles and amphibious craft. The planking installed on the wing walls is sometimes referred to as batter boards. The planking installed on the deck surfaces is sometimes referred to as beach boards. The planking materials and the extent and style of their attachment to the structure will vary with the class of ship. Examples are shown in [Figure 4-11](#). Evaluate the condition of the bulkheads and decks in well deck areas that were made accessible by the removal of selected planking (see [paragraph 4-2.2.5](#)). Evaluate the condition of the securing studs for cracks, corrosion, or mechanical damage. If the survey of the accessible areas indicates that there is evidence of widespread coating failure and corrosion under the planking, then document the condition and

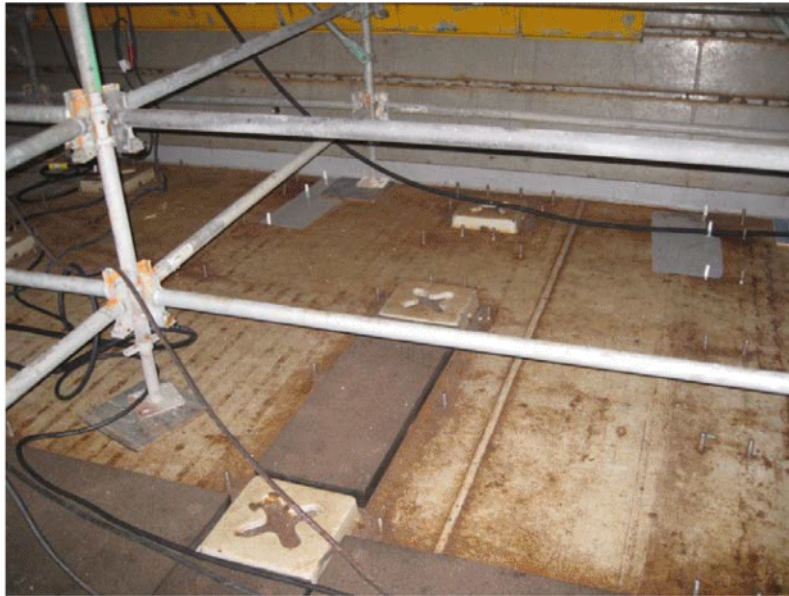
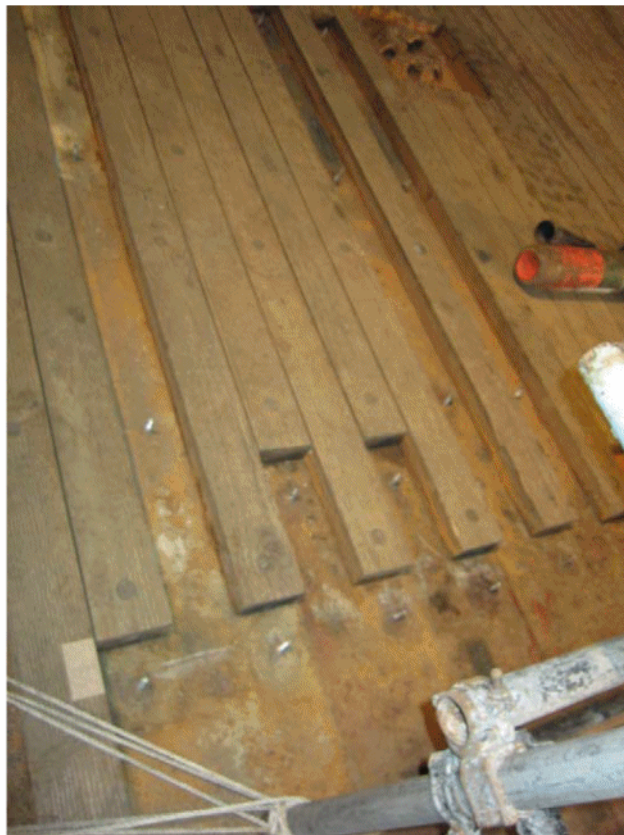
C. Deck Under Composite Material Beach Boards

D. Well Deck Under Wood Beach Boards

Figure 4-11.2 Well Deck Wing Wall And Deck Surface Areas In Way Of Planking, Continued

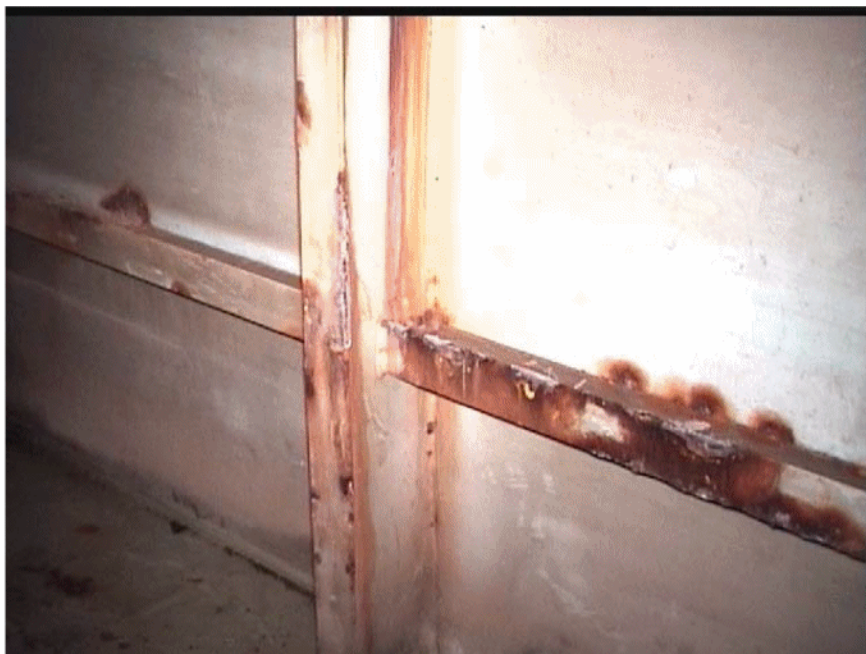
B. Coating failure initiated at stiffener edges and welds

Figure 4-12 Coating Breakdown Initiating in Tank Overhead and Stiffener Zones

4-4.1 Zone-Based Coating Condition Reporting. Coating deterioration initiates and progresses at varying rates on different surfaces on a ship for a variety of reasons. For example, as illustrated in [Figure 4-12](#) a tank top (overhead) corrodes differently than the tank bottom, and coating failure and corrosion often initiates sooner on stiffening elements due to the greater occurrence of edges and welds associated with them as compared to other zones.

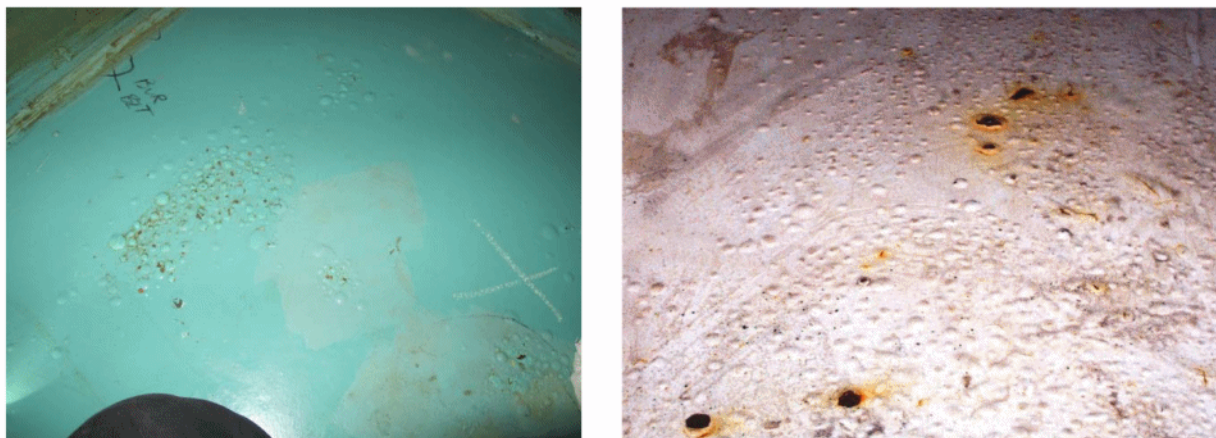
Figure 4-13 Examples of Osmotic Blistering Found in In-Service Tanks

4-4.3.3.1 Solvent Entrapment and Osmotic Blistering. The evaluation and disposition of blisters in a coating system that has been in service for a period of time is predominantly concerned with blisters caused by two phenomena: solvent entrapment and osmotic blistering. Solvent entrapment blisters are caused by improper coating application, and while they generally should be identified and remediated as a part of the coating application QA process, in some cases they are not, and may still remain in the coating system at the time it is surveyed long after the original application. Osmotic blistering is caused by the penetration of water under a paint film over time, for a variety of reasons, and is primarily a concern on surfaces subject to constant or frequent immersion. It is for this reason that separate blistering evaluations are only required in tanks and voids. In general, the great majority of coating blisters that will be found during Level 1 surveys on in-service vessels will be osmotic blisters. Examples are shown in [Figure 4-13](#).

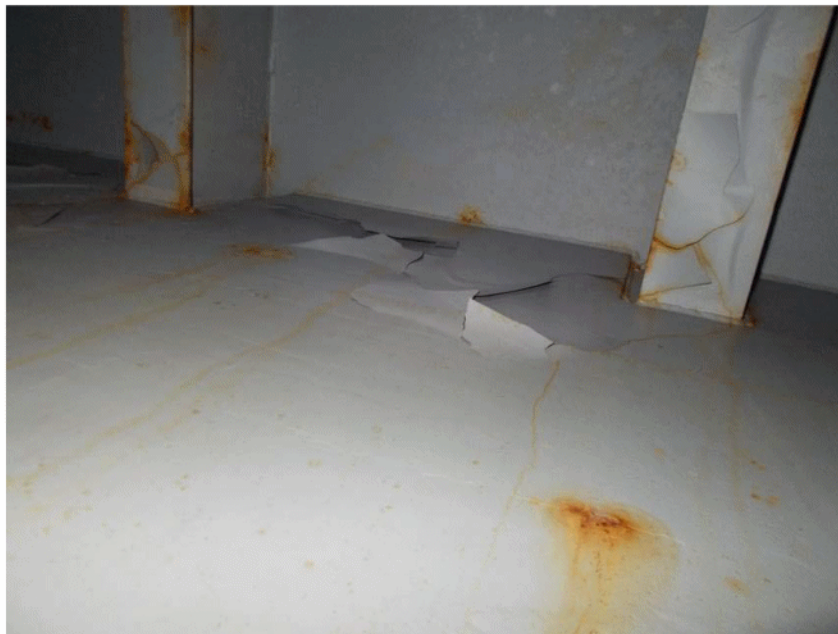
Delaminated Topcoat

Figure 4-15 Disbonded and Delaminated Coatings

4-4.3.4 Coating Delamination and Disbonding. *Disbonded* coating is defined as failure of all layers of the coating system down to bare metal, such that the coating no longer provides any corrosion protection. *Delaminated* coating is defined as one or more coats lifting off an underlying coat that is still providing some degree of corrosion protection. Examples are shown in [Figure 4-15](#).

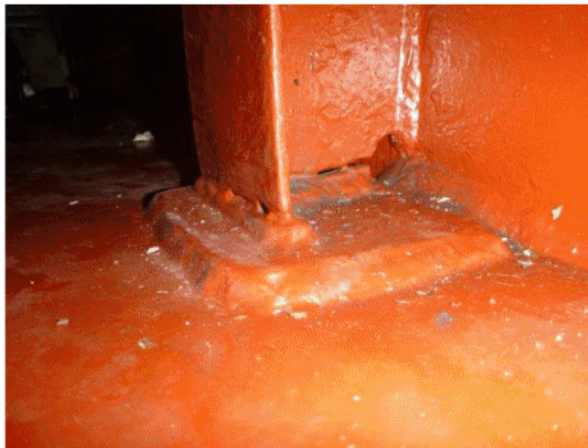
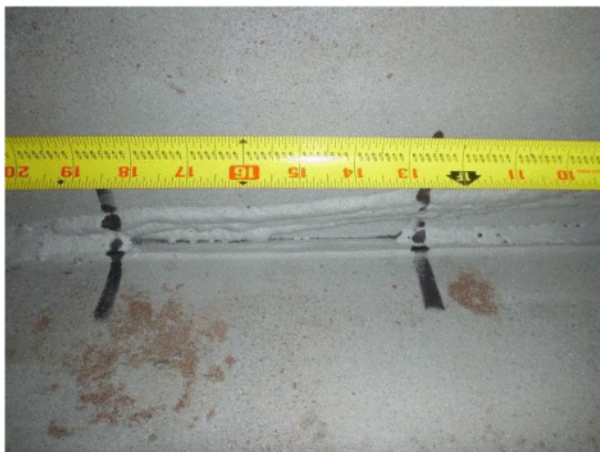
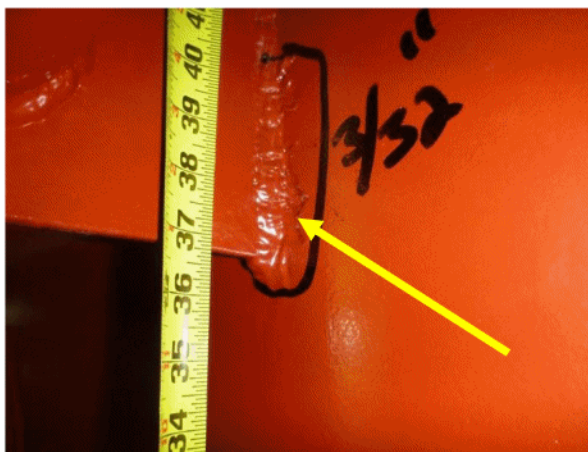
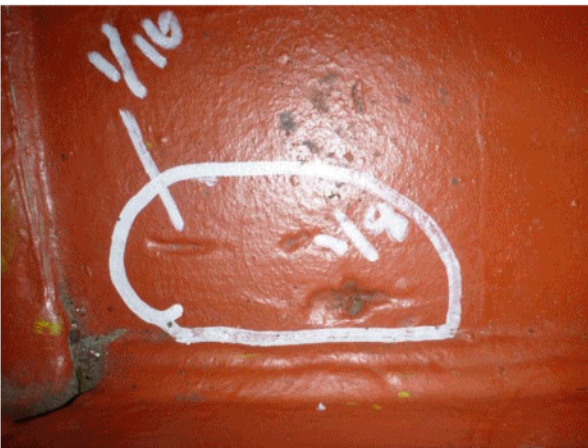
Crack in weld

Incomplete Weld

Incomplete Fillet Weld

Undercut Base Metal At Weld Toe

Gouges in Plate

Figure 4-19 Examples of Reportable Weld and Workmanship Defects

- j. **Workmanship Defects:** Defective workmanship is anything that does not comply with structural fabrication specifications from the time of initial construction or repair. Areas with obvious deficient workmanship should be determined in the visual examination of the surfaces of the compartment. Note that there is no requirement or expectation for the Level 1 surveyor to review the actual structure configuration and workmanship against the ship construction drawings; however, obvious defects shall be reported in the comments section of the survey forms. Examples of reportable items are described below, some of which are illustrated in [Figure 4-19](#):
