Naval Facilities Engineering Command

Inspection of Wood Beams & Trusses

NAVFAC MO-111.1

September 1985

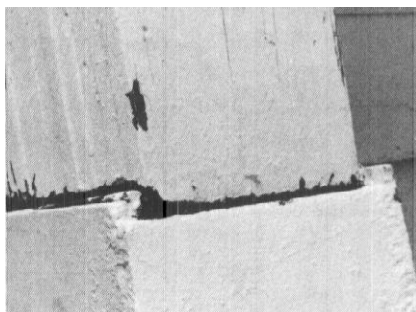
Figure 4-4. (B) Dark area is evidence of localized decay at the top of the metal collar.
