Naval Facilities Engineering Command

Inspection of Wood Beams & Trusses

NAVFAC MO-111.1

September 1985

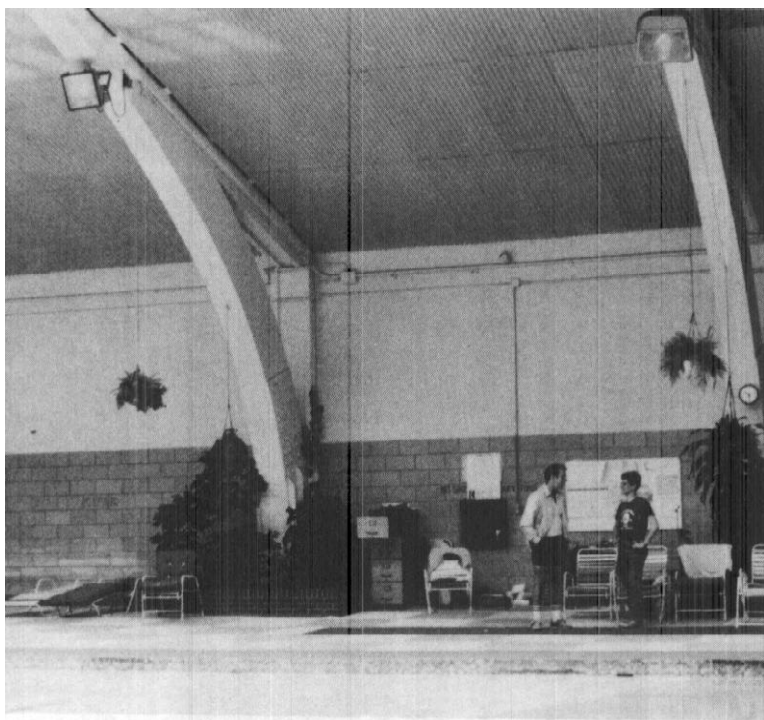
Figure 4-2. Glulam arches with rating 100. No sign of deflection or deterioration.

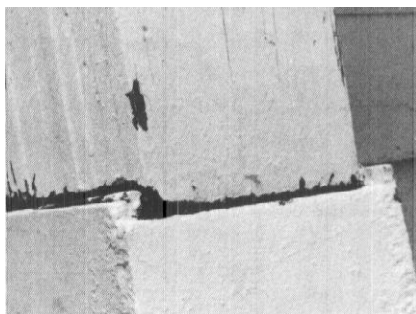
Figure 4-4. (B) Dark area is evidence of localized decay at the top of the metal collar.

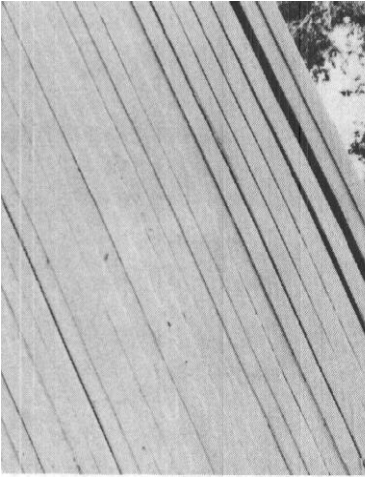
Figure 4-5. Glulam arches with rating 40. (A) Severe delamination in a localized area in the outer laminations.

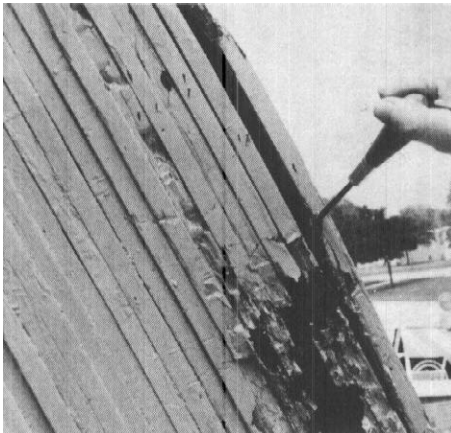
Figure 4-5. (C) Combination of delamination and severe decay. This condition was limited to the outer one-fifth of the member; any more extensive decay and delamination or any evidence of settlement should be rated as 20.

4.1.1 DEFLECTION. Arches should maintain their original shape without noticeable change unless there is a problem such as delamination, loose connectors, or some type of wood failure. Excessive deflection at the crown can usually be detected visually by the flat appearance instead of the continuation of the curve. There may also be evidence of crushing or splitting at connectors. In extreme cases there will be a downward deflection at the crown joint. Such a deflection will often result in roof leaks and be accompanied by water stains. The amount of deflection is difficult to assess since there is no reference point unless measurements from the crown to the floor were recorded at the time of construction. In some cases an estimate of the deflection can be made by comparing the crown-to-floor distance with that of an arch that appears in good condition. Any flattening of the crown should receive a rating of 60. A slightly downward deflection should be rated 20 (Figs. 4-6B and 4-5C).
