**DOT/FAA/AR-03/74**

# **Bonded Repair of Aircraft Composite Sandwich Structures**

February 2004

Final Report

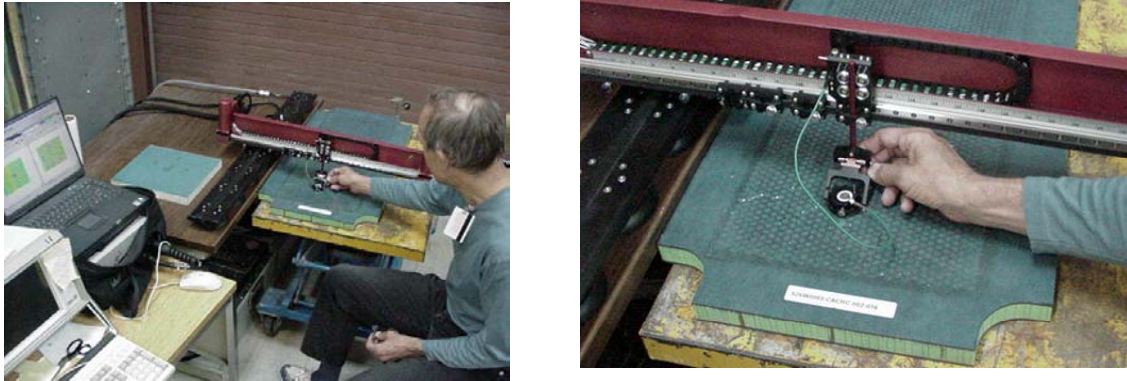
the structure affect the time of wave travel and the amount of energy received. Phase and amplitude displays are used to detect flaws in an A-scan signal. This information can be color-coded into a two-dimensional map (C-scan) to highlight the variations in phase and amplitude that indicate the existence of a flaw. The MAUS C-scan device used for this investigation is shown in figure 11.

FIGURE 11. MAUS C-SCAN DEVICE

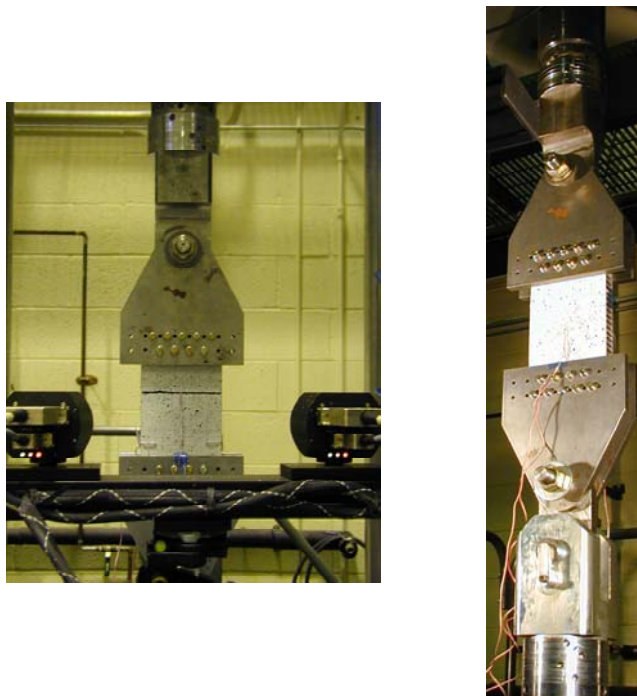
A Boeing fixture, shown in figure 31, was used for testing the unidirectional tension coupons. The fixture was mounted on clevises using cylindrical pins. The clevises were bolted to the load frame. The MTS hydraulic test machine used a 110-kip actuator for loading. As previously mentioned, the MTS machines were periodically calibrated according to the ASTM E4 standard so that the measured load was within 1% of the actual load.

FIGURE 31. UNIDIRECTIONAL TENSION COUPON TEST SETUP

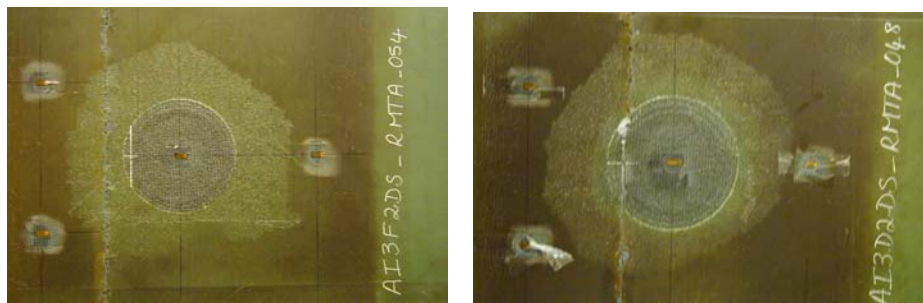
FIGURE 42. FAILURE MODES FOR THE 1/8-inch CORE IMPACTED LARGE FOUR-POINT BENDING BEAMS

For the 1/8-inch core undamaged beams, 50% of the coupons failed in the repair, while the remaining 50% failed outside the repair. For the impacted 1/8-inch core coupons, half of the coupons failed through the impact, while the other half failed outside the repair, as shown in figures 41 and 42.
