MIL-STD-289A
2 December 1968
SUPERSEDING
MIL-STD-289
26 August 1955

MILITARY STANDARD
VISUAL INSPECTION GUIDE
FOR
RUBBER SHEET MATERIAL

VISUAL INSPECTION GUIDE FOR RUBBER SHEET MATERIAL

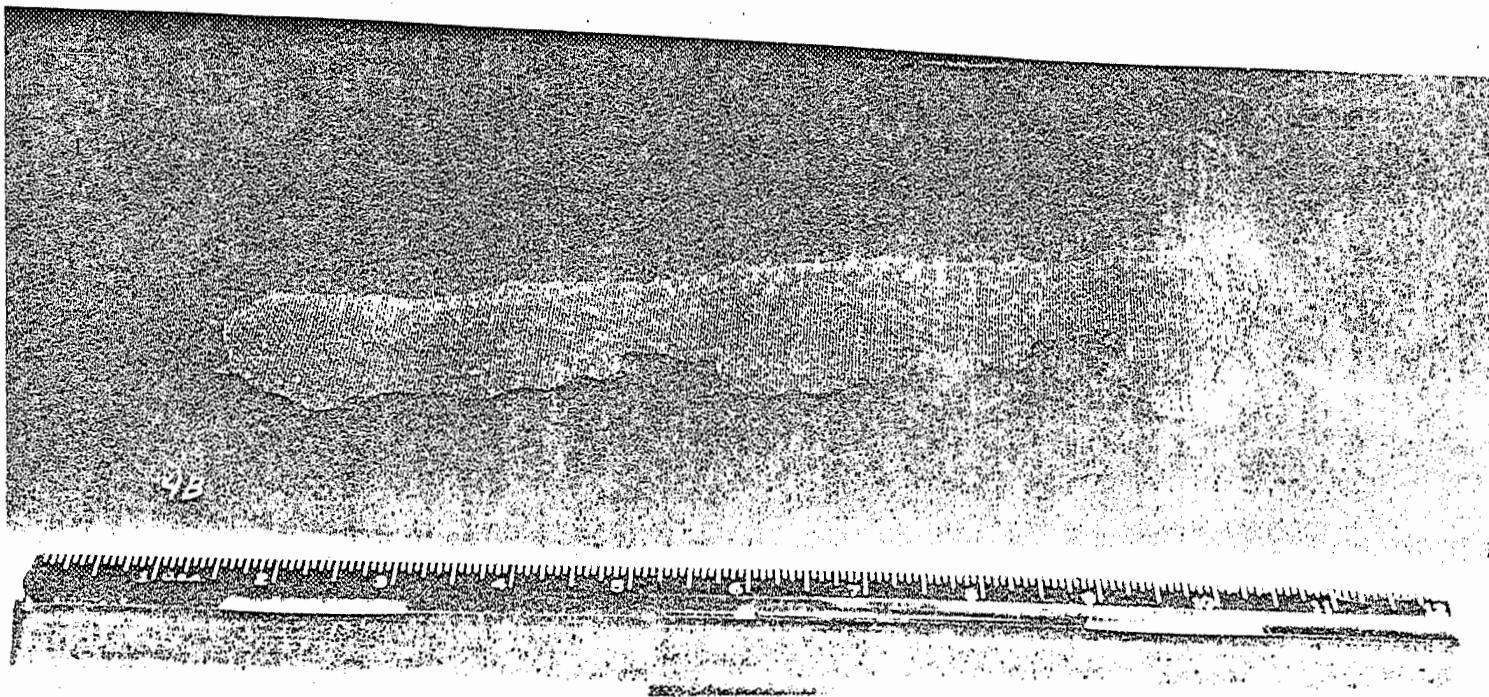
Figure 3 - Surface void - face stock missing - major.

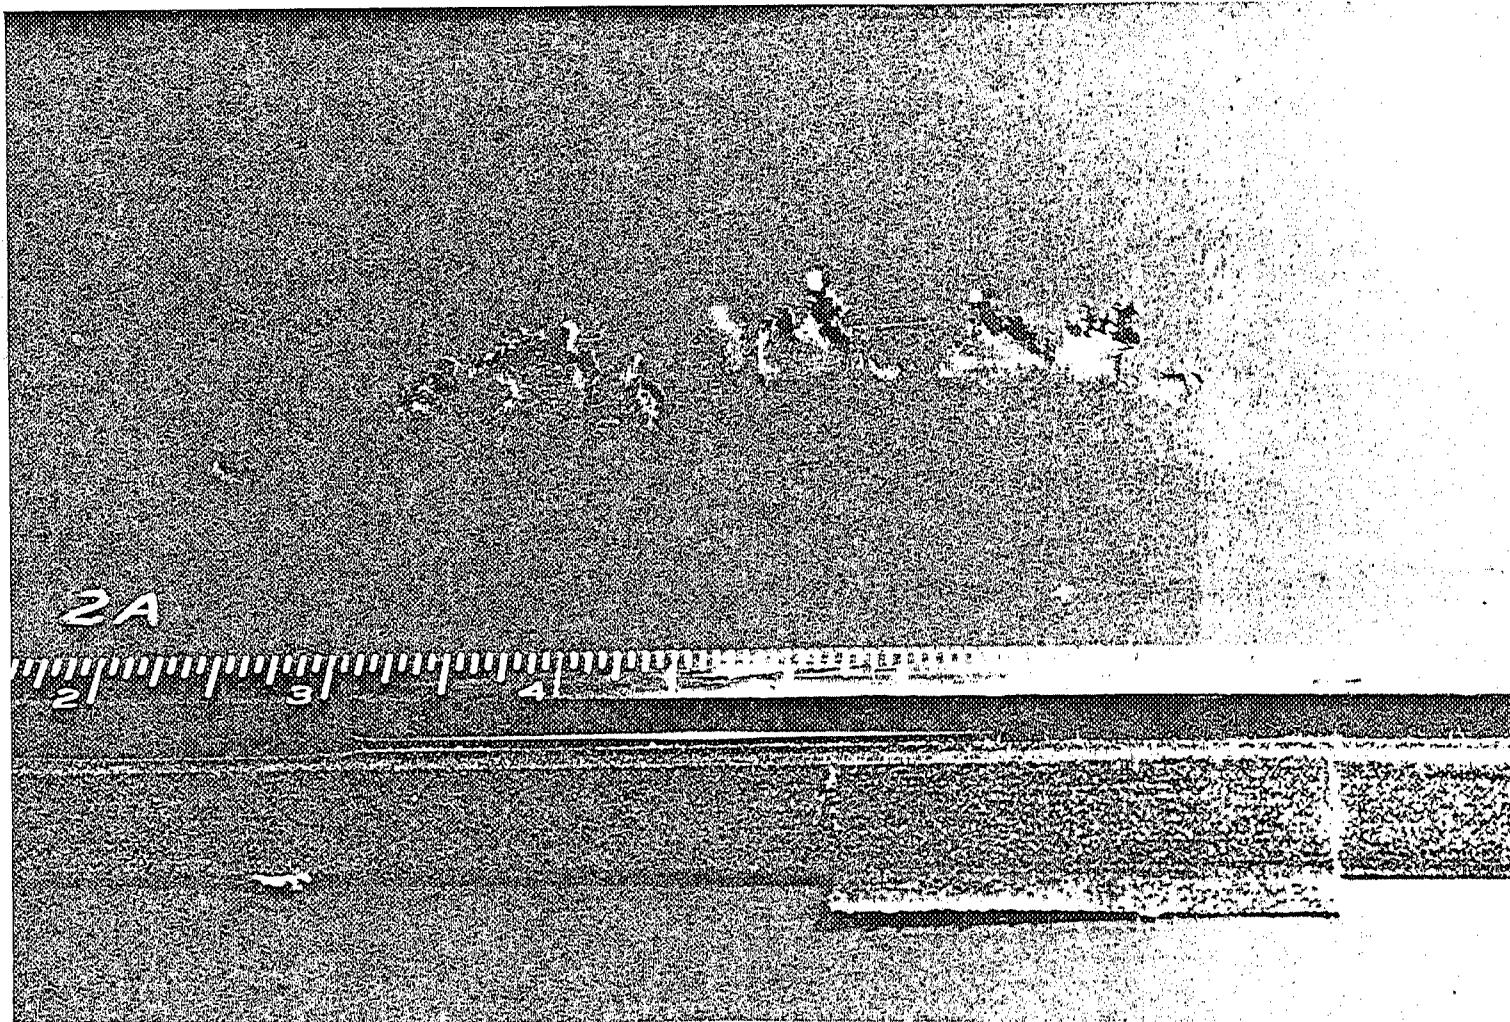
Figure 7 - Trapped air - face stock missing - major.

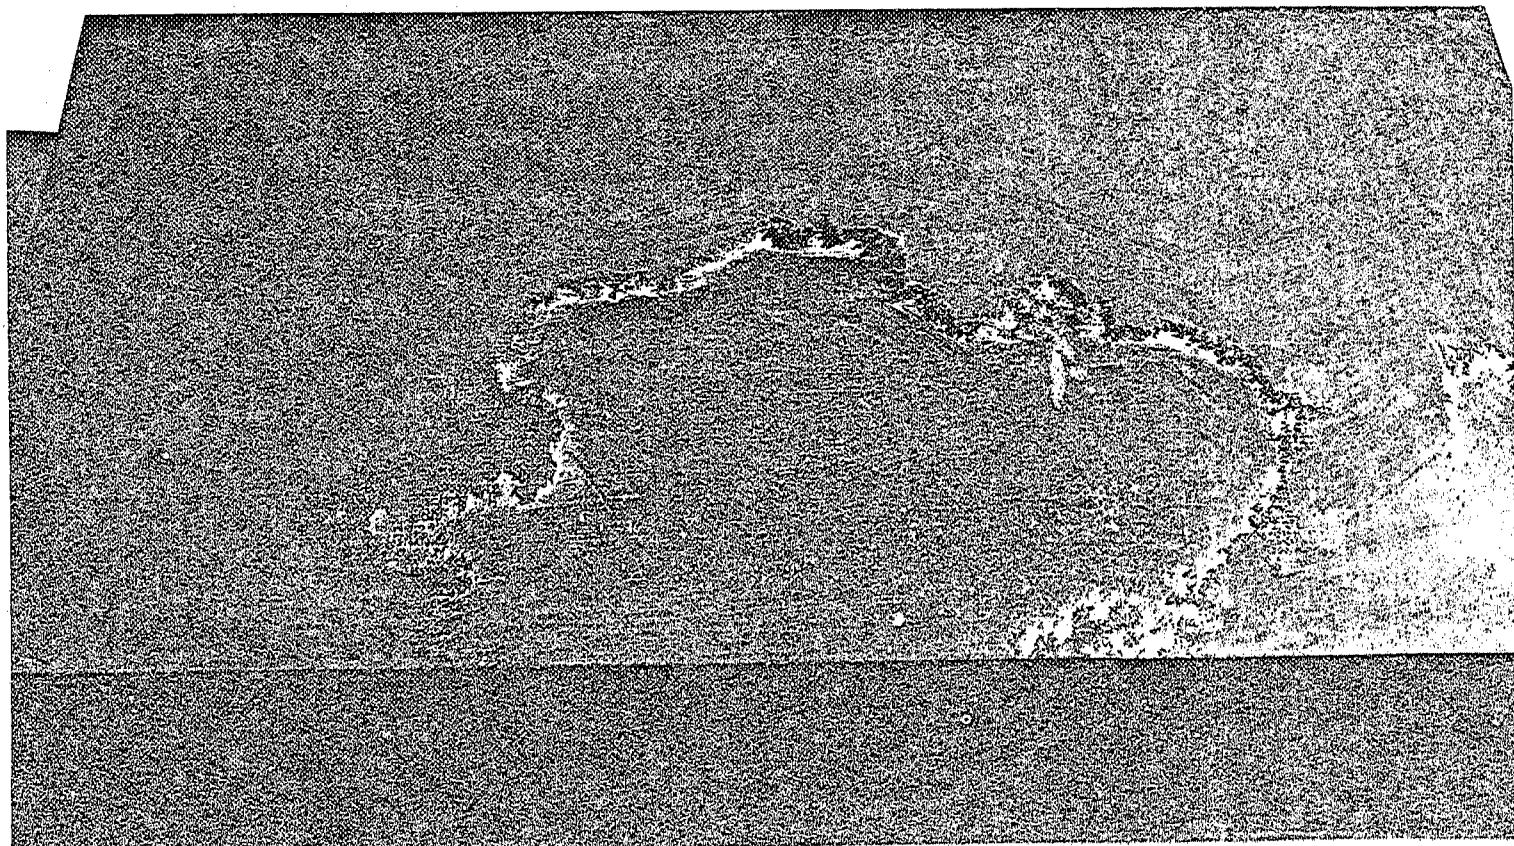
Figure 8 - Trapped air - face stock missing - major.

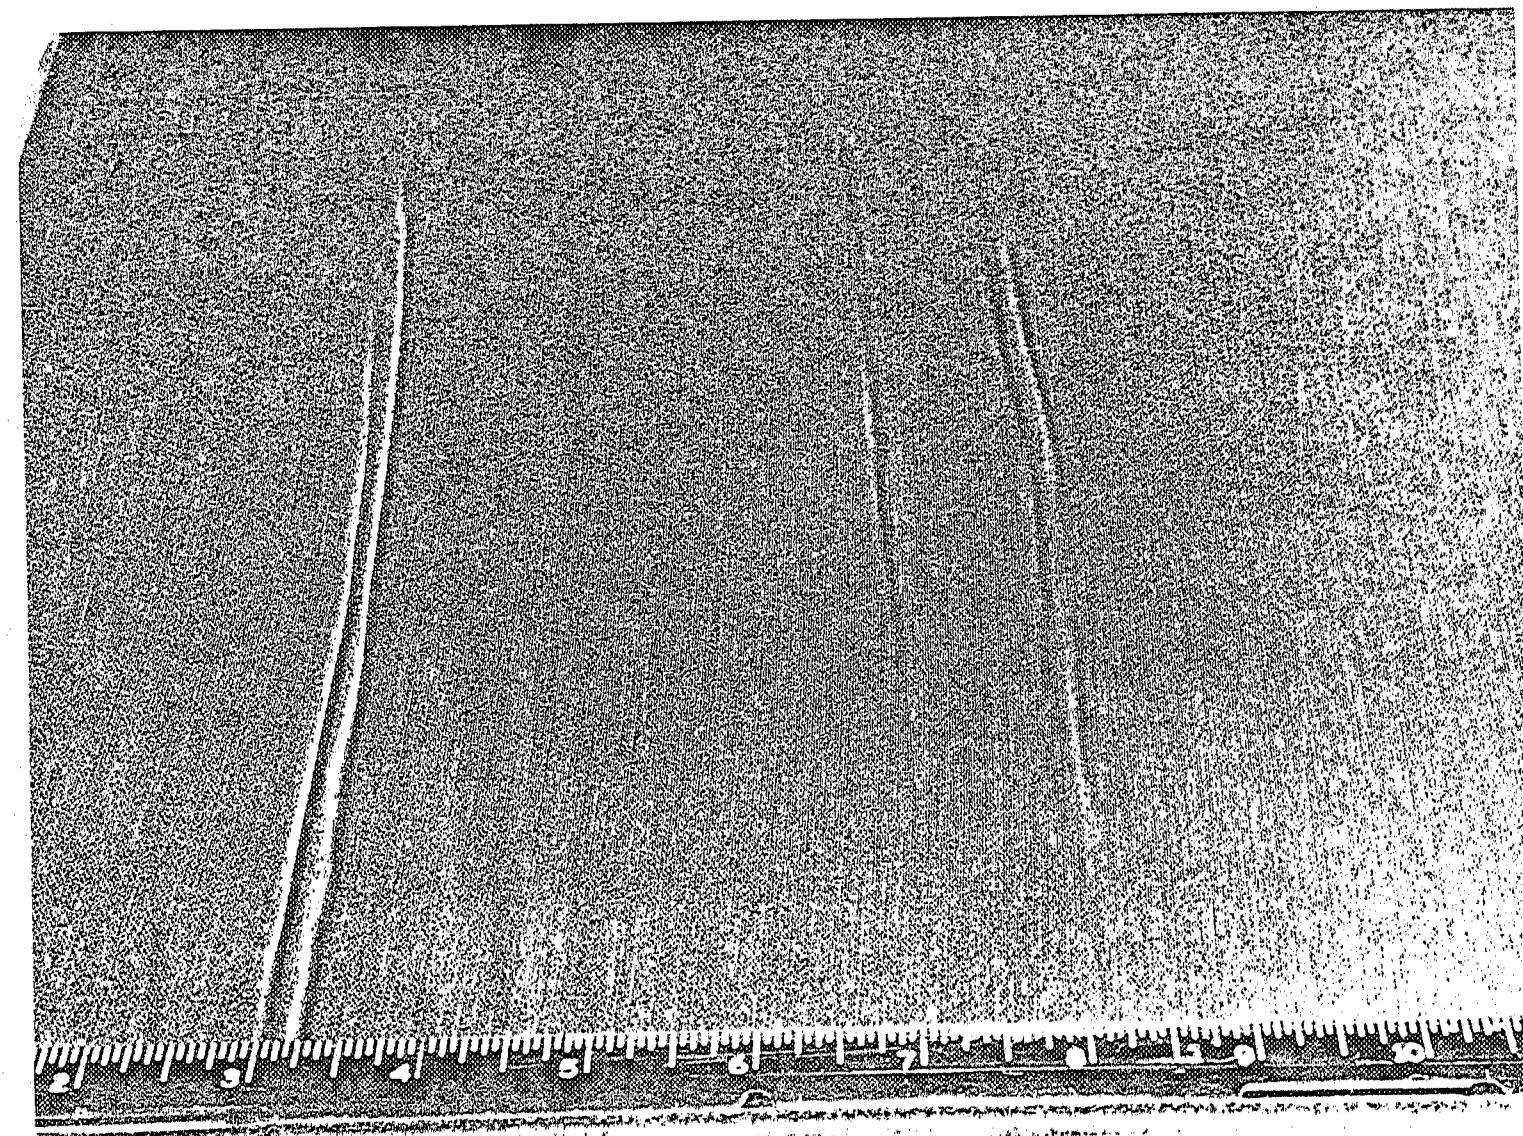
Figure 10 - Liner wrinkle - major.

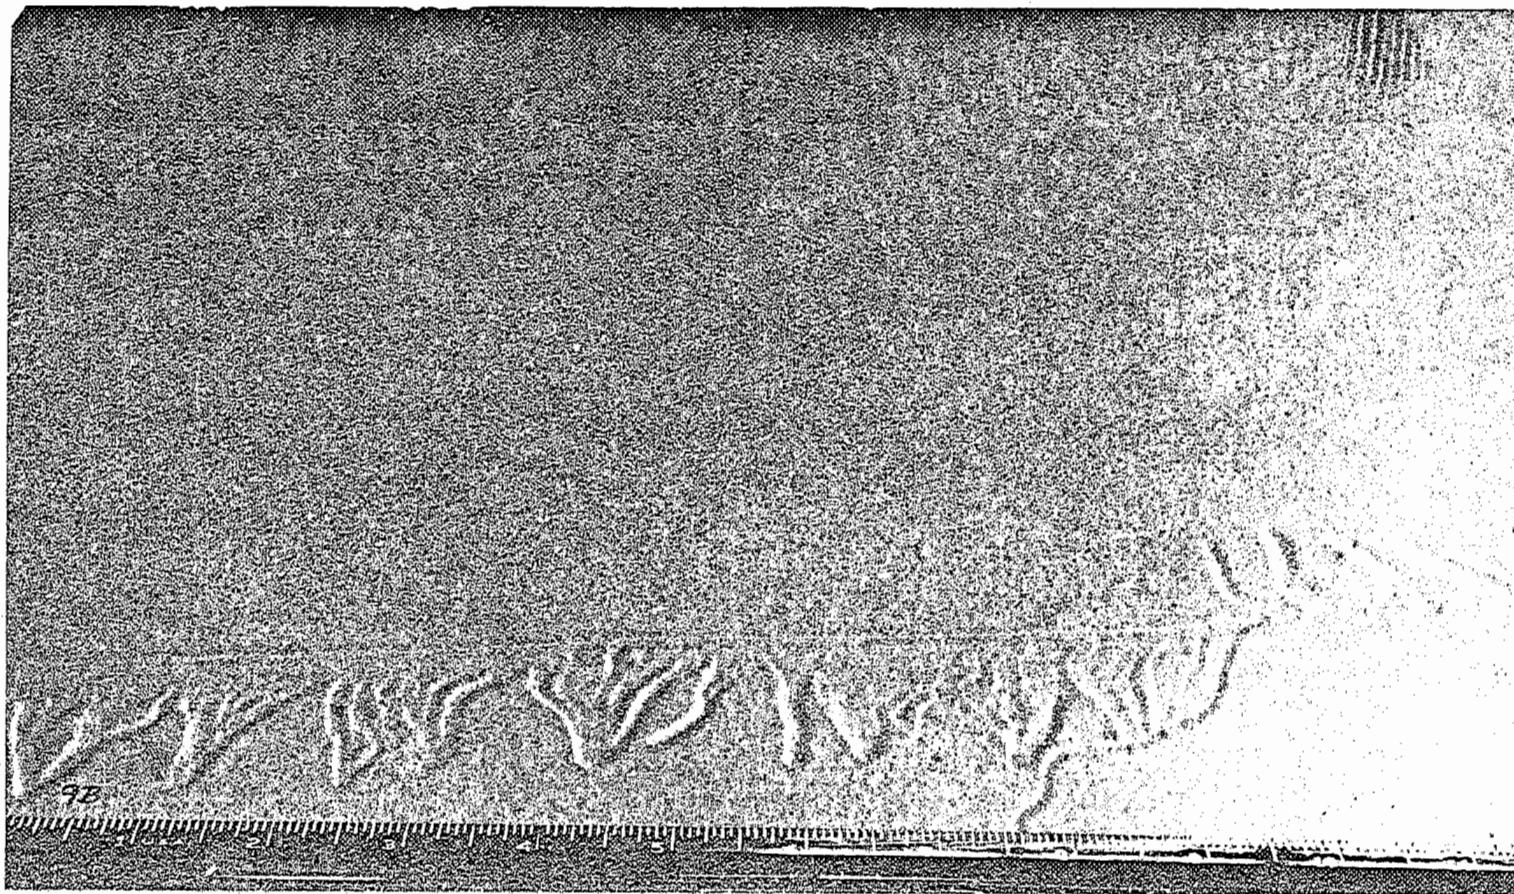
Figure 11 - Overlap liner wrinkle - major.

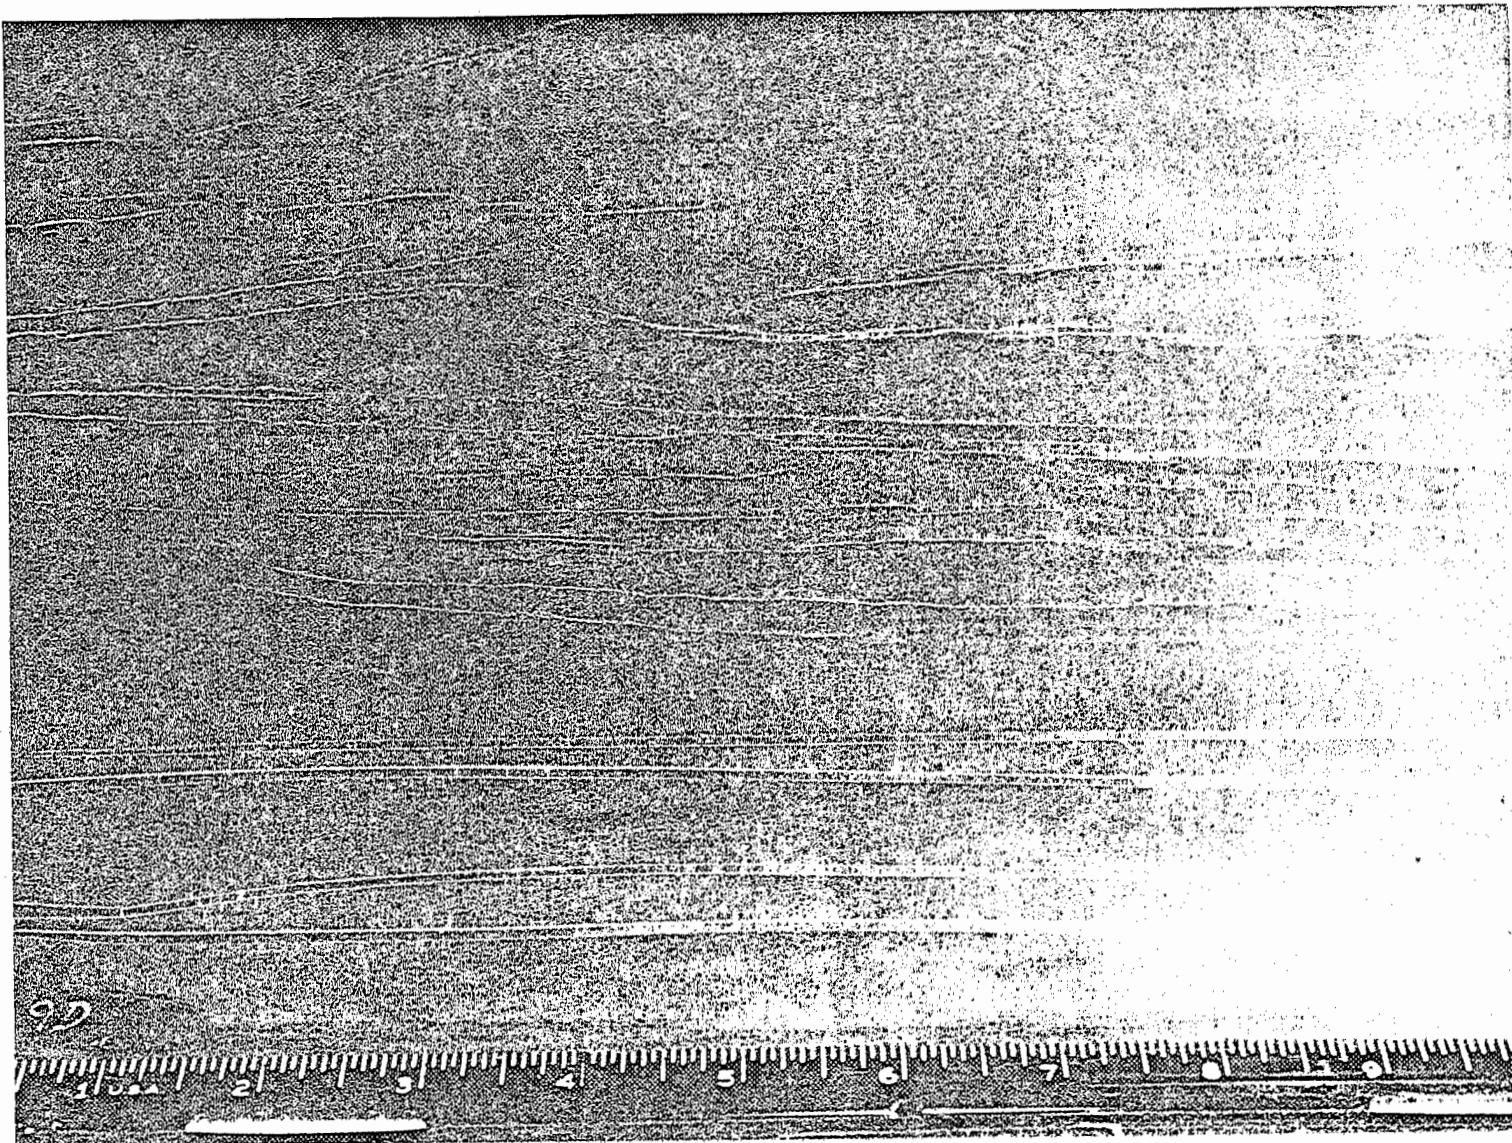
Figure 12 - Liner wrinkle - minor.

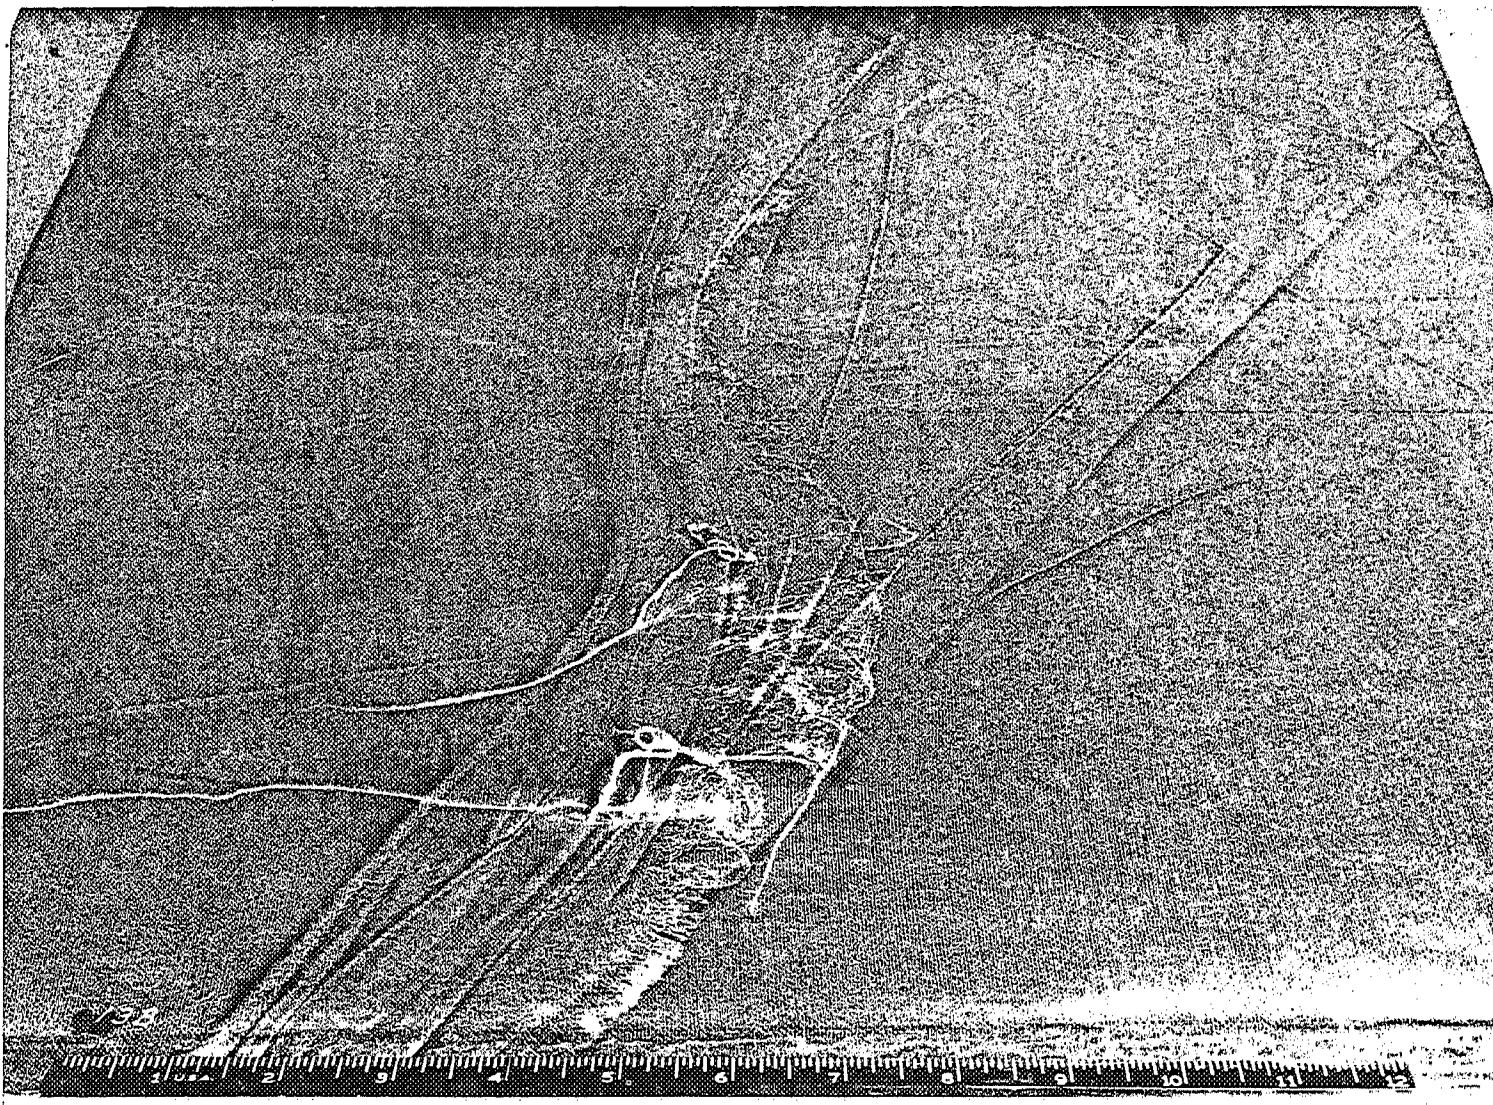
Figure 13 - Stuck liner - major.

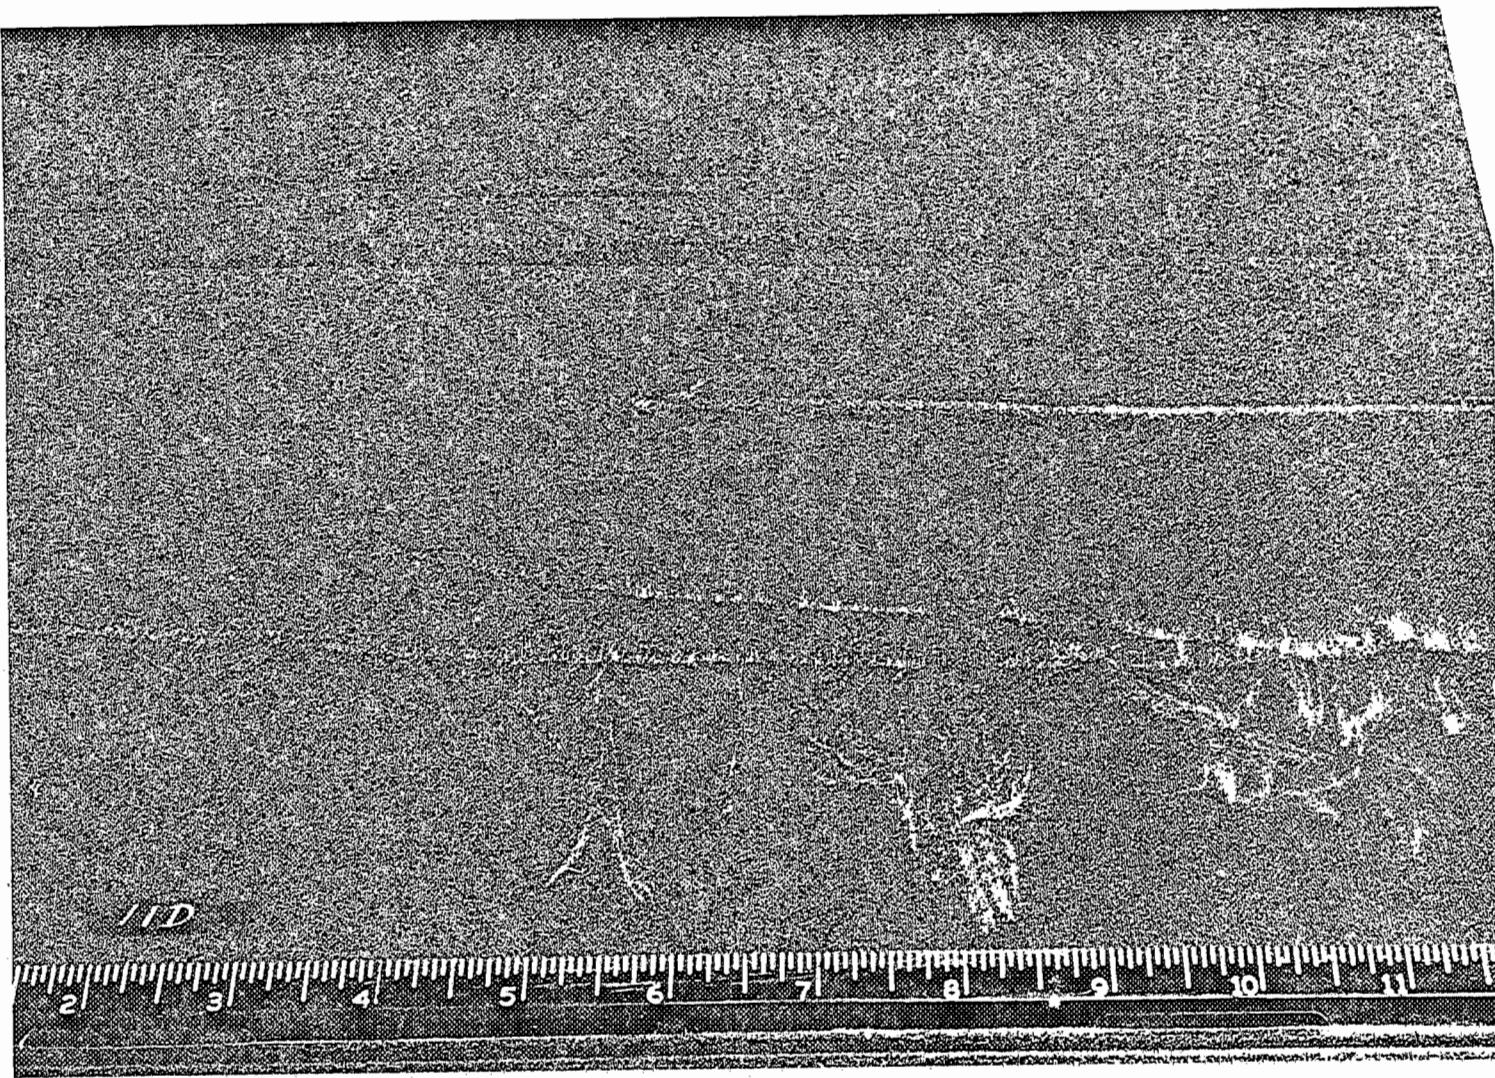
Figure 14 - Stuck liner - slightly rougher than cloth impression - minor.

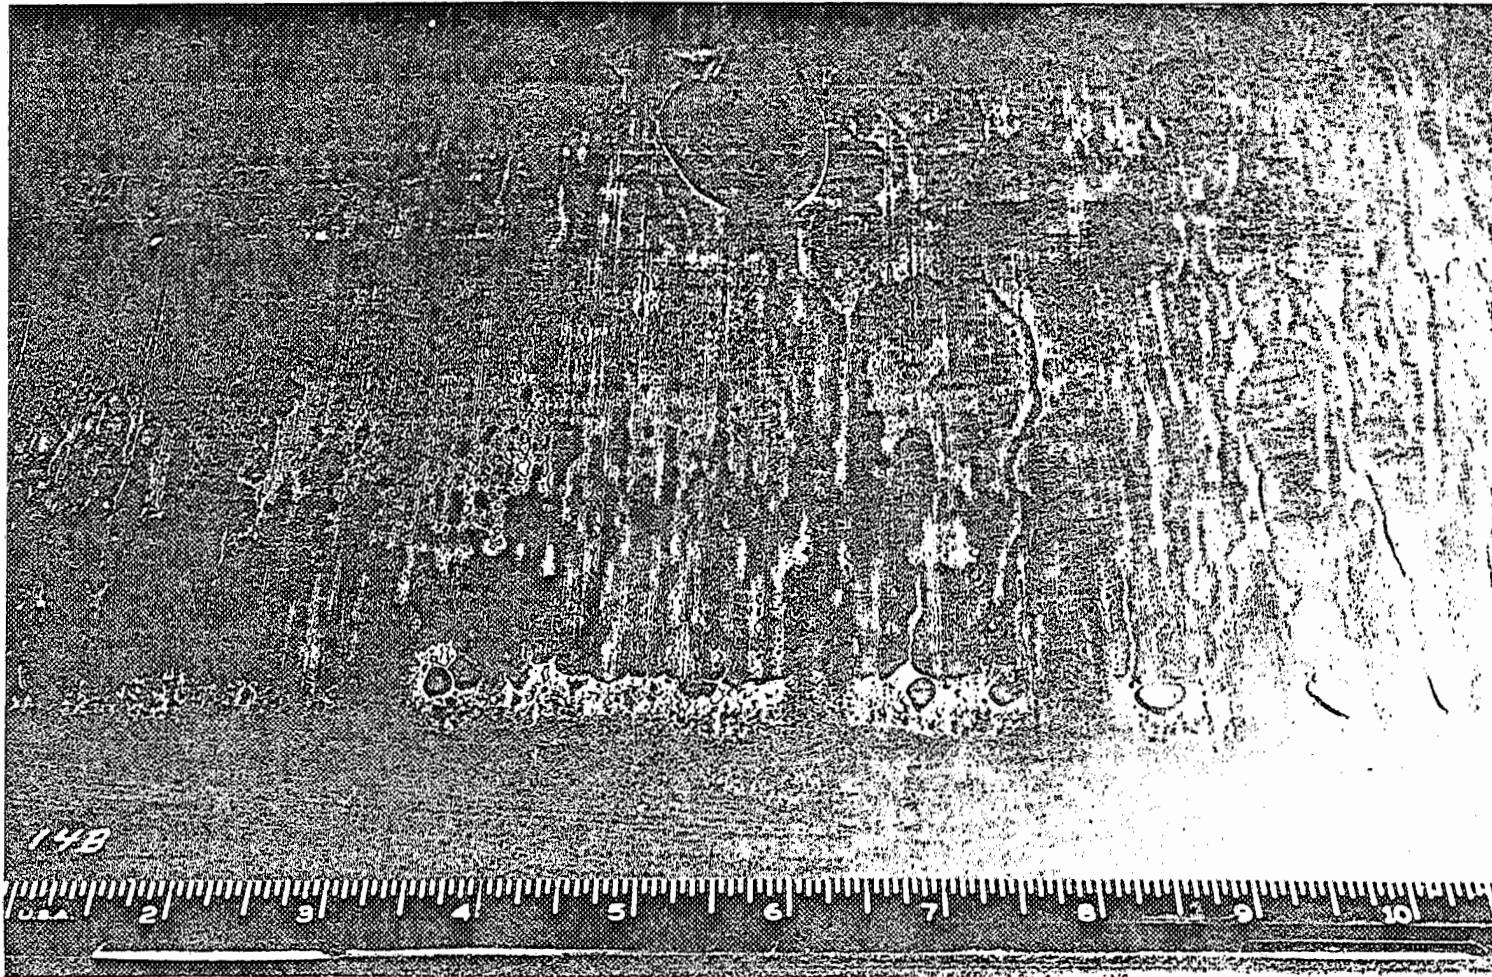
Figure 15 - Press change (liner) - major.

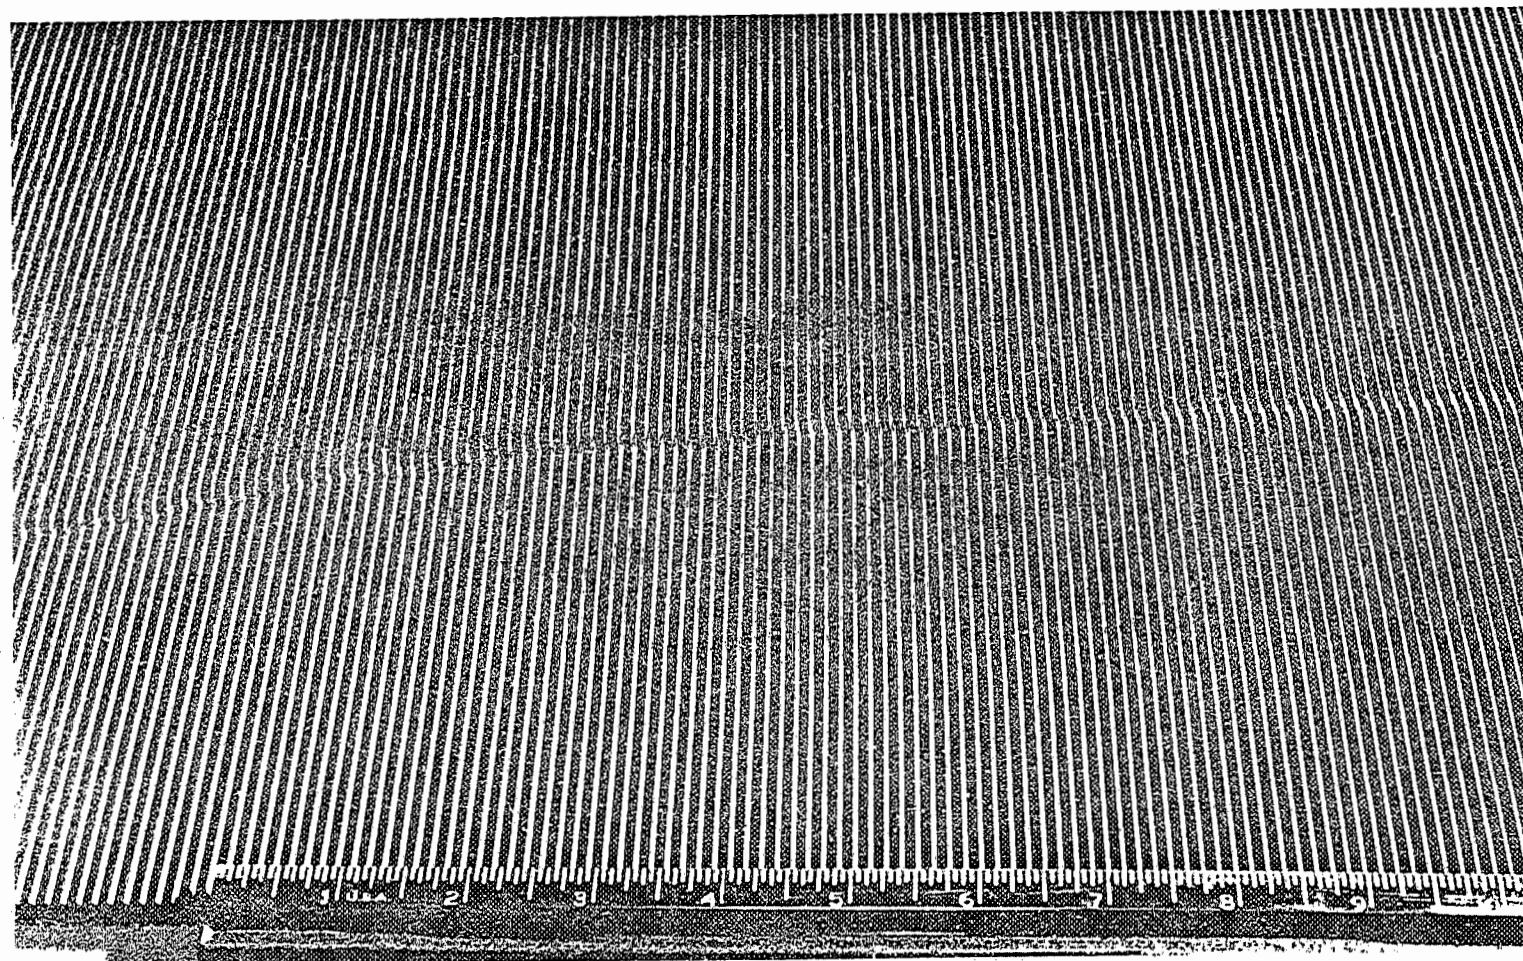
Figure 16 - Press change - Pattern slightly out of phase - not a defect.

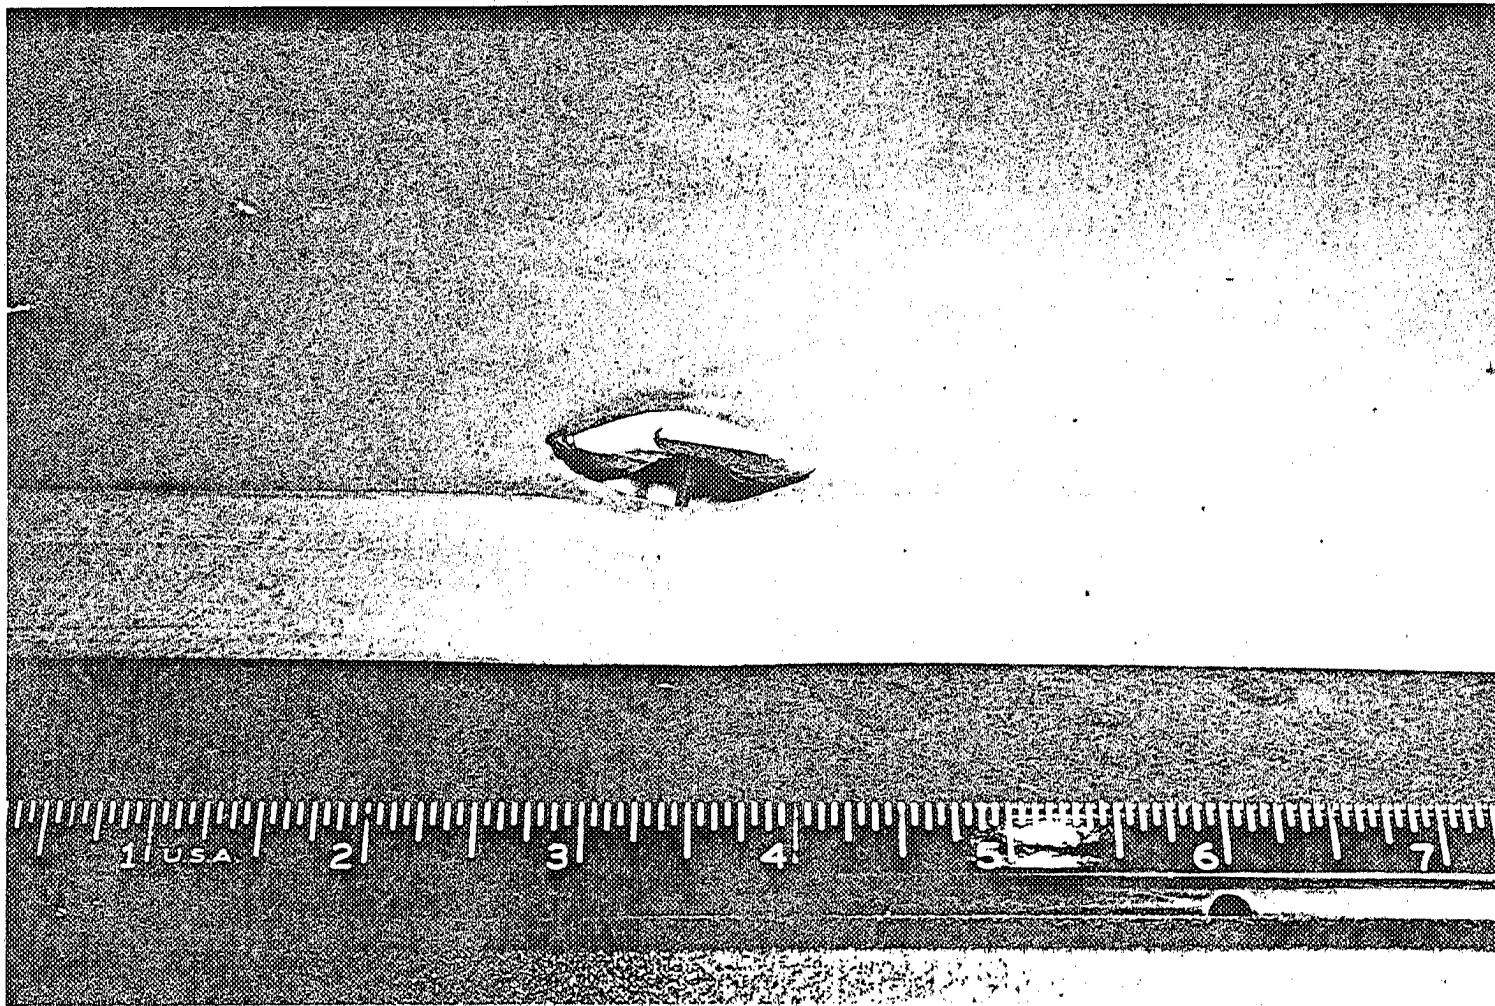
Figure 17 - Air blister (peg used to accentuate) - major.

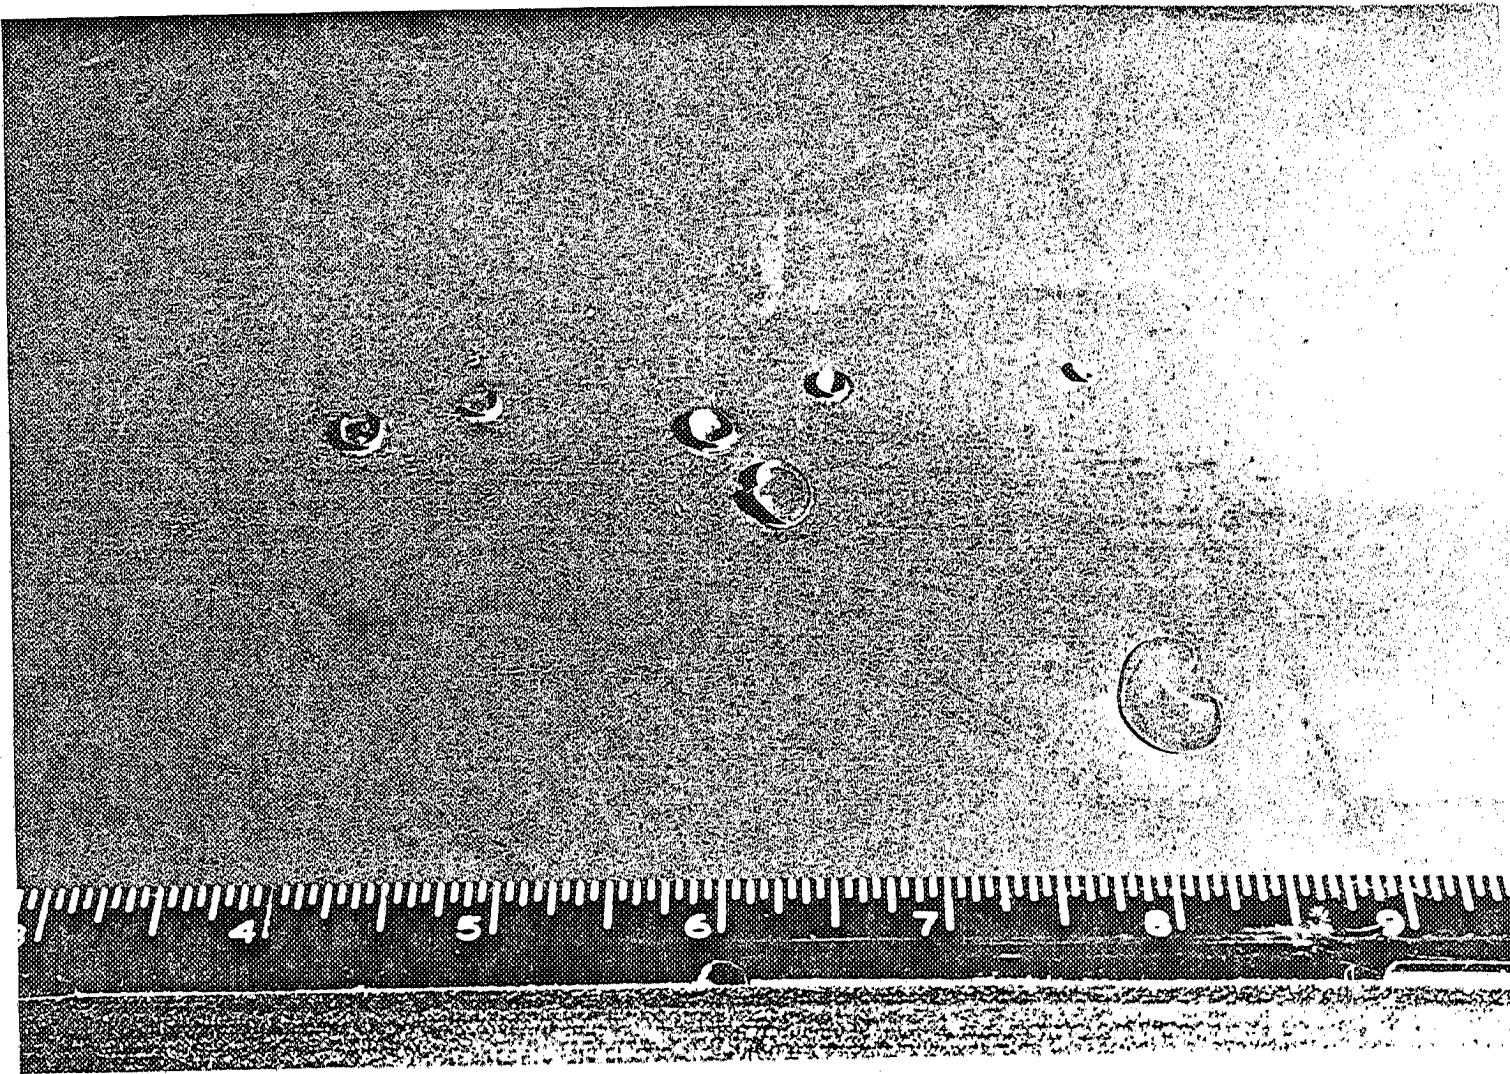
Figure 18 - Broken blister - major.

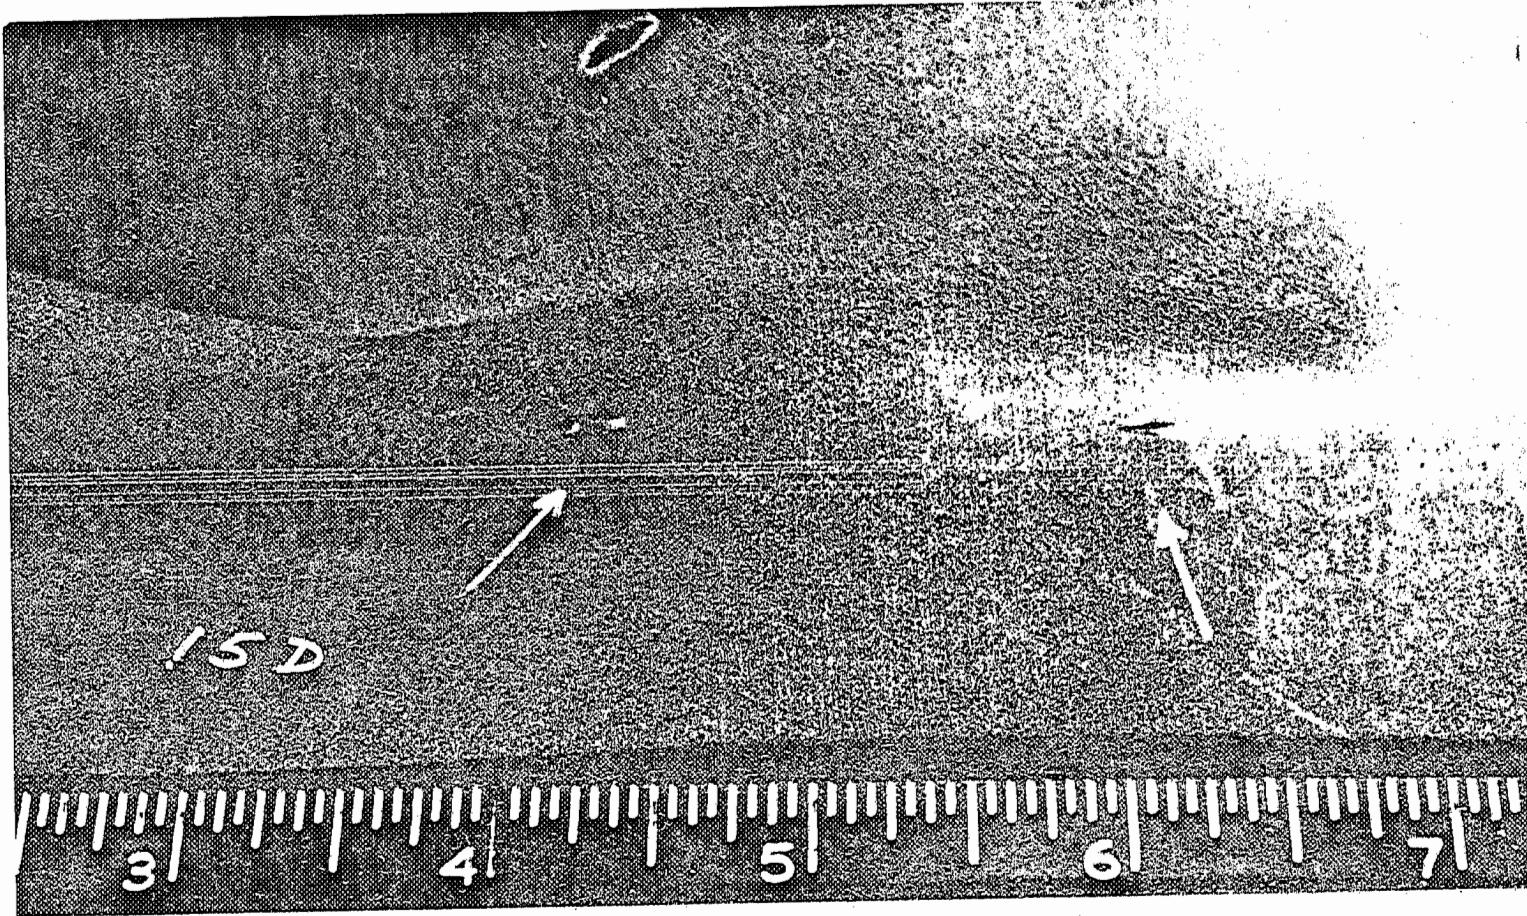
Figure 20 - Heat blister - major.

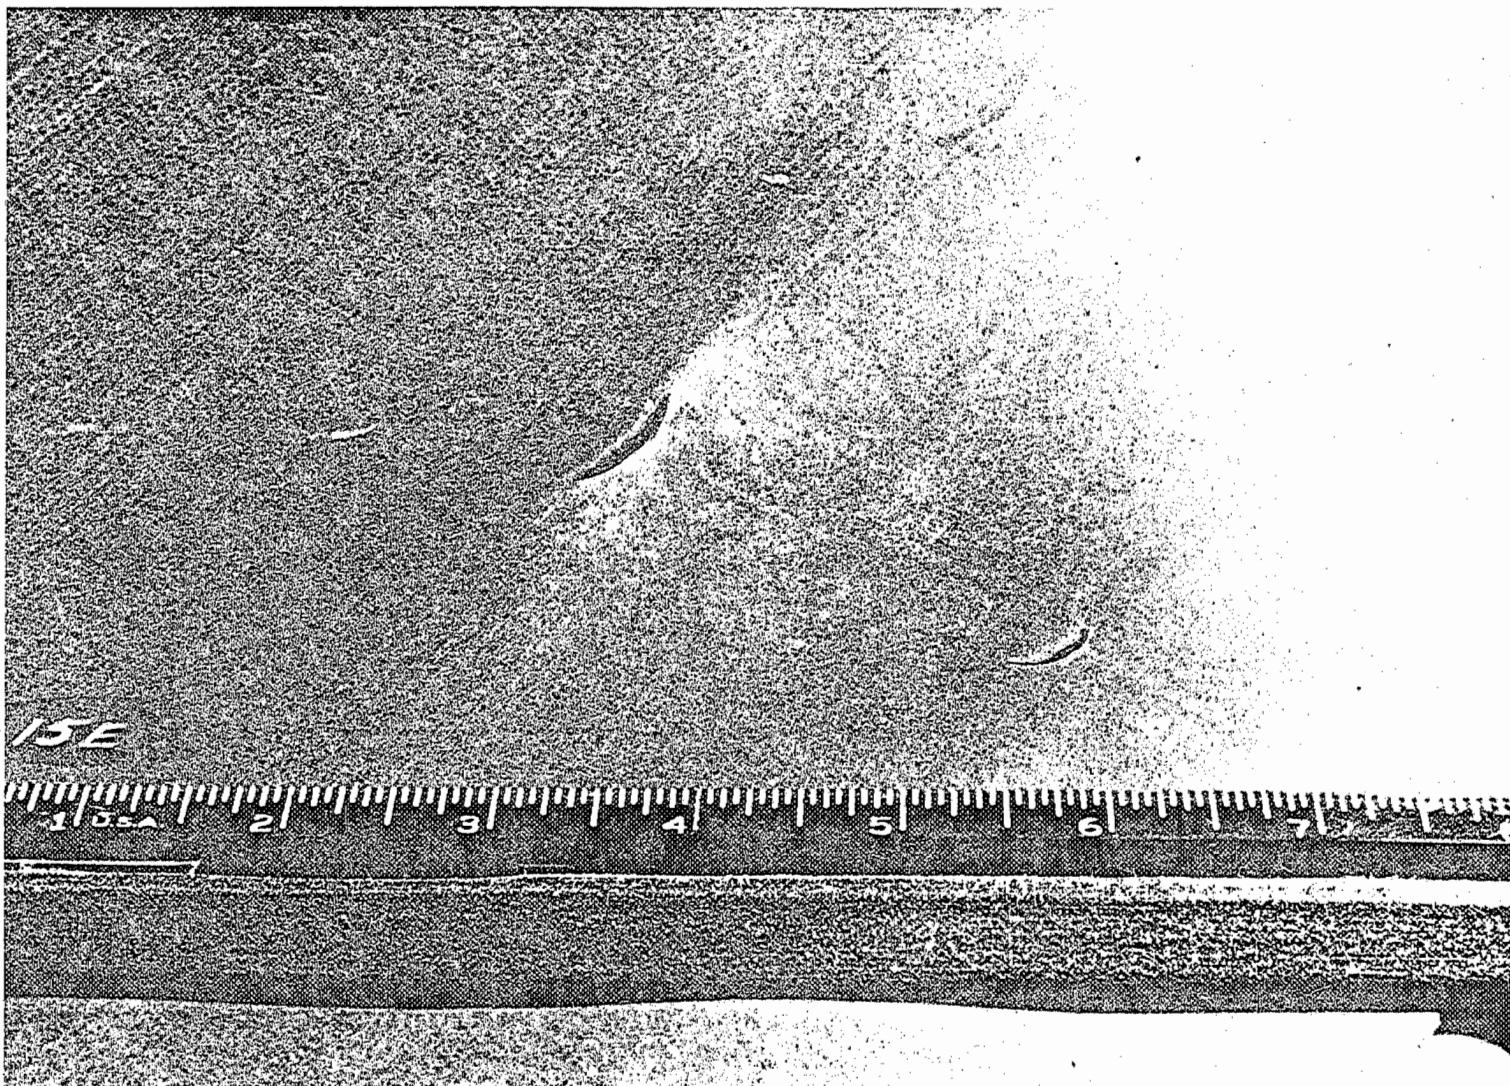
Figure 21 - Folded over blister - major.

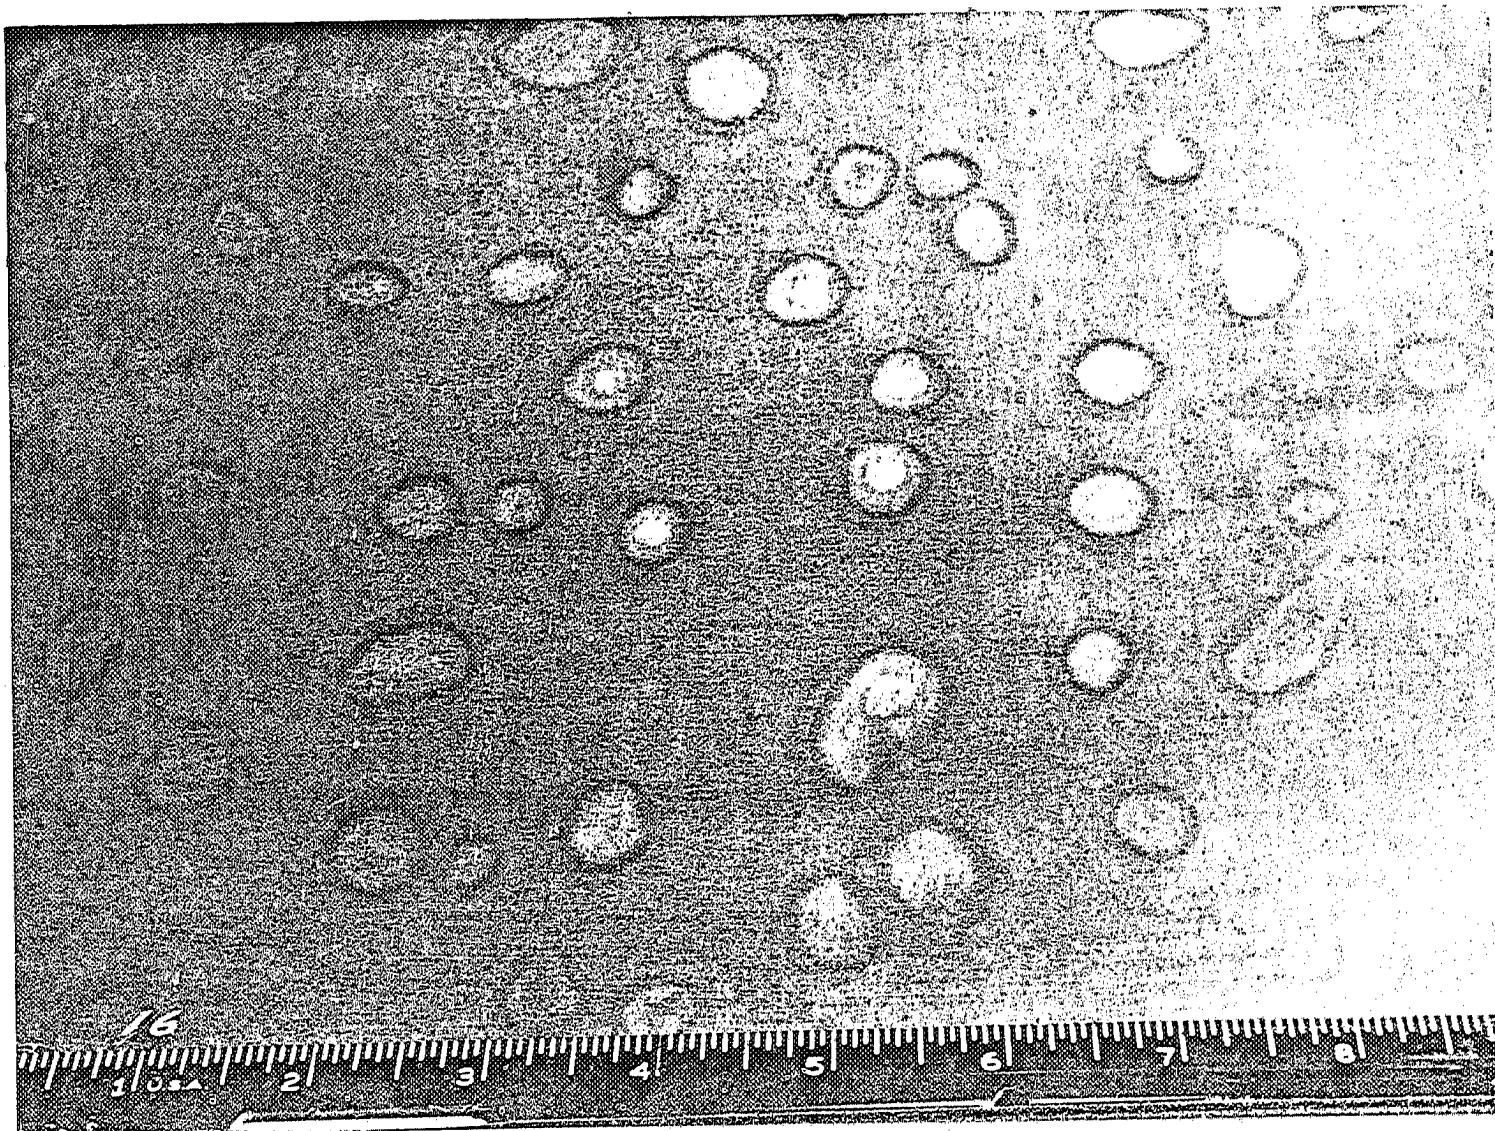
Figure 22 - Surface blemish - no voids or protrusions - not a defect.
