MIL-STD-289A
2 December 1968
SUPERSEDING
MIL-STD-289
26 August 1955

MILITARY STANDARD
VISUAL INSPECTION GUIDE
FOR
RUBBER SHEET MATERIAL

VISUAL INSPECTION GUIDE FOR RUBBER SHEET MATERIAL

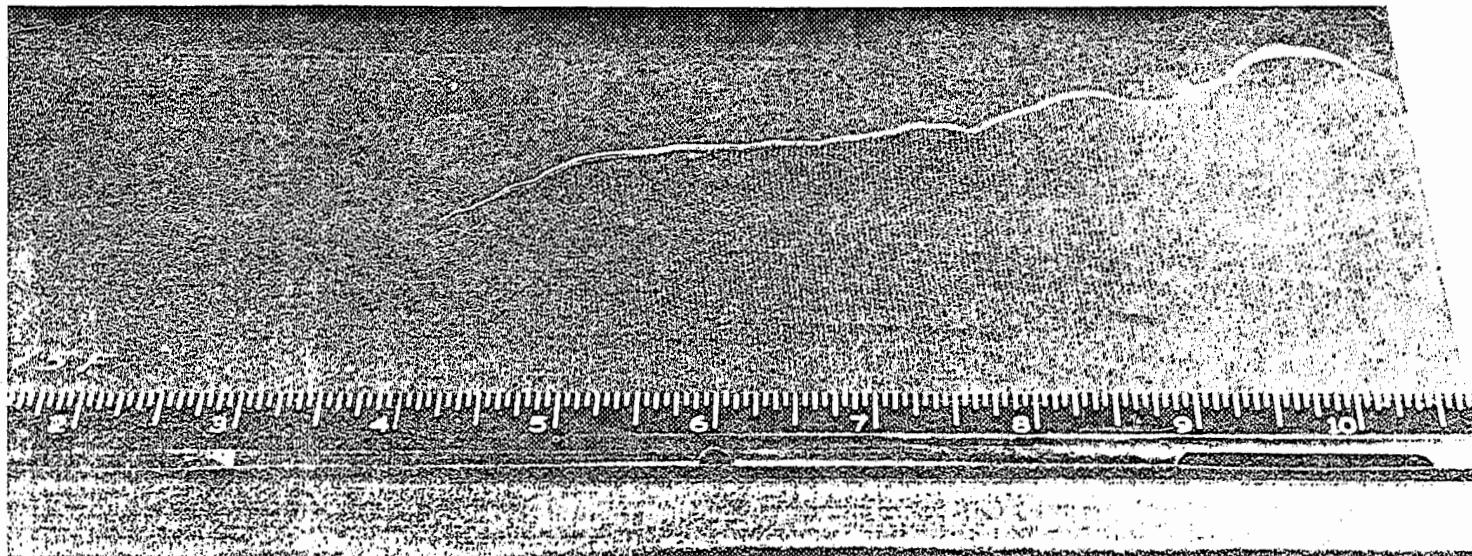
Figure 23 - Fold over - major.

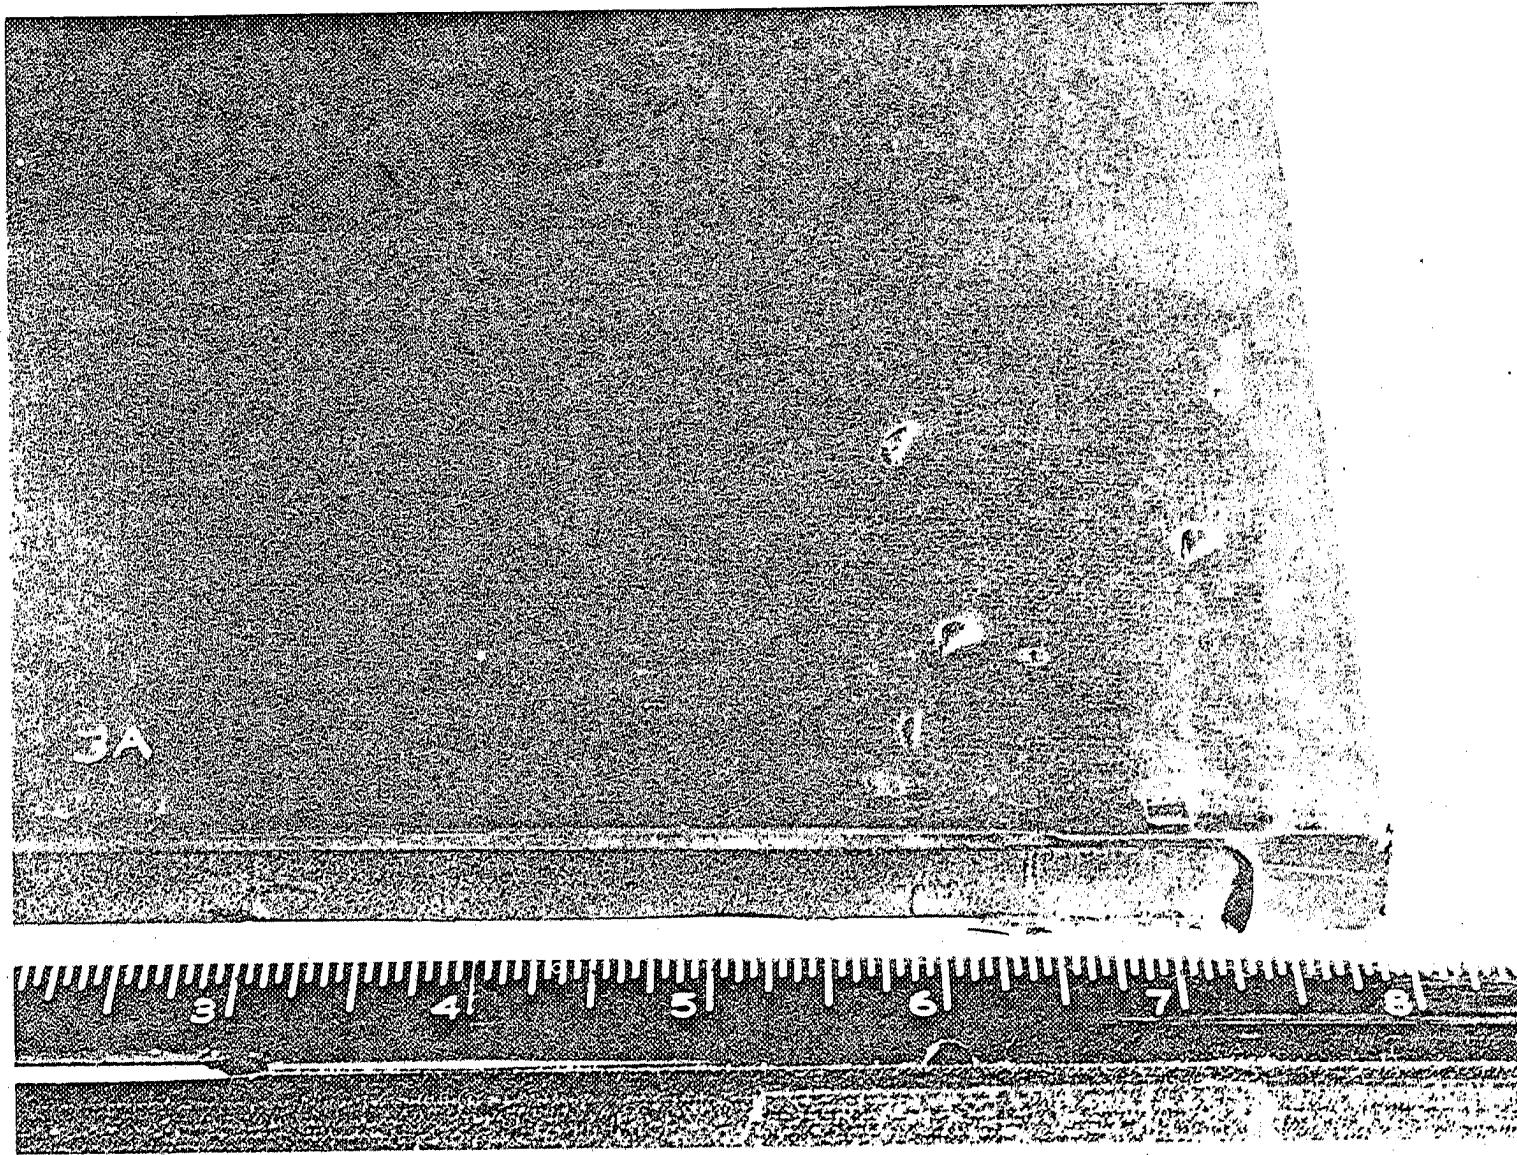
Figure 24 - Surface lumps - major.

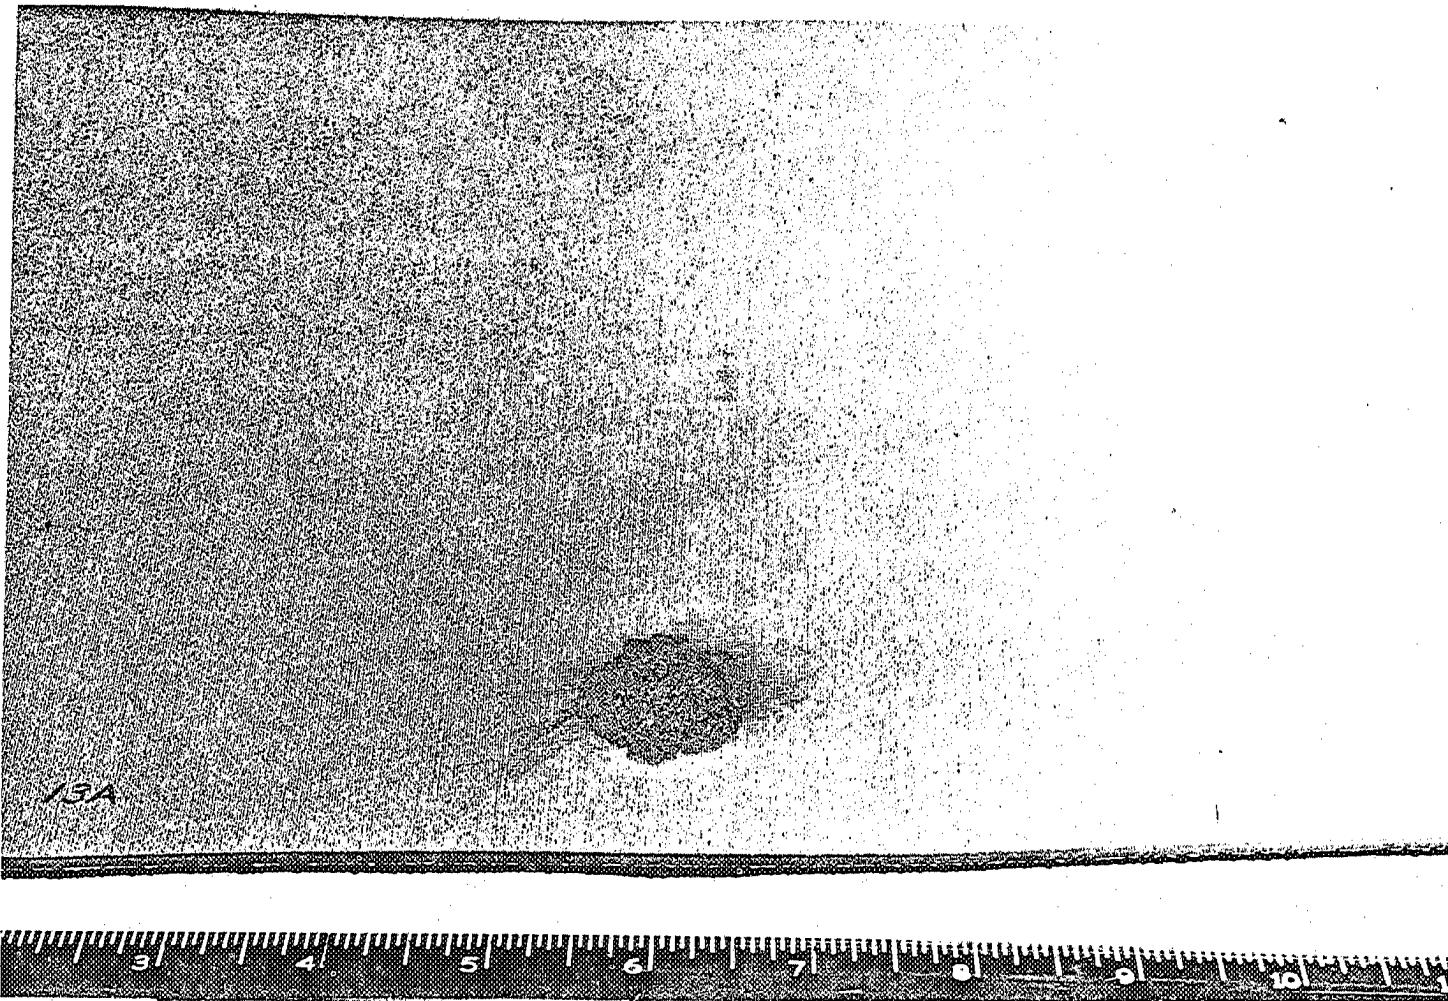
Figure 25 - Foreign material - major.

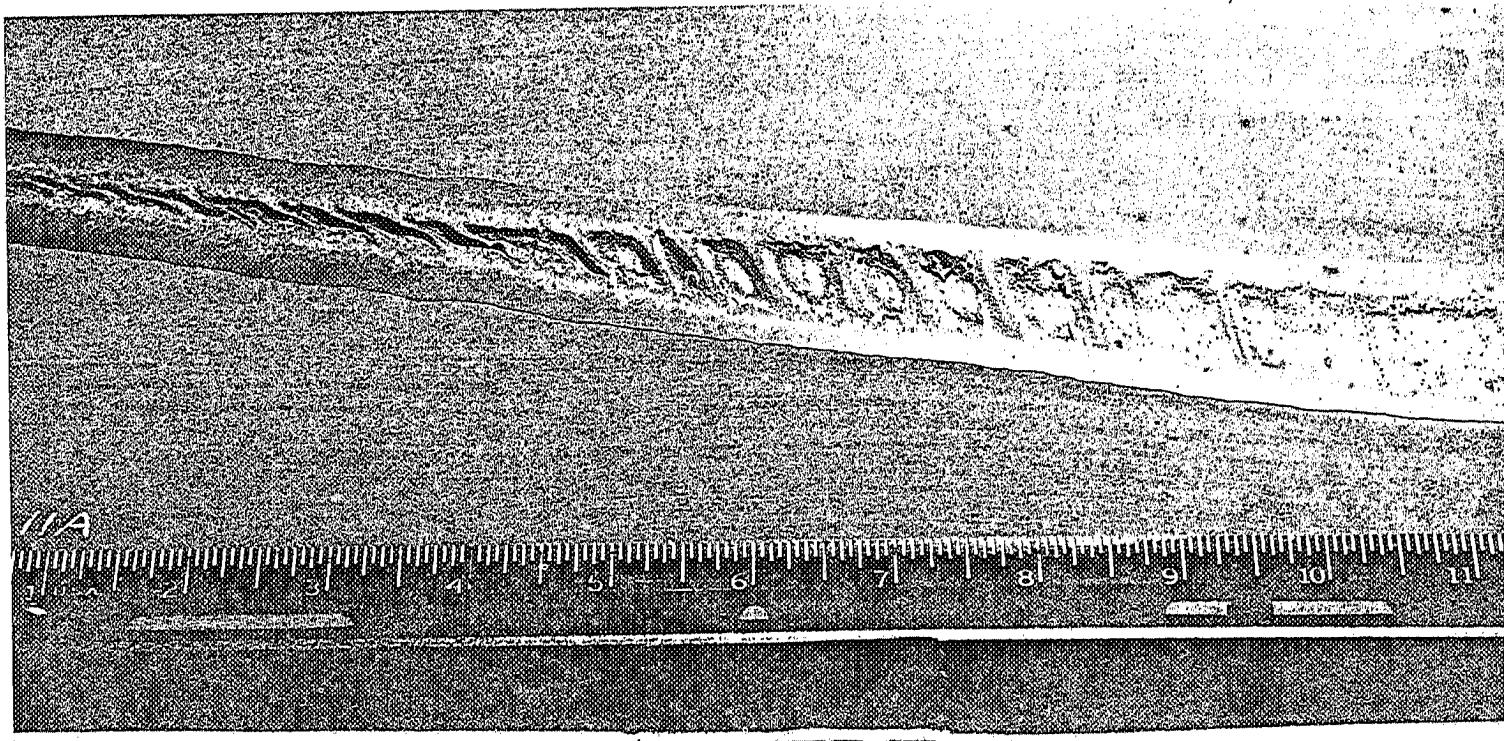
Figure 26 - Foreign material - major.

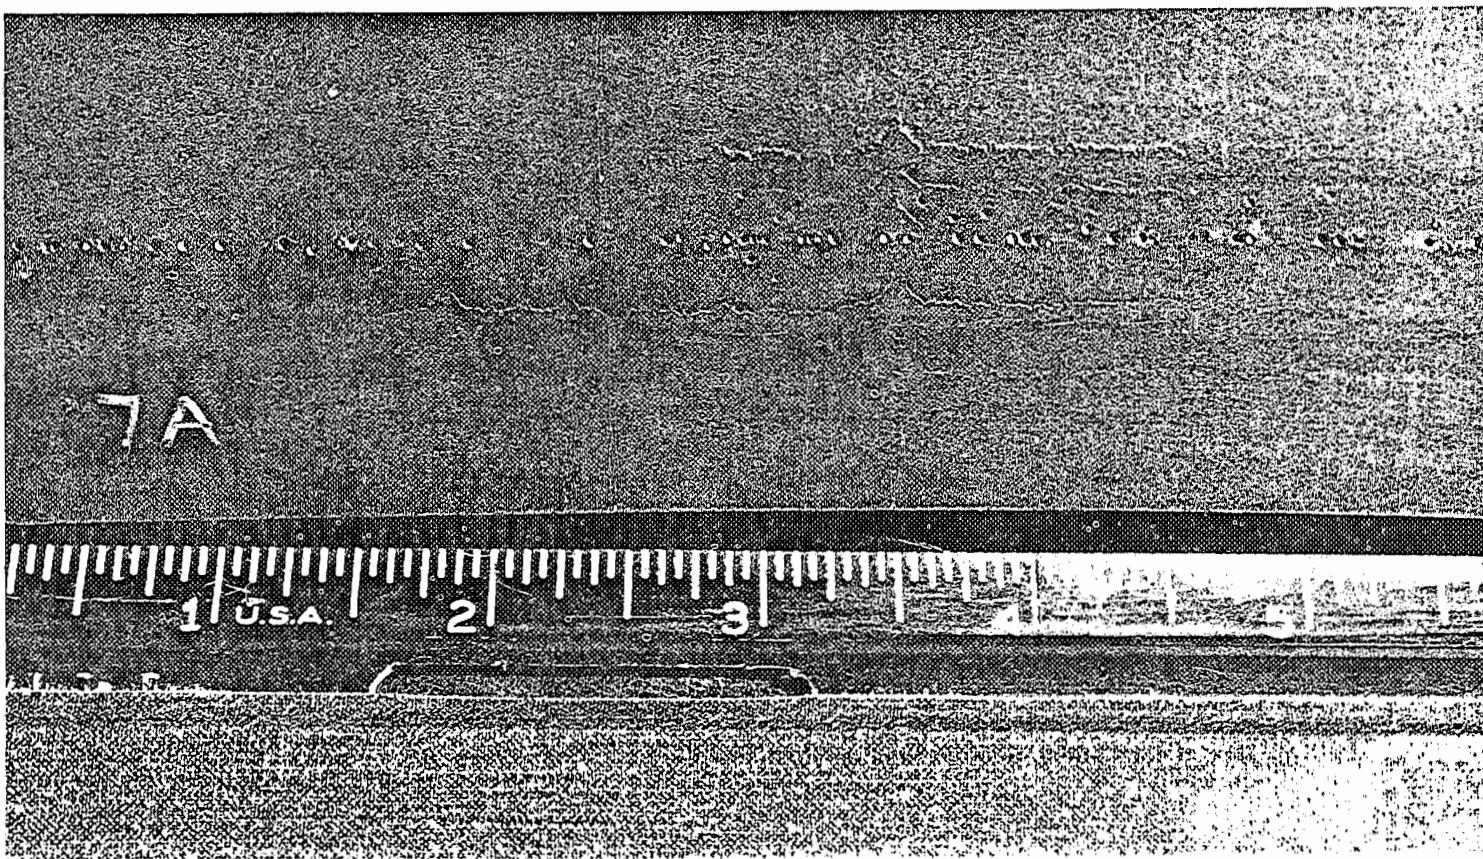
Figure 29 - Porosity (top view) - major.

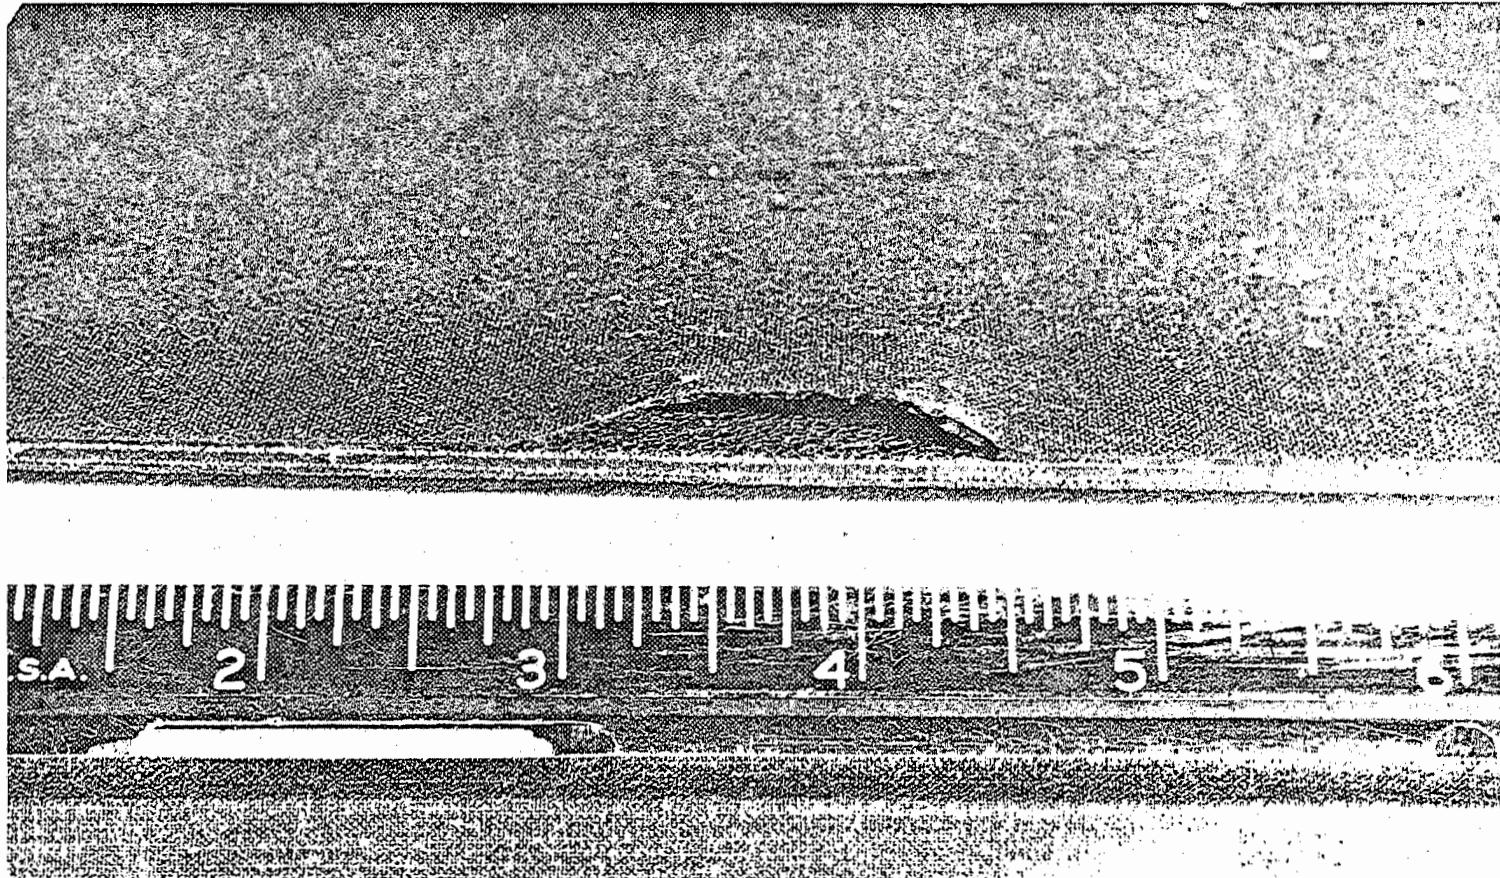
Figure 32 - Delamination (end view) - major.
