## Reducing the Risks of Nonstructural Earthquake Damage

#### A Practical Guide

FEMA 74/September 1994 Supersedes 1985 Edition

WISS, JANNEY, ELSTNER ASSOCIATES, INC.

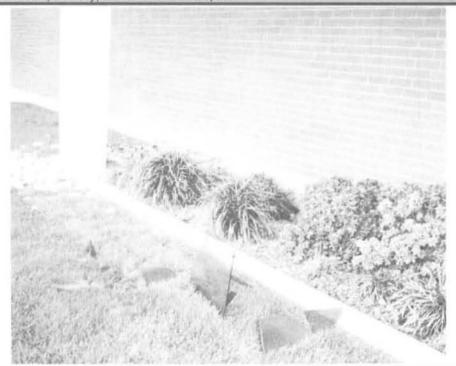
Shard of broken nontempered glass that fell several stories from a multistory building Earthquake Damage: 1994, Northridge, California Photo Credit: Wiss, Janney, Elstner Associates, Inc.

has occurred during past earthquakes include broken glass, overturned tall and heavy cabinets or shelves, falling ceilings or overhead light fixtures, ruptured gas lines or other piping containing hazardous materials, damaged friable asbestos materials, falling pieces of decorative brickwork or precast concrete panels, and collapsed masonry walls or fences. (Figures 2 and 3).

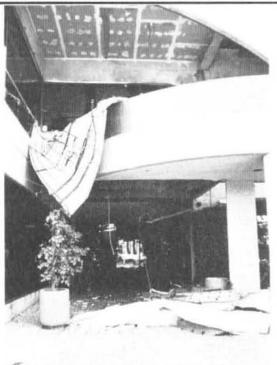
Failure of heavy stucco soffit at building entrance Earthquake Damage: 1994, Northridge, California Photo Credit: Robert Reitherman

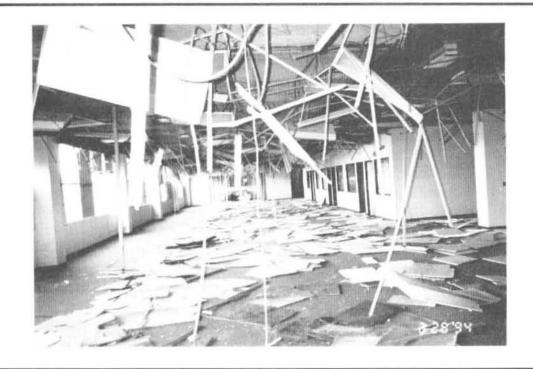
Complete loss of suspended ceiling and light fixtures Earthquake Damage: 1994, Northridge, California Photo Credit: Wiss, Janney, Elstner Associates, Inc.

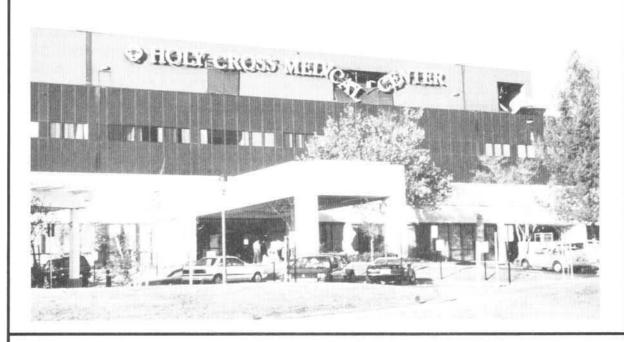
HVAC damage at Holy Cross Medical Center in Sylmar—damage to signage and louvers caused when suspended fans in the mechanical penthouse swung and impacted the louver panels. HVAC service outage caused the temporary evacuation of all patients.

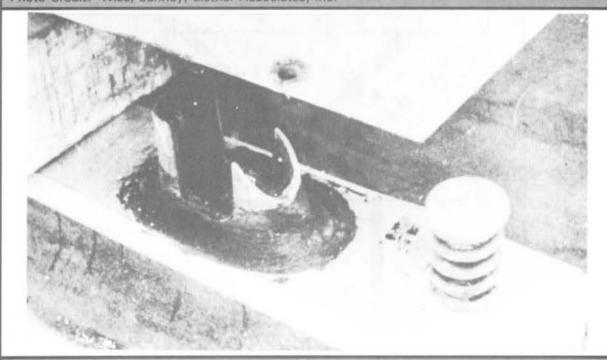
Failed chiller due mount due to insufficient shear resistance.

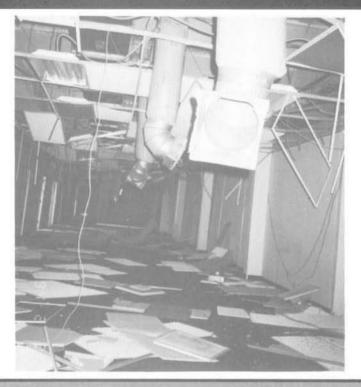
Air diffusers fell to the floor.

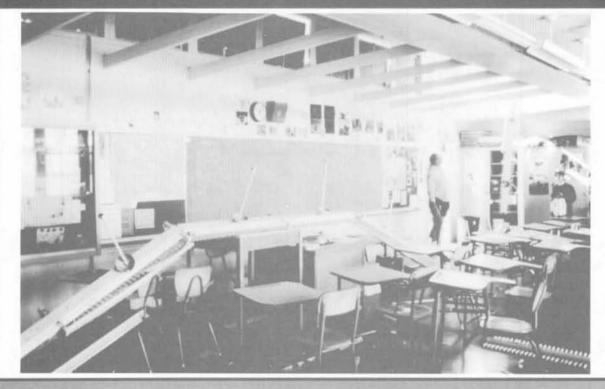
Failure of light fixtures at Northridge Junior High School Earthquake Damage: 1994, Northridge, California

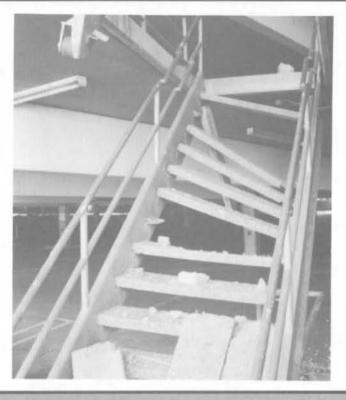
- TO PREVENT DAMAGE TO STAIRS THEY SHOULD BE MODIFIED TO ALLOW THEM TO SLIDE AT LANDINGS WITH "GANG PLANK" DETAILS; THIS IS DESIRABLE FOR FLEXIBLE FRAME BUILDINGS.
- IF STAIR ENCLOSURES ARE CONSTRUCTED USING BRITTLE MATERIALS, SUCH AS, HOLLOW CLAY TILE, GLASS BLOCK PARTITIONS, OR SKYLIGHTS, IT IS RECOMMENDED THAT THEY BE ENCAPSULATED OR REPLACED TO PREVENT FALLING HAZARDS AND DEBRIS IN THE STAIRWELL.
- PROVIDE ANCHORAGE FOR PIPES, LIGHTING OR DUCTS IN STAIRWELLS TO PREVENT FALLING HAZARDS AND DEBRIS.

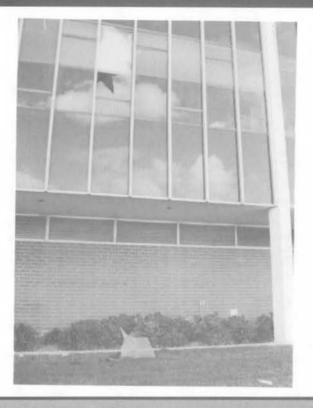
- USE OF TEMPERED GLASS WILL GREATLY REDUCE THE SEISMIC HAZARD. TEMPERED GLASS MAY STILL BREAK, BUT WILL BREAK INTO SMALL DULL FRAGMENTS INSTEAD OF LARGE DANGEROUS SHARDS.
- POLYESTER SHATTER RESISTANT FILMS ARE AVAILABLE THAT HELP HOLD TOGETHER FRAGMENTS OF ANY PANES THAT CRACK IN AN EARTHQUAKE. (TYPICAL SOLAR FILM MAY NOT BE ADEQUATE FOR THIS PURPOSE).
- USE OF LAMINATED GLASS FOR STOREFRONTS REDUCES SEISMIC RISK AND ALSO INCREASES PROTECTION FROM BURGLARY OR VANDALISM.
- SMALLER, OPERABLE, AND WOODEN FRAMED WINDOWS TOLERATE MORE LATERAL DRIFT.
- FOR NEW CONSTRUCTION, STIFFER BUILDINGS AND GLAZING WITH MORE THAN
  THE STANDARD EDGE CLEARANCES MAY BE DESIRABLE. CHECK WHETHER OR NOT
  THE BUILDING'S CALCULATED SEISMIC DRIFT HAS BEEN CONSIDERED IN THE
  DESIGN OF THE GLAZING.

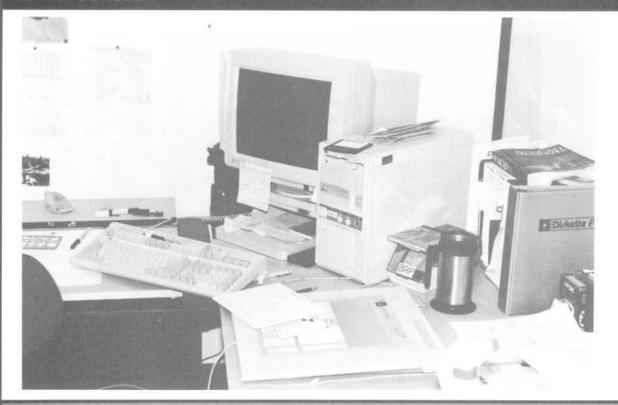
Unsecured computers may fall and suffer damage Photo Credit: Wiss, Janney, Elstner Associates, Inc.

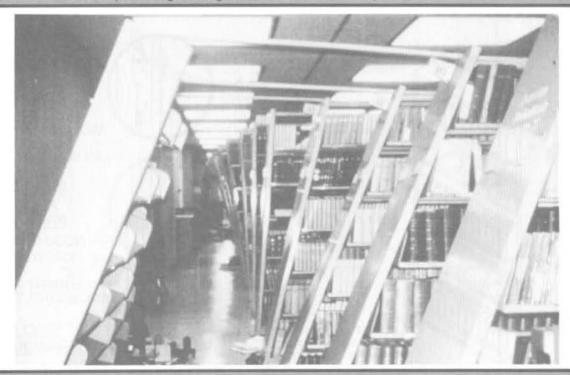
Failure of inadequately upgraded library shelving Earthquake Damage: 1987, Whittier Narrows, California

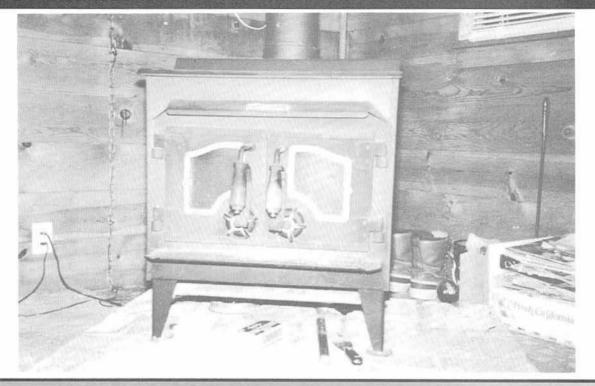
Unrestrained wood burning stove Photo Credit: Wiss, Janney, Elstner Associates, Inc.

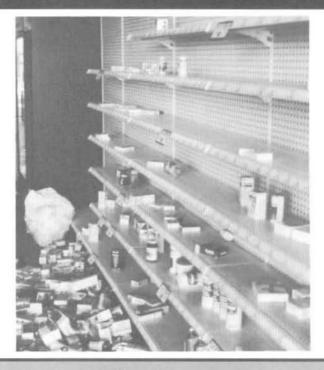
Spilled pharmaceutical and medical supplies.
