Reducing the Risks of Nonstructural Earthquake Damage

A Practical Guide

**FEMA 74/September 1994
Supersedes 1985 Edition**

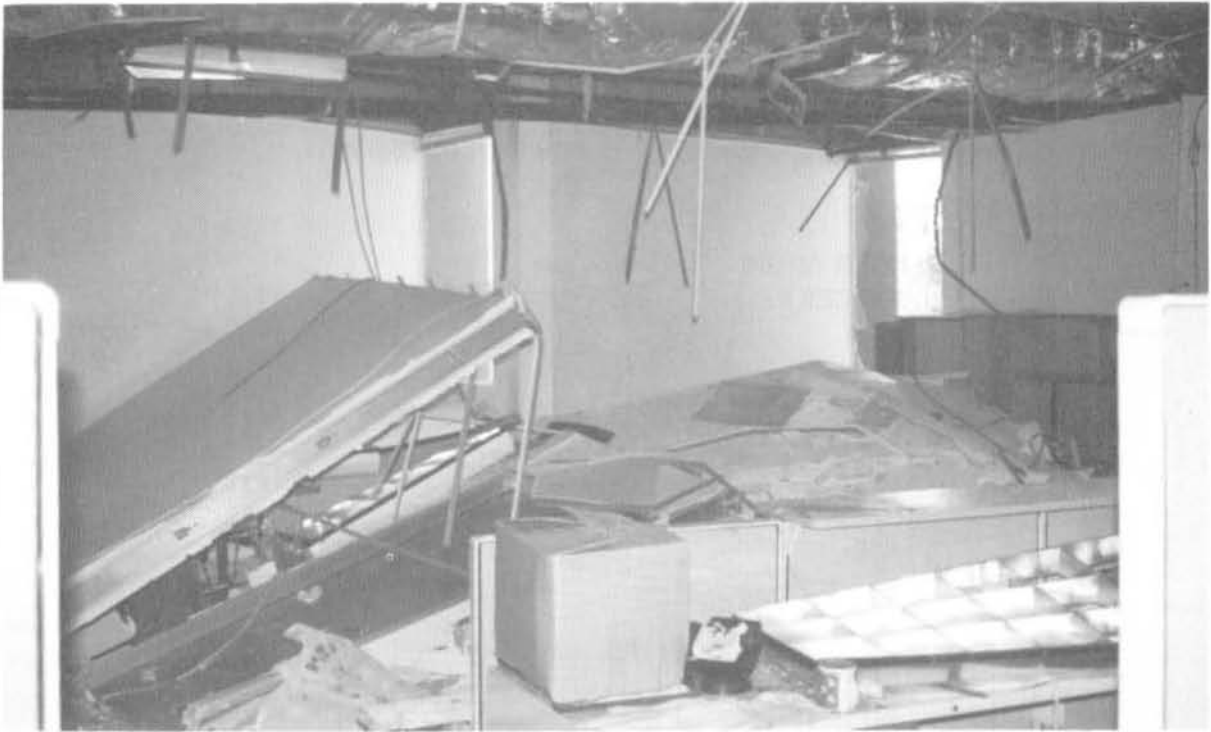
Failure of office partitions, ceilings, and light fixtures
Earthquake Damage: 1994, Northridge, California
Photo Credit: Wiss, Janney, Elstner Associates, Inc.

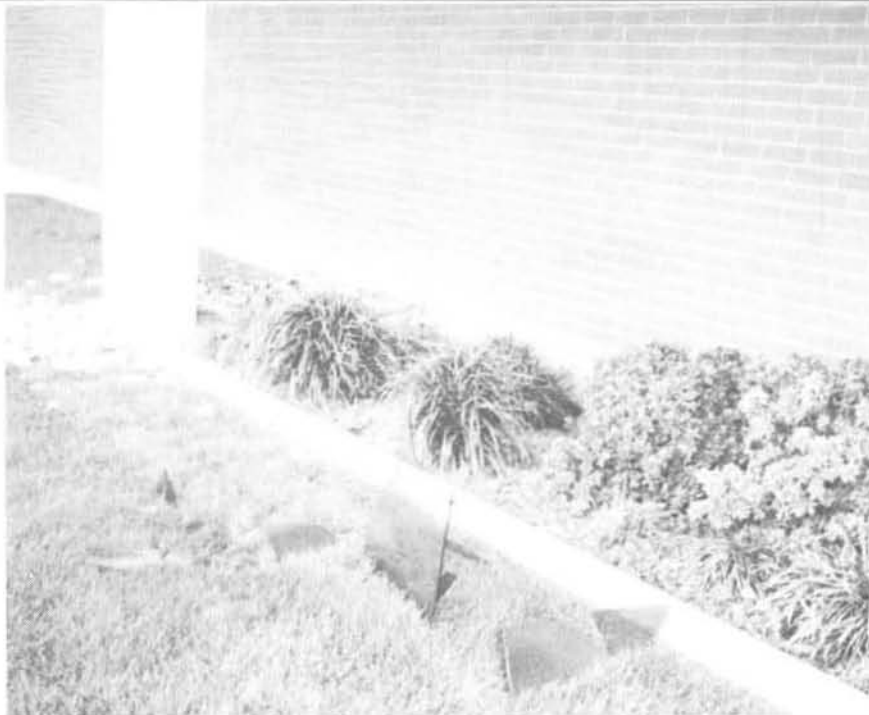
Shard of broken nontempered glass that fell several stories from a multistory building
Earthquake Damage: 1994, Northridge, California
Photo Credit: Wiss, Janney, Elstner Associates, Inc.

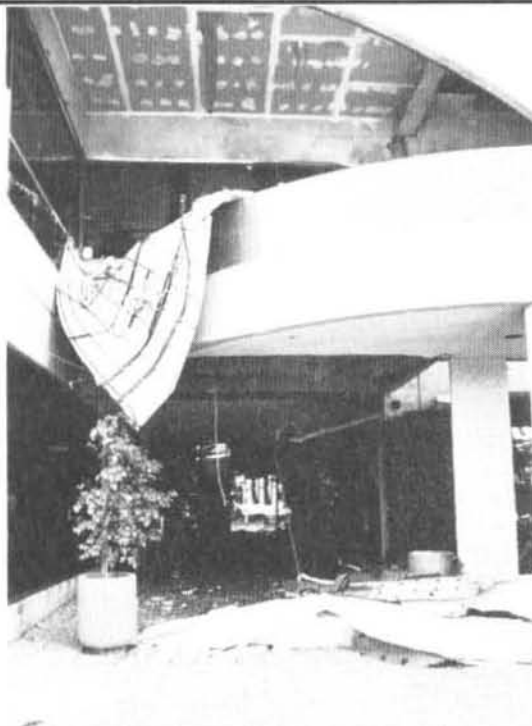
Failure of heavy stucco soffit at building entrance
Earthquake Damage: 1994, Northridge, California
Photo Credit: Robert Reitherman

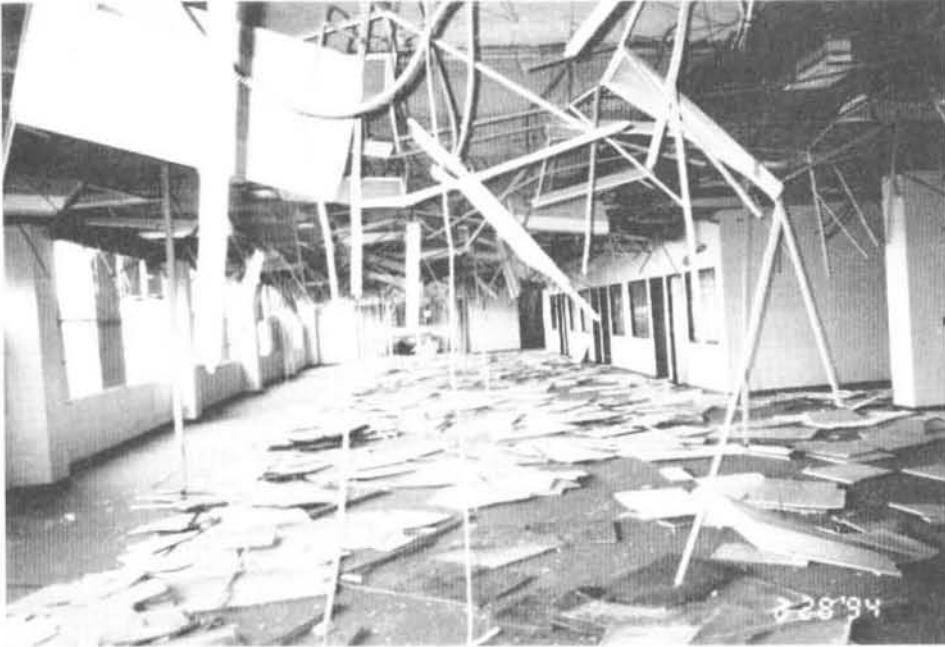
Complete loss of suspended ceiling and light fixtures
Earthquake Damage: 1994, Northridge, California
Photo Credit: Wiss, Janney, Elstner Associates, Inc.

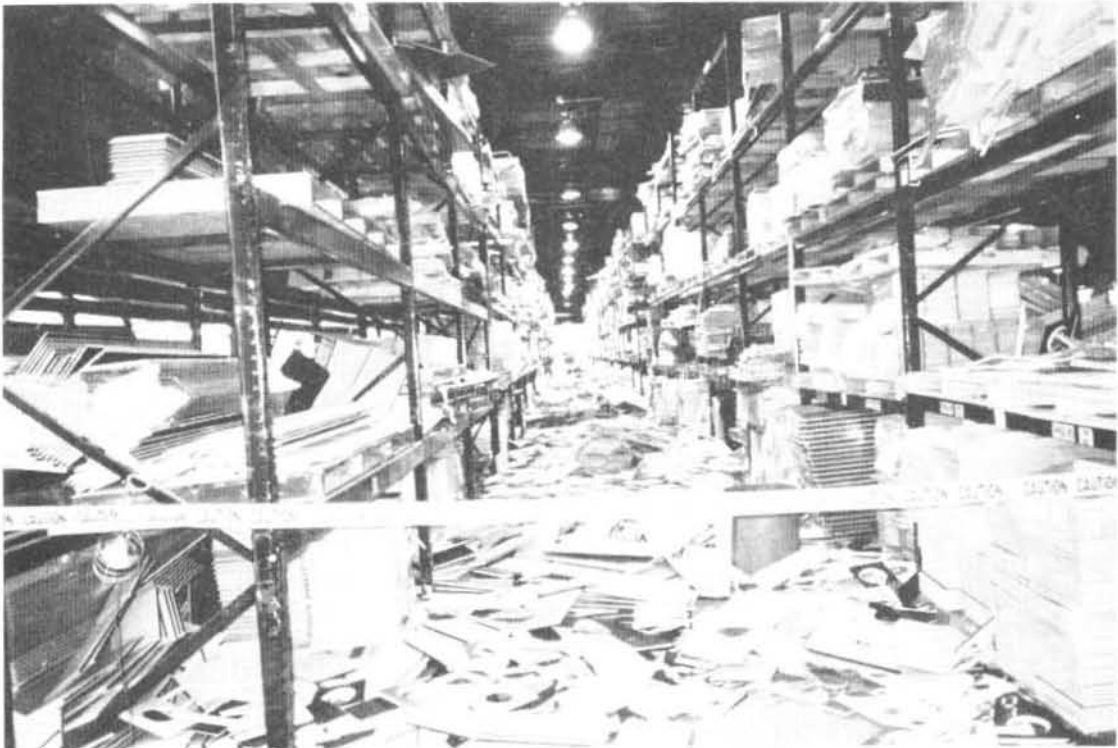
Damage to inventory on industrial storage racks
Earthquake Damage: 1994, Northridge, California
Photo Credit: Wiss, Janney, Elstner Associates, Inc.

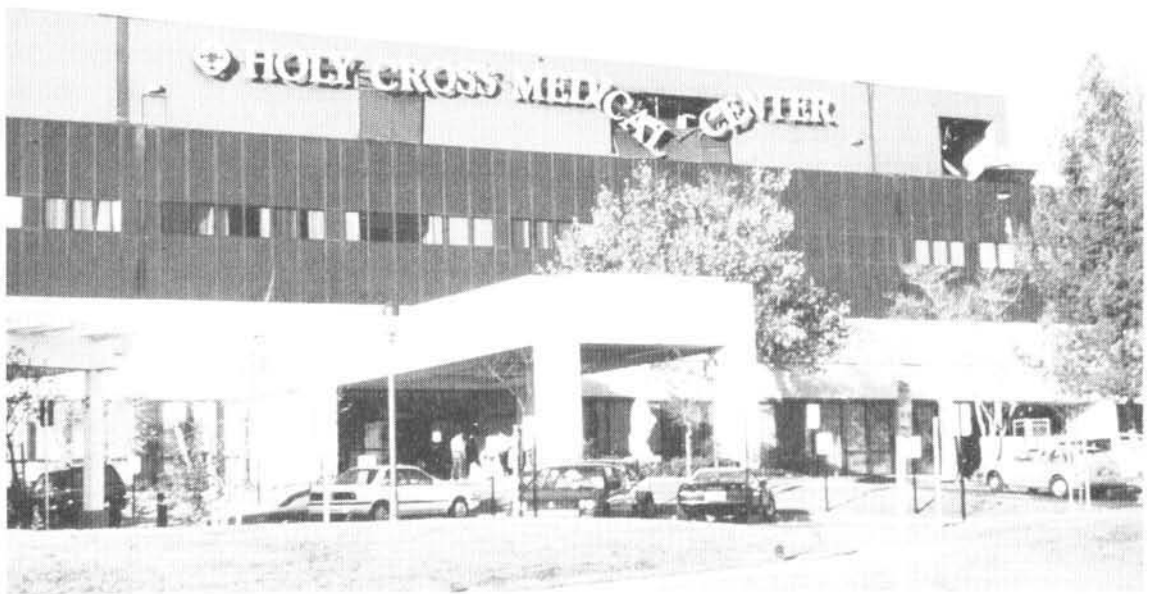
HVAC damage at Holy Cross Medical Center in Sylmar—damage to signage and louvers caused when suspended fans in the mechanical penthouse swung and impacted the louver panels. HVAC service outage caused the temporary evacuation of all patients.
Earthquake Damage: 1994, Northridge, California
Photo Credit: Robert Reitherman

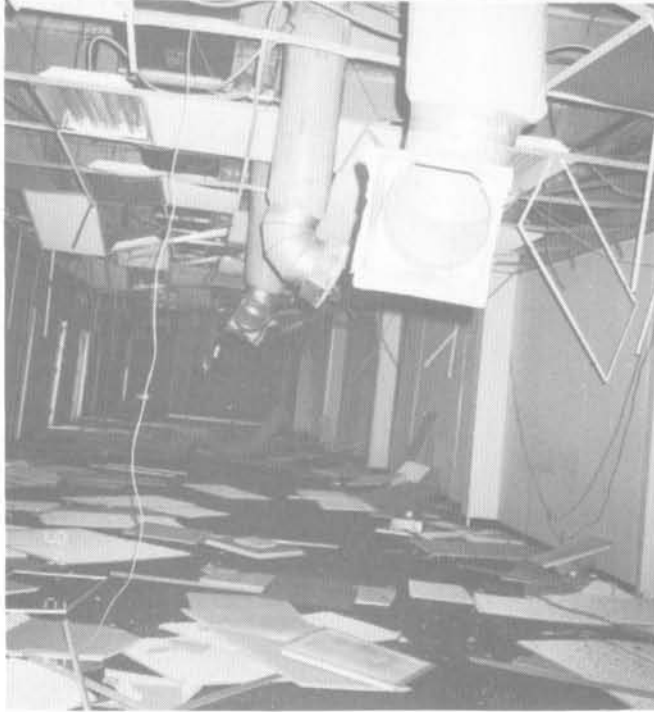
Air diffusers fell to the floor.
Earthquake Damage: 1994, Northridge, California
Photo Credit: Wiss, Janney, Elstner Associates, Inc

12 GAUGE WIRES AT EACH
CORNER OR AT LEAST
AT DIAGONALLY OPPOSITE
CORNERS

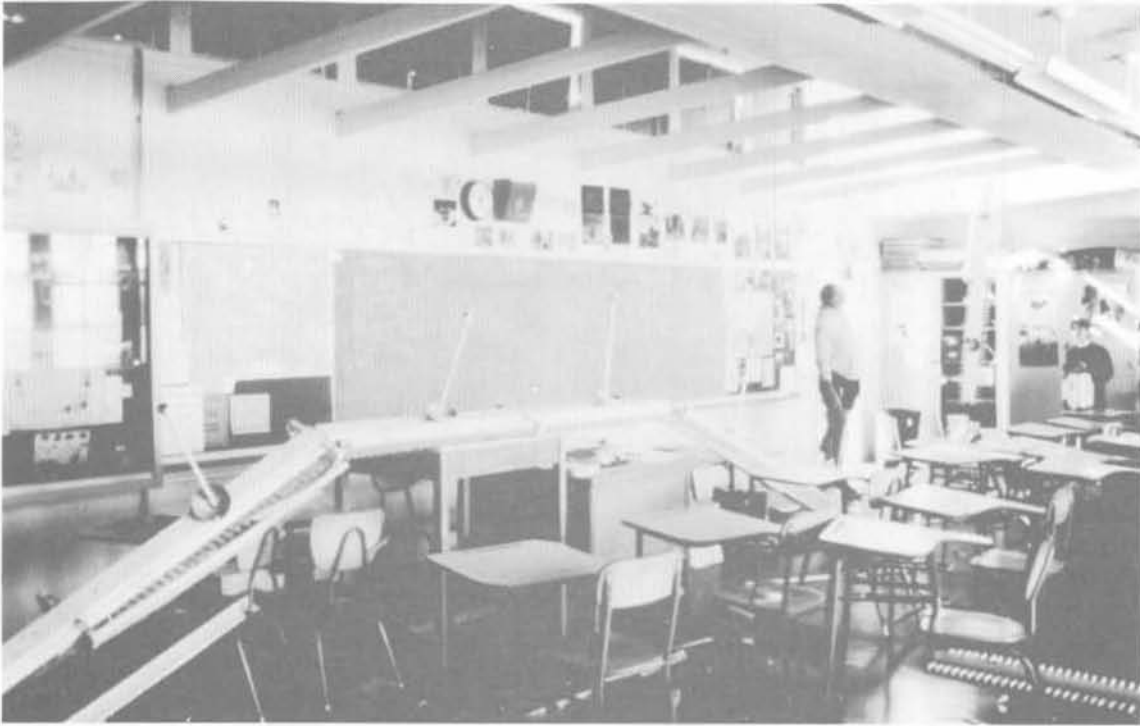
Failure of light fixtures at Northridge Junior High School
 Earthquake Damage: 1994, Northridge, California
 Photo Credit: Earthquake Engineering Research Institute, Gary L. McGavin

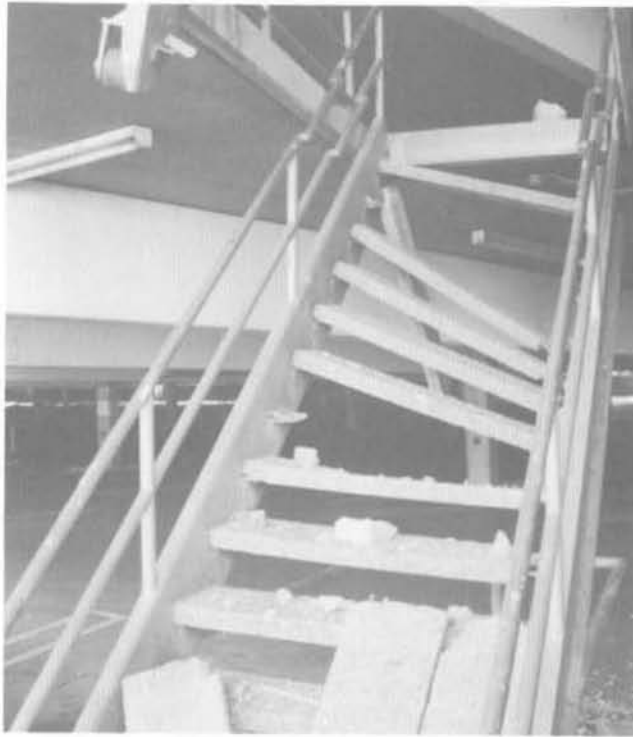
- TO PREVENT DAMAGE TO STAIRS THEY SHOULD BE MODIFIED TO ALLOW THEM TO SLIDE AT LANDINGS WITH "GANG PLANK" DETAILS; THIS IS DESIRABLE FOR FLEXIBLE FRAME BUILDINGS.
- IF STAIR ENCLOSURES ARE CONSTRUCTED USING BRITTLE MATERIALS, SUCH AS, HOLLOW CLAY TILE, GLASS BLOCK PARTITIONS, OR SKYLIGHTS, IT IS RECOMMENDED THAT THEY BE ENCAPSULATED OR REPLACED TO PREVENT FALLING HAZARDS AND DEBRIS IN THE STAIRWELL.
- PROVIDE ANCHORAGE FOR PIPES, LIGHTING OR DUCTS IN STAIRWELLS TO PREVENT FALLING HAZARDS AND DEBRIS.

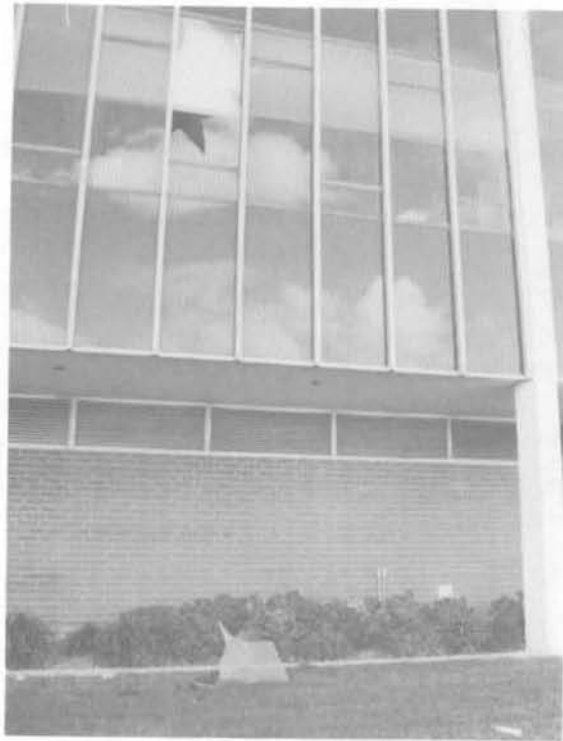
- USE OF TEMPERED GLASS WILL GREATLY REDUCE THE SEISMIC HAZARD. TEMPERED GLASS MAY STILL BREAK, BUT WILL BREAK INTO SMALL DULL FRAGMENTS INSTEAD OF LARGE DANGEROUS SHARDS.
- POLYESTER SHATTER RESISTANT FILMS ARE AVAILABLE THAT HELP HOLD TOGETHER FRAGMENTS OF ANY PANES THAT CRACK IN AN EARTHQUAKE. (TYPICAL SOLAR FILM MAY NOT BE ADEQUATE FOR THIS PURPOSE).
- USE OF LAMINATED GLASS FOR STOREFRONTS REDUCES SEISMIC RISK AND ALSO INCREASES PROTECTION FROM BURGLARY OR VANDALISM.
- SMALLER, OPERABLE, AND WOODEN FRAMED WINDOWS TOLERATE MORE LATERAL DRIFT.
- FOR NEW CONSTRUCTION, STIFFER BUILDINGS AND GLAZING WITH MORE THAN THE STANDARD EDGE CLEARANCES MAY BE DESIRABLE. CHECK WHETHER OR NOT THE BUILDING'S CALCULATED SEISMIC DRIFT HAS BEEN CONSIDERED IN THE DESIGN OF THE GLAZING.

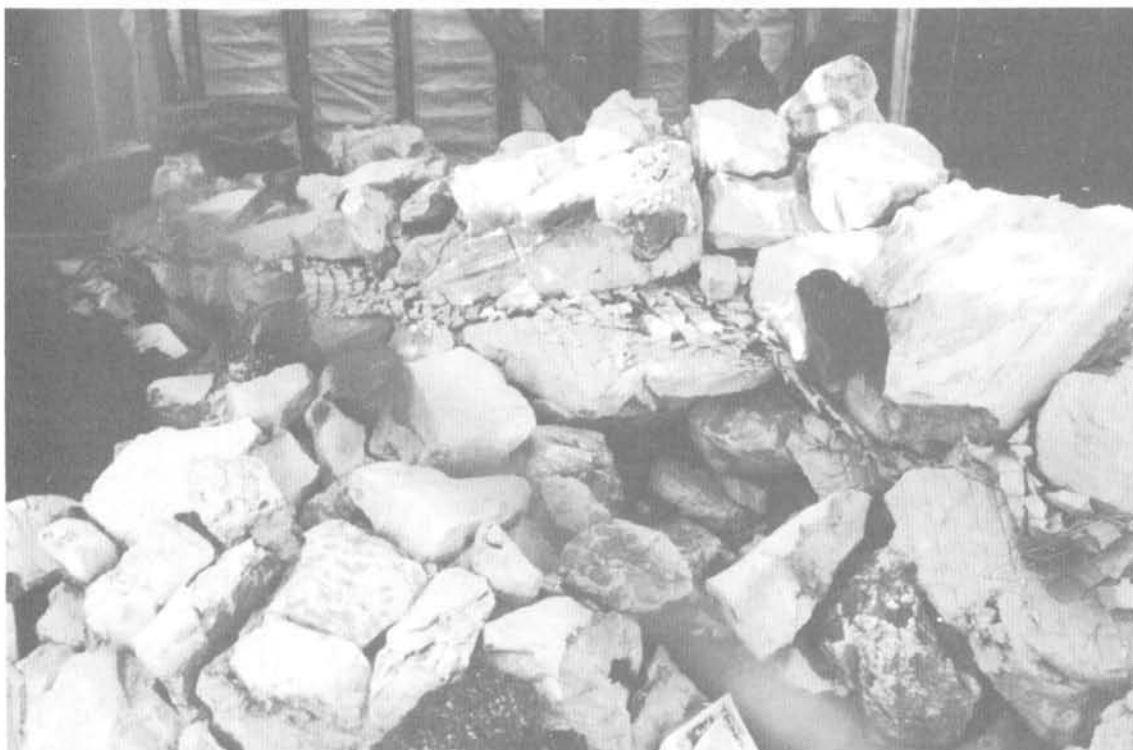
- SEE APPLICABLE BUILDING CODE REQUIREMENTS FOR LIMITATIONS REGARDING THE HEIGHT, AREA, UNIT SIZE, AND UNIT WEIGHT OF EITHER ADHERED OR ANCHORED VENEER SYSTEMS. REFER TO THE CODE SECTIONS FOR SPECIFIC REQUIREMENTS FOR BACKING, TIES, AND REINFORCEMENT. (FOR EXAMPLE, SECTION 1403 OF THE 1994 UBC).
- VENEER SYSTEMS MUST ALSO AT LEAST MEET THE MINIMUM LATERAL FORCE REQUIREMENTS FOR NONSTRUCTURAL COMPONENTS. (FOR EXAMPLE, THE REQUIREMENTS FOR EXTERIOR AND INTERIOR ORNAMENTATION AND APPENDAGES IN CHAPTER 16 OF THE 1994 UBC).
- REMOVAL OF VENEER MOUNTED OVER ENTRANCES OR OTHER POTENTIALLY CROWDED LOCATIONS IS THE MOST RELIABLE UPGRADE SOLUTION.

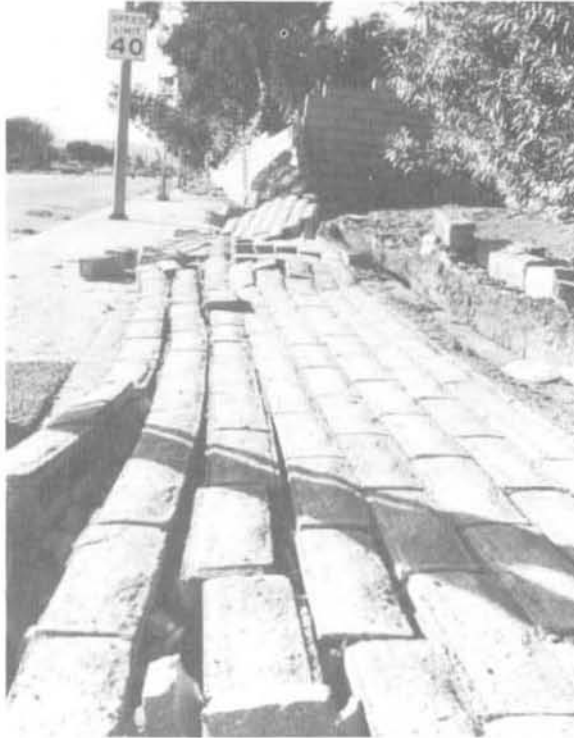
- MANY MILES OF POORLY CONSTRUCTED CONCRETE MASONRY UNIT (CMU) FENCES WERE DAMAGED DURING THE 1994 NORTHRIDGE EARTHQUAKE. COLLAPSE OF WALLS WITH INADEQUATE OR ABSENT REINFORCING AND/OR FOUNDATIONS WAS COMMON IN NORTHRIDGE AND SYLMAR. IN MANY CASES, MOST OF THE SIDEWALK WAS COVERED WITH DEBRIS, AS SHOWN ABOVE.
- FREESTANDING WALLS OR FENCES BUILT OF CMU, BRICK, OR STONE NEED TO BE ENGINEERED AND CONSTRUCTED WITH APPROPRIATE FOUNDATIONS, ADEQUATE REINFORCEMENT, AND GOOD QUALITY MORTAR.
- STANDARD DETAILS FOR LOW FENCES OR SHORT RETAINING WALLS MAY BE AVAILABLE FROM THE LOCAL BUILDING DEPARTMENT.

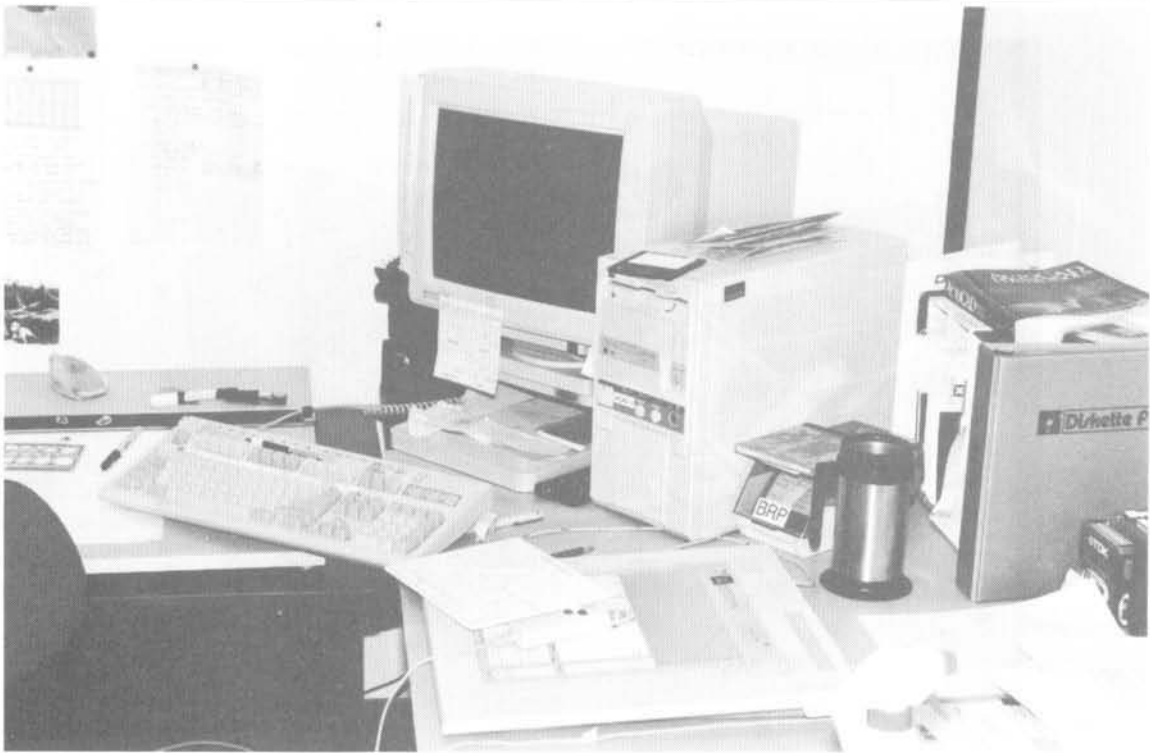
Unsecured computers may fall and suffer damage
Photo Credit: Wiss, Janney, Elstner Associates, Inc.

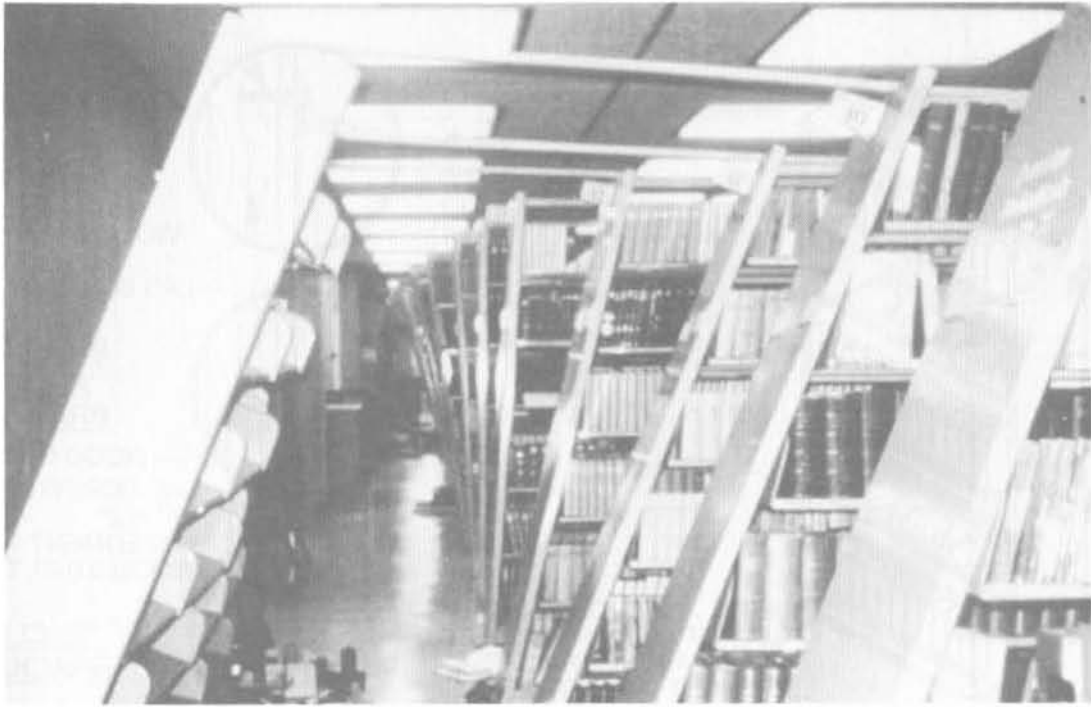
Failure of inadequately upgraded library shelving
Earthquake Damage: 1987, Whittier Narrows, California
Photo Credit: Earthquake Engineering Research Institute, Marshall Lew & Greg Brandow **C12b**

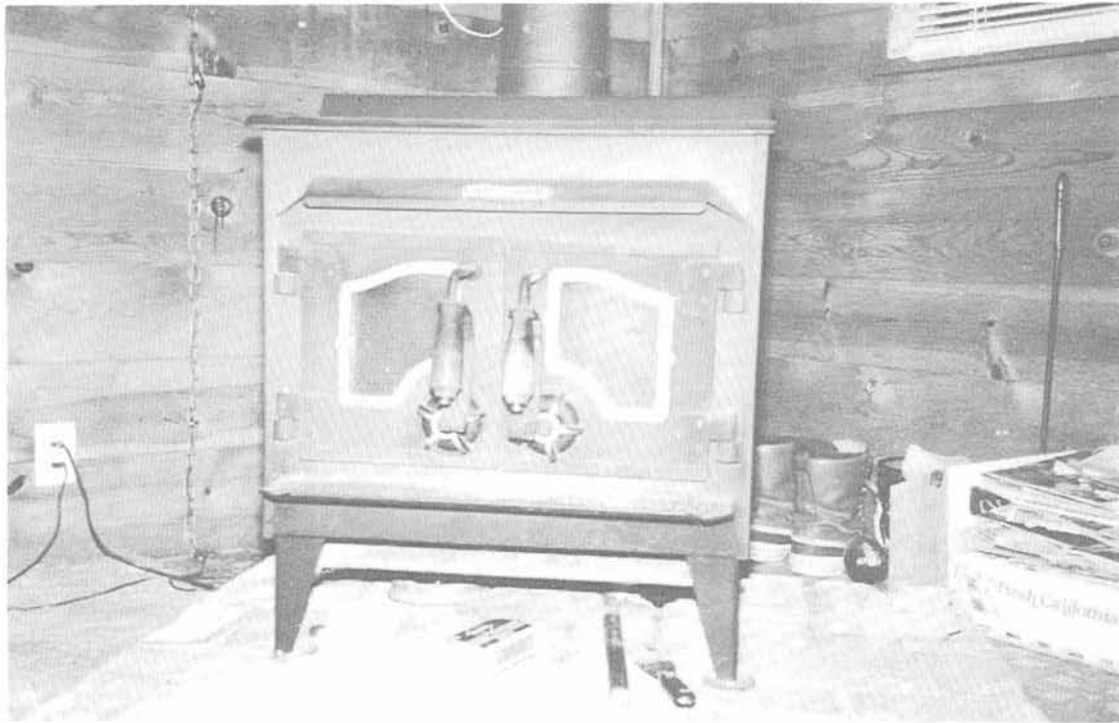
Unrestrained wood burning stove
 Photo Credit: Wiss, Janney, Elstner Associates, Inc.

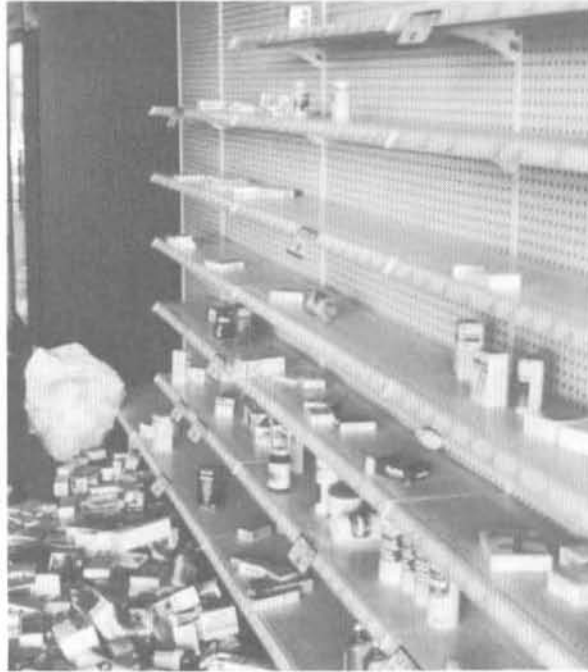
Spilled pharmaceutical and medical supplies.
 Earthquake Damage: 1994, Northridge, California
 Photo Credit: Robert Reitherman
