NASA/TM—2006–214323

**Experimental Observations for Determining
the Maximum Torque Values to Apply
to Composite Components Mechanically
Joined With Fasteners
(MSFC Center Director's Discretionary Fund Final Report,
Project No. 03–13)**

F.P. Thomas

February 2006

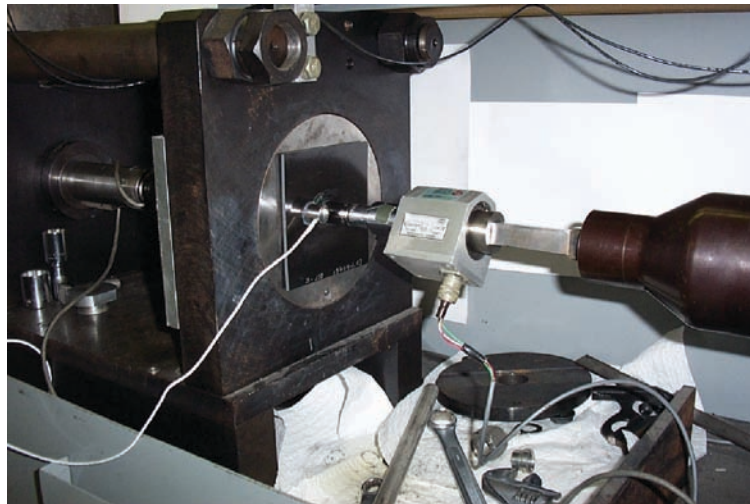
Figure 1. Torque versus tension test.

Testing consisted of installing a fastener in a specimen (table 1), placing the AE transducer on the test specimen, and tightening the fastener until either the fastener reached its maximum tension allowable or the composite specimen failed. Figure 1 shows a test specimen in the torque versus tension tester at MSFC. Figure 2 is a graphic model of the torque versus tension test machine and identifies its major components. Figures 3 and 4 are a top view and a cross-sectional view of the torque versus tension machine, respectively. Figure 5 is a detailed view of the typical test setup. Figure 6 identifies the specific components of the test setup. The bolt head is retained in a specialized fixture attached to the load cell of the torque versus tension tester. The test specimen is positioned on a stationary reaction plate with the shank of the bolt protruding through the stationary reaction plate and the test specimen. A nut retains the test specimen to the stationary reaction plate. For this initial testing, the torque versus tension machine's standard reaction plate was used. The reaction plate provides a mounting area for the test specimen and provides the reaction to the torque-induced compressive bolt load. The reaction plate has an approximately 2-in diameter hole in the center. An adjustable torque transducer provides the tightening operation by turning the nut. The torque versus tension tester records the bolt tension and the corresponding torque produced during the tightening sequence.

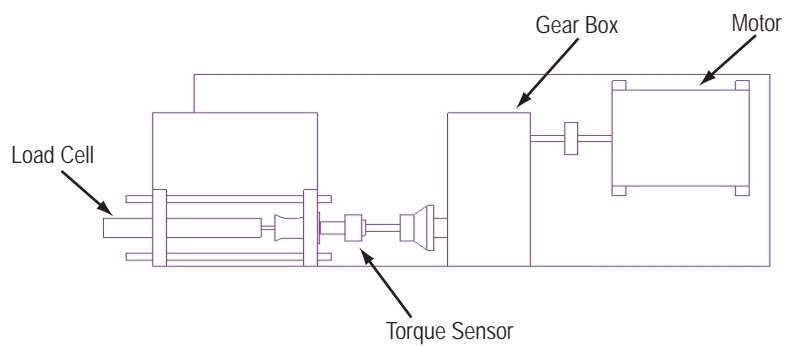
Figure 3. Top view of torque versus tension machine.

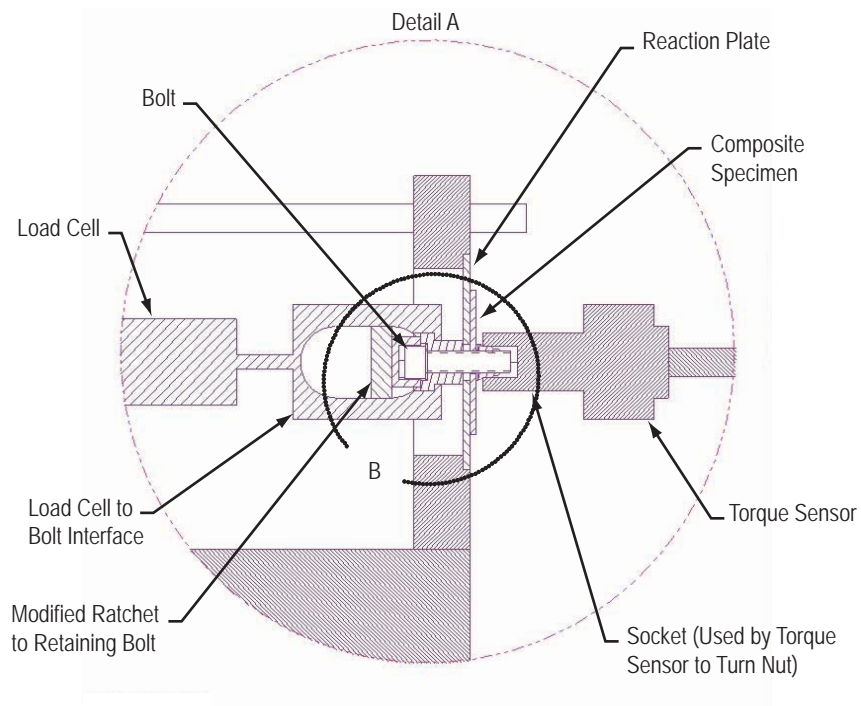
Figure 5. Detailed view of test setup.

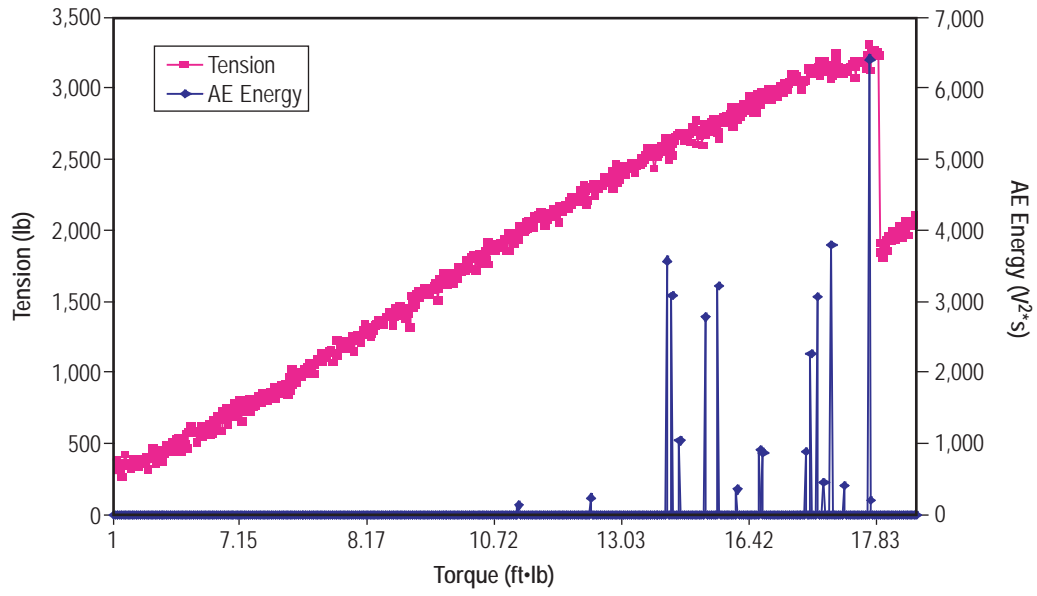
Figure 7. Torque versus tension and torque versus acoustic emissions energy—specimen 33.

Referring to figure 7, torque versus tension and torque versus AE energy—specimen 33, most of the internal structural deformation, due to bending, occurs as the tension approaches its maximum and the resulting acoustic energy levels are larger than during any other portion of the test. Table 7 summarizes the maximum acoustic energy levels recorded for the 72 initial tests. The maximum acoustic energy level occurs at the maximum tension. Although the deformation is caused by bending, the key observations are that the deformation is captured by the acoustic sensor and essentially no acoustic waves are detected at the MSFC–STD–486, Table VI safe torque levels. This indicates that there is no evidence of damage to the specimen at the MSFC–STD–486, Table VI torque levels.

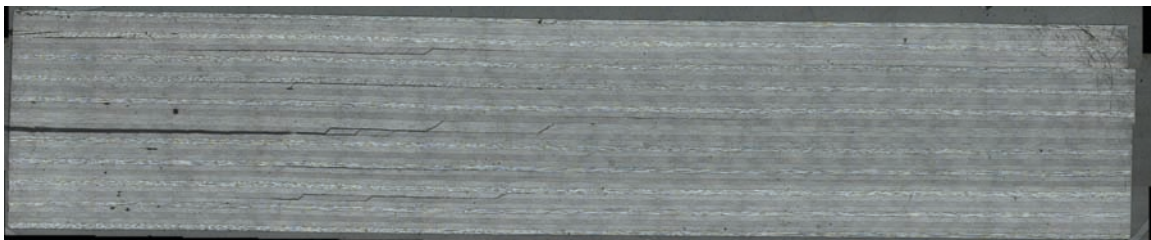
Figure 9. Photomicroscopy.

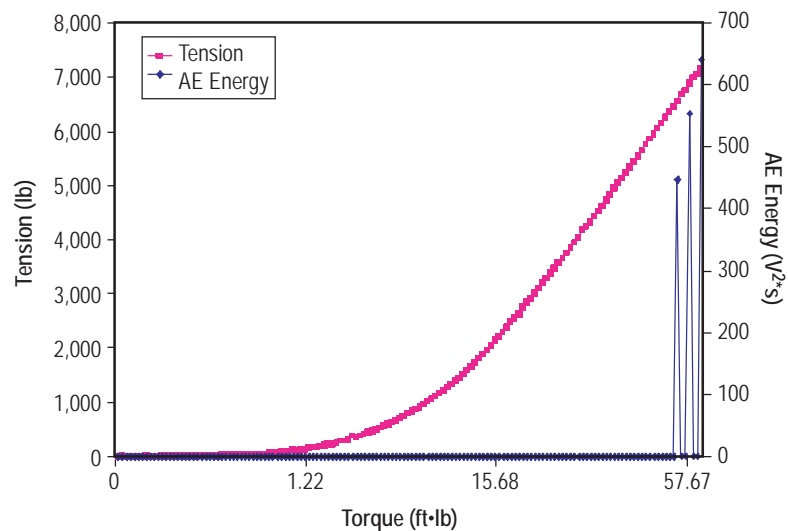
Figure 10 shows the results from a follow-on test using a 1/2-in bolt, IM7/8552 material, 0.185-in thick specimen that was torqued to a maximum of 61 ft•lb. This test specimen had the highest acoustic energy level, 642 V^2*s , of all the follow-on tests performed. The acoustic energy level recorded is significantly less than as observed in the initial tests, but suggests that there may be minor movement

of the internal structure. This is most likely due to redistribution of the matrix material during the torquing sequence. Also, detectable acoustic energy waves could be generated by the rubbing of the washer against the composite component or the metallic socket. Table 8 summarizes the maximum acoustic energy levels recorded for the 288 follow-on tests and indicates that the acoustic energy levels, for specimens torqued to the maximum specified in MSFC-STD-486, Table VI, is not sufficient to cause damage to the composite component. In addition, each of the follow-on tested specimens were subjected to thermography analysis and revealed no indications of permanent internal damage (appendix B). Therefore, the acoustic energy levels observed for these tests indicate that torquing to the values specified in MSFC-STD-486, Table VI are acceptable for the materials and thicknesses tested.

Figure 10. Torque versus tension and torque versus acoustic emissions energy follow-on test with 1/2-in bolt, IM7/8552 material, 0.185-in thick.
