NICHROME RESISTOR PROPERTIES AND RELIABILITY

ROME AIR DEVELOPMENT CENTER

RADC-TR-73-181  
Final In-House Report  
June 1973

Clyde H. Lane

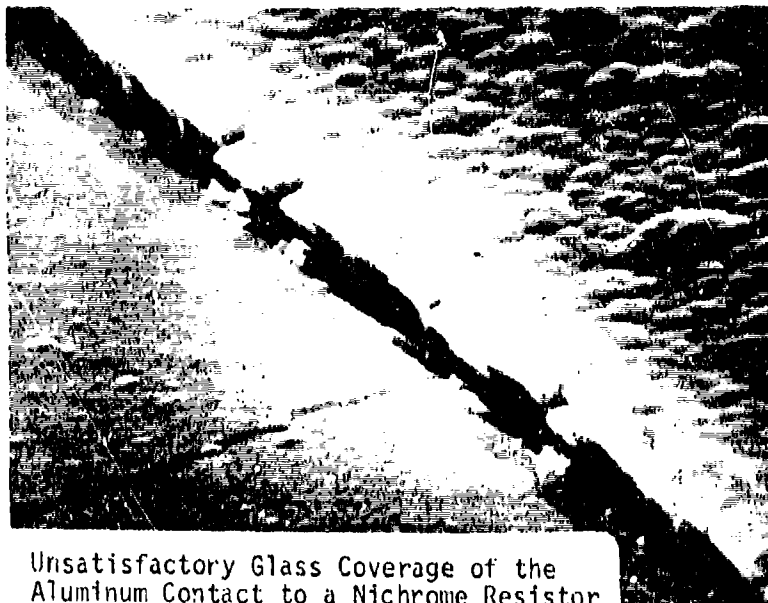
Unsatisfactory Glass Coverage of the  
Aluminum Contact to a Nichrome Resistor  
Figure 1

**Straightforward** chemical corrosion can occur as long as the appropriate ions are present. The crack or pin hole simply provides access to the nichrome. Evidence of simple chemical corrosion on the quad gates was later found also. This fact implicates process control in resistor fabrication as well as in packaging. The Scanning Electron Microscope (SEM) photograph in Figure 1 shows another process control problem, poor step coverage of the aluminum-nichrome termination by the evaporated glass. This forms a pocket which readily catches available water.

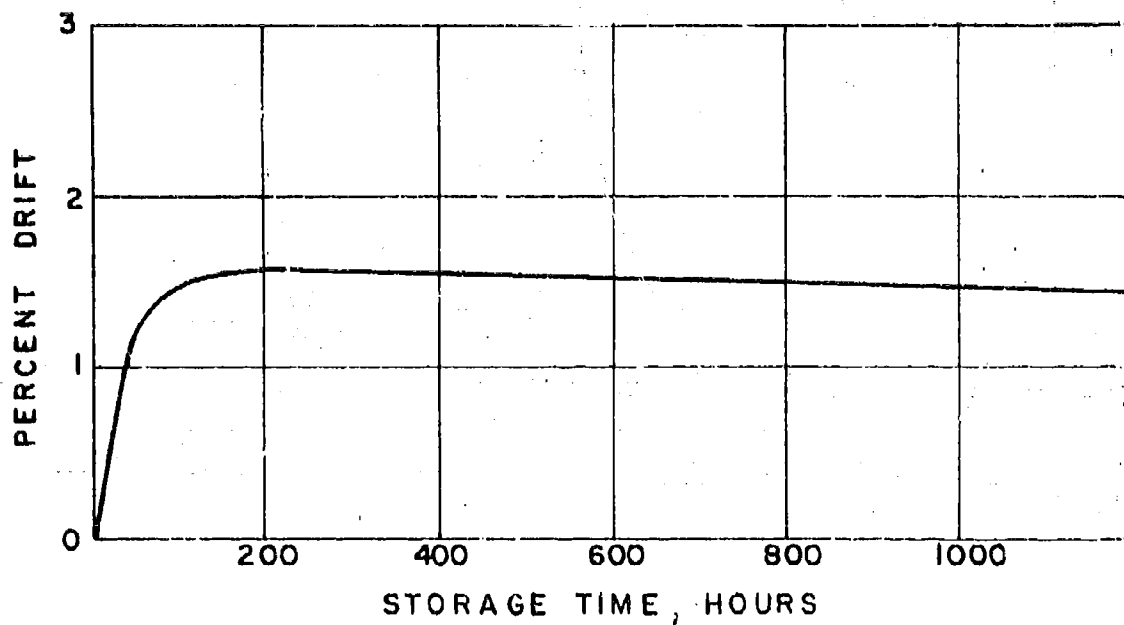
Figure 13  
Component Reliability Nichrome Resistors 200°C Storage

Room temperature, following conditioning at 50% uncontrolled R.H.-  
24 hours.  
Figures 13 and 14 give the results of the tests. Figure 13 gives assurance that the resistors were good under elevated temperature conditions. Figure 14 shows that all resistors on test failed the temperature-humidity-power test catastrophically at 800 hours.
