NICHROME RESISTOR PROPERTIES AND RELIABILITY

RADC-TR-73-181  
Final In-House Report  
June 1973

Clyde H. Lane

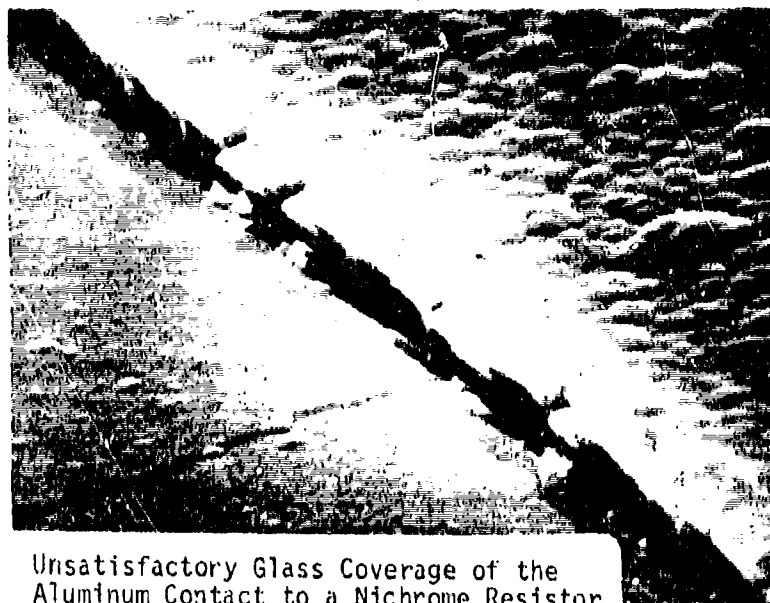
**Straightforward** chemical corrosion can occur as long as the appropriate ions are present. The crack or pin hole simply provides access to the nichrome. Evidence of simple chemical corrosion on the quad gates was later found also. This fact implicates process control in resistor fabrication as well as in packaging. The Scanning Electron Microscope (SEM) photograph in Figure 1 shows another process control problem, poor step coverage of the aluminum-nichrome termination by the evaporated glass. This forms a pocket which readily catches available water.

Unsatisfactory Glass Coverage of the  
Aluminum Contact to a Nichrome Resistor
