Naval Facilities Engineering Command

Inspection, Maintenance and Procurement Procedures for **Wood Poles**

NAVFAC MO-312.3

September 1992

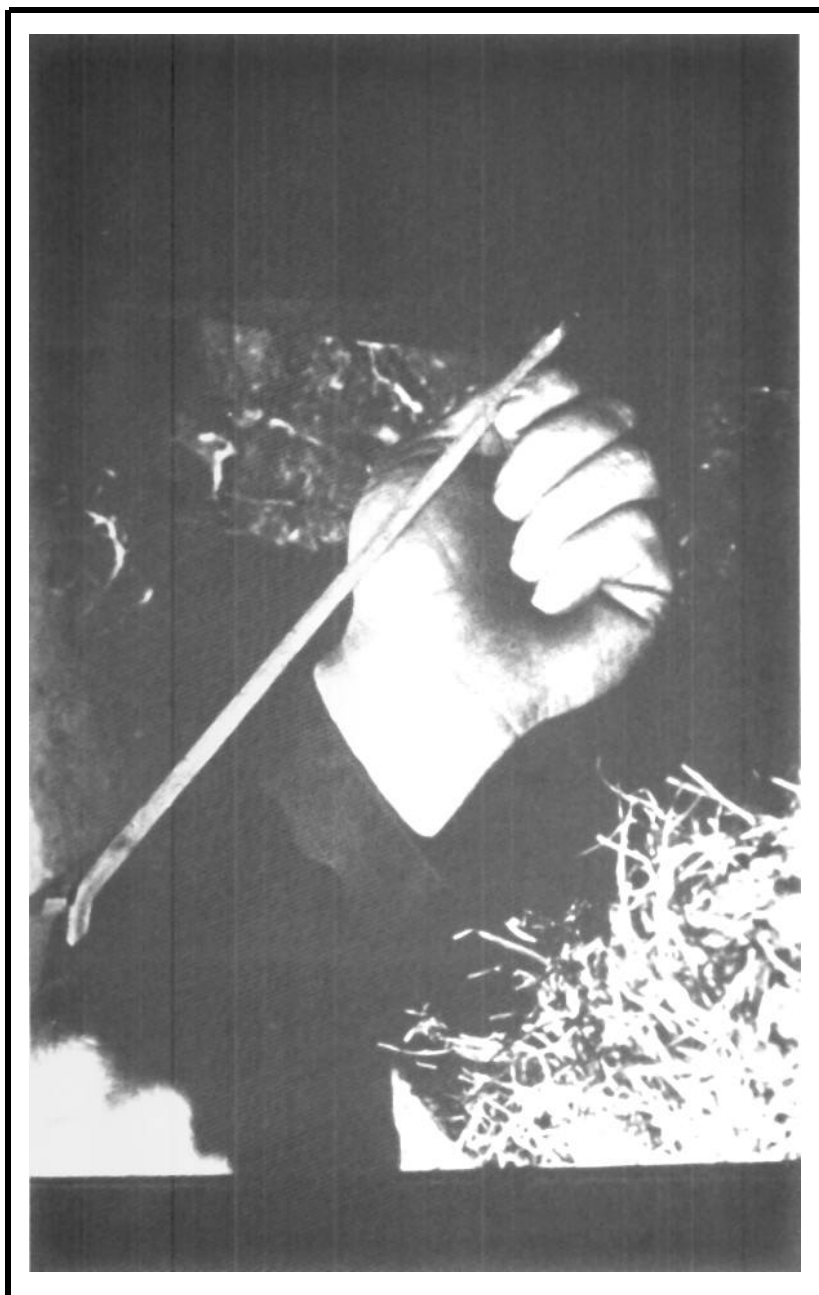
Figure 5
Shell Thickness Indicator

Shell Thickness Indicator. A shell thickness indicator [Figure (5)] can be used to determine the thickness of the non-decayed wood when poles are drilled rather than using an increment borer. The rod is inserted into the hole and then pulled back with pressure against the side of the hole. The hook at the end will catch on the remaining sound wood.

When pushing a tight fitting shell-thickness indicator into a hole, you can feel the tip of the hook pass from one growth ring to another in solid

wood, but not in rotten wood.
